# Uniform Mitigation Verification Inspection Form

**RE: Palmetto Dunes Condominium**  
**7841 Classic Court**  
**Estero, FL 33928**  
**Roofing Restoration**  
KEG File #20RN-0085  
**Wind Mitigation**  
**Permit # 1721125-0**

| Palmetto Dunes CAI – Roofing Project | | | |

REPORT: FR # 17

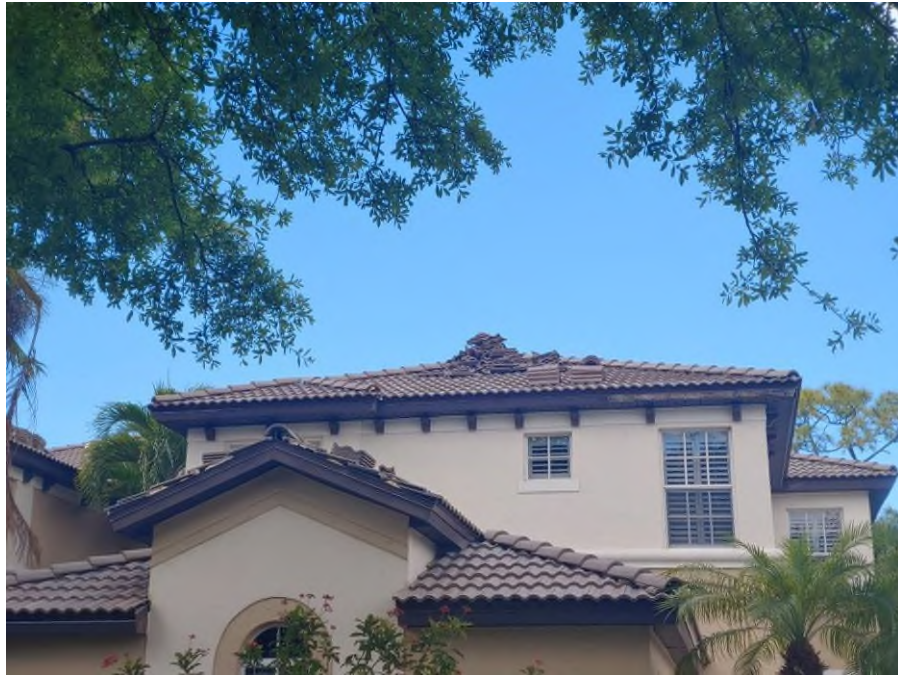
**Photograph #1: Roof tile installations were in progress on building 7841.**

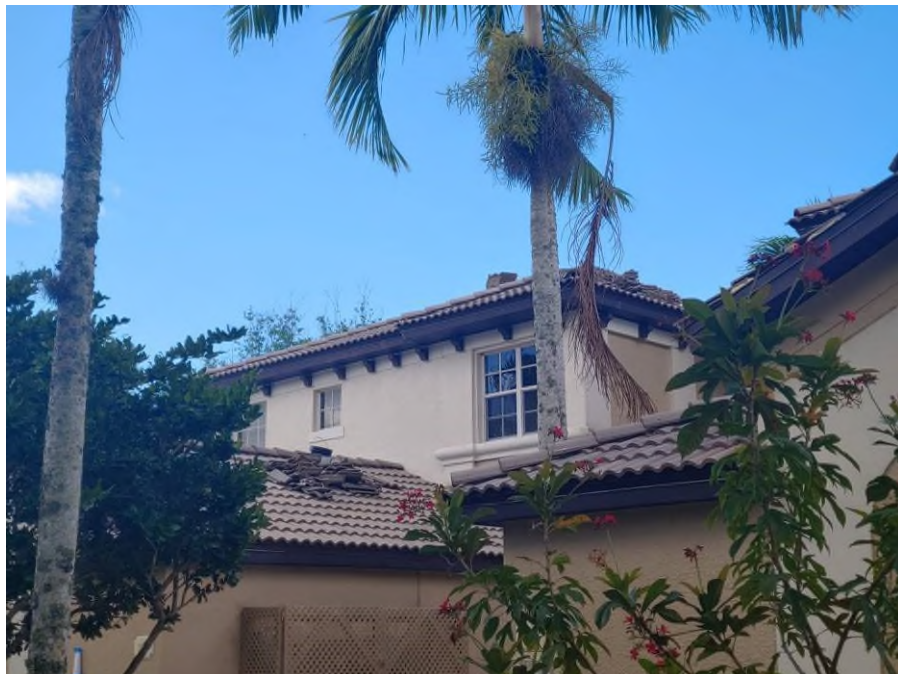
**Photograph #2: Roof tile installations were in progress on building 7841.**

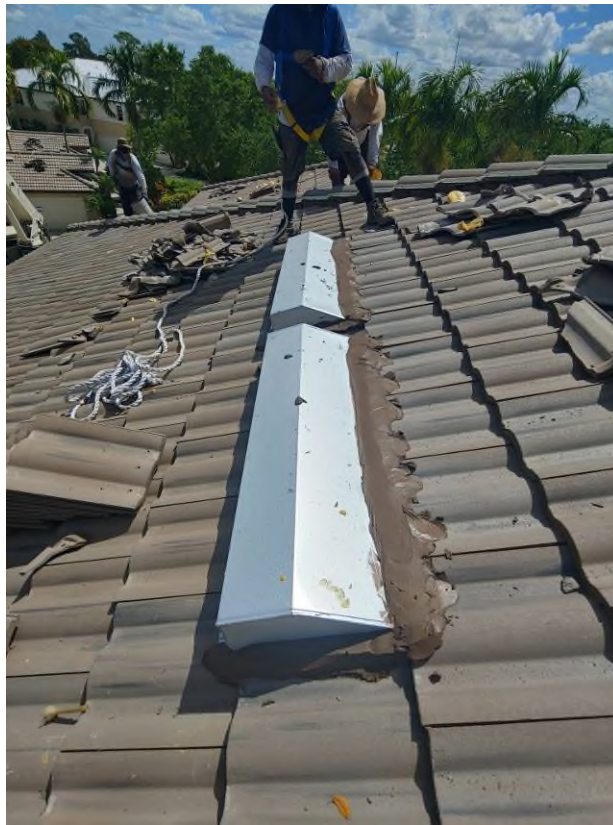
**Photograph #3: Mortar adhesive application was in progress surrounding the exhaust vents on building 21700.**

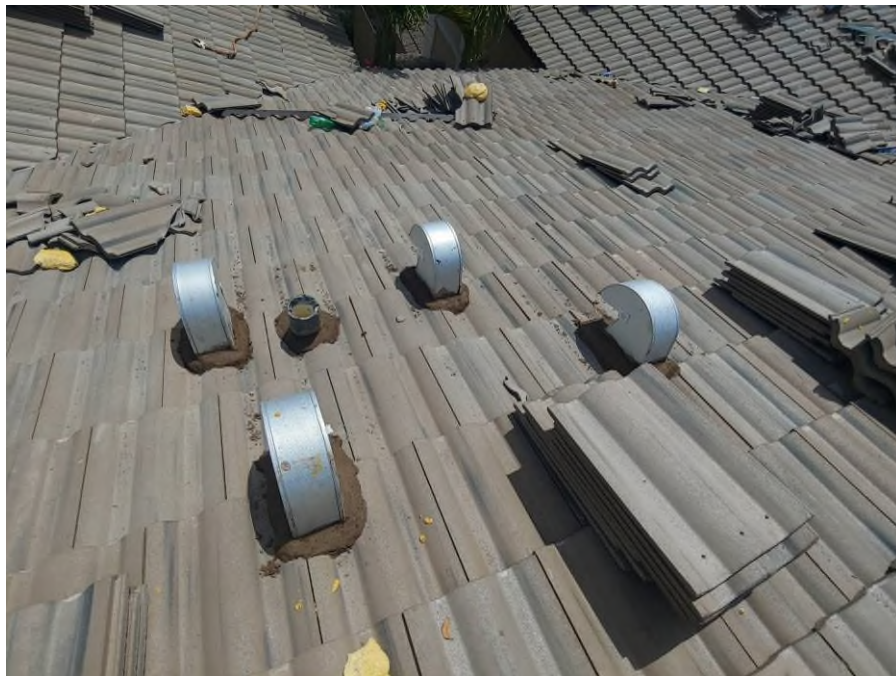
**Photograph #4: Mortar adhesive application was in progress surrounding the exhaust vents and pipes on building 21700.**

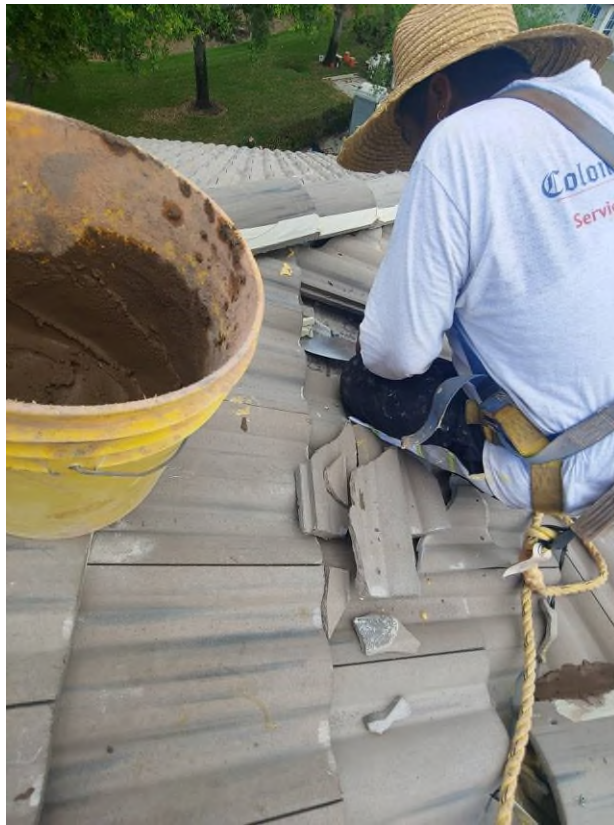
**Photograph #7: Broken field tile replacement was in progress on building 21700.**

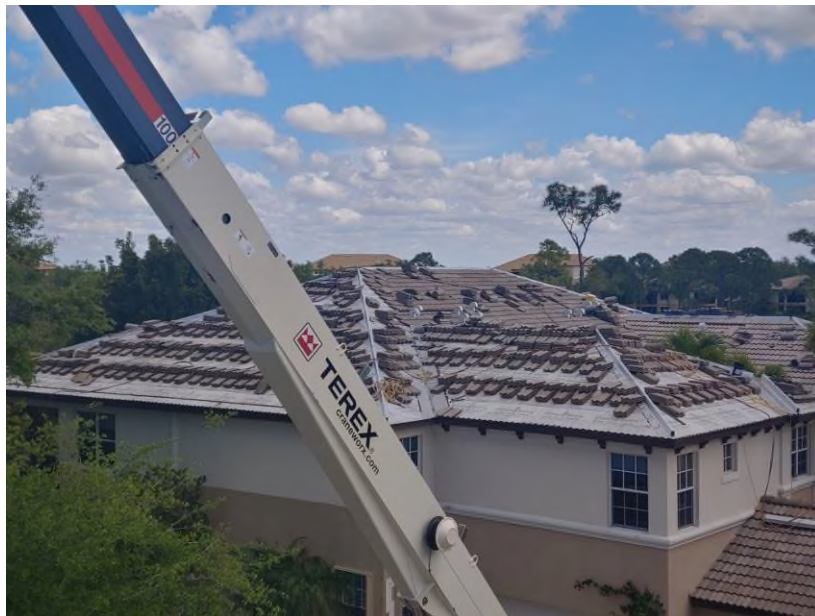
**Photograph #8: Roof tiles installation were in progress on building 21711.**

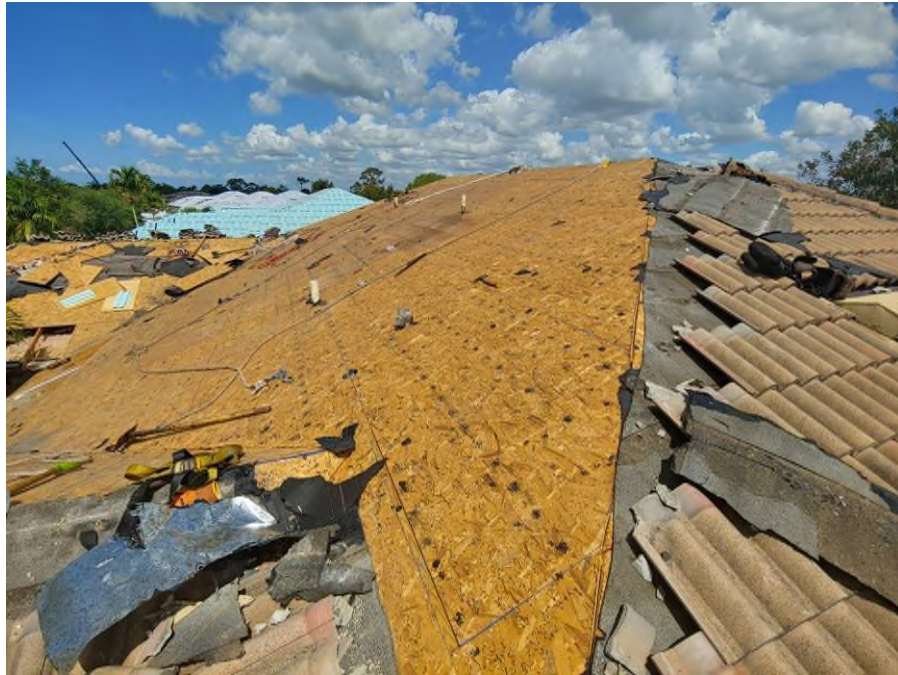
**Photograph #9: Roof tile removal was in progress on building 21771.**

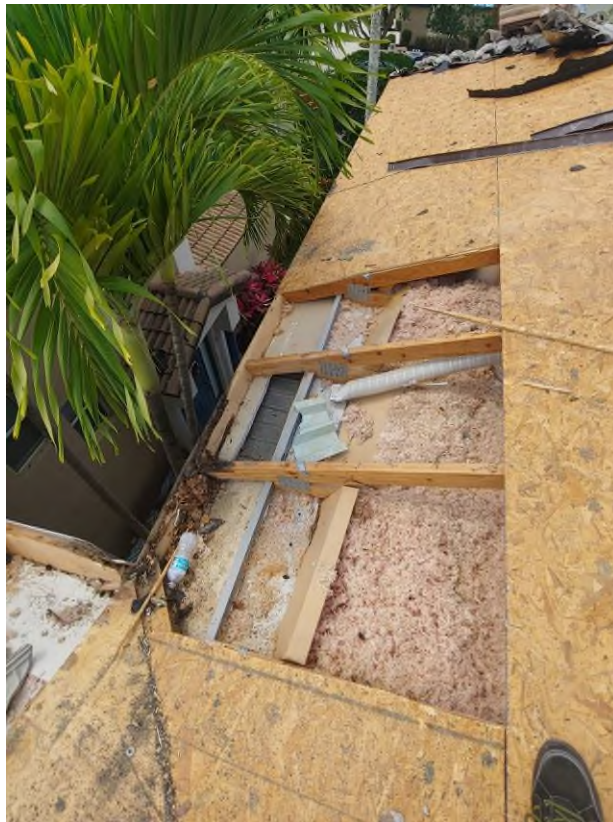
**Photograph #10: Existing strap clips on the trusses have the required minimum quantity of nails on building 21771.**

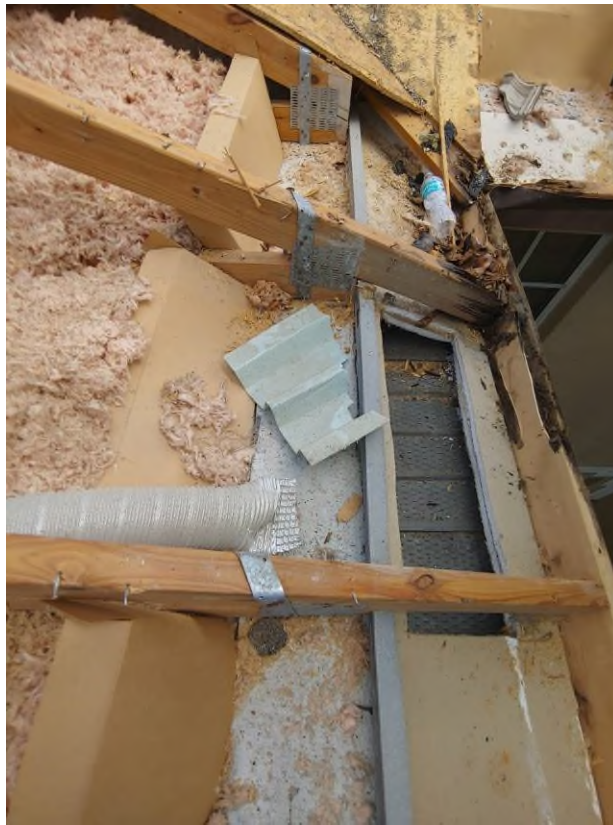
**Photograph #11: Existing strap clips on the trusses have the required minimum quantity of nails on building 21771.**

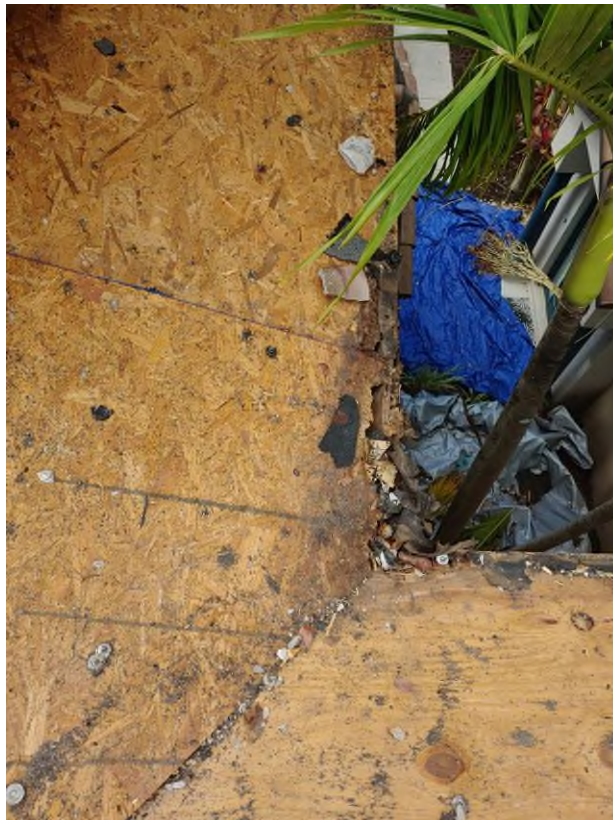
**Photograph #12: Rotten fascia, truss and plywood sheathing were observed on building 21771.**

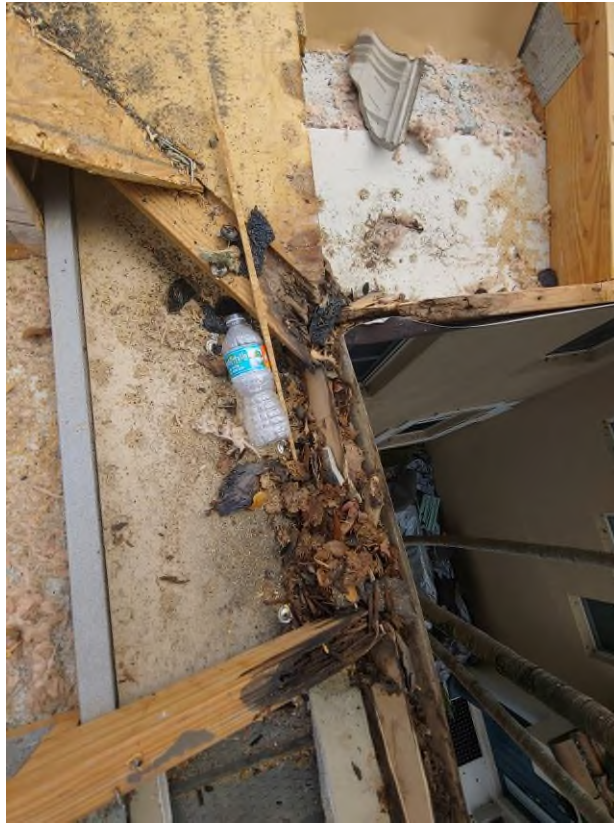
**Photograph #13: Rotten fascia, truss and plywood sheathing were observed on building 21771.**

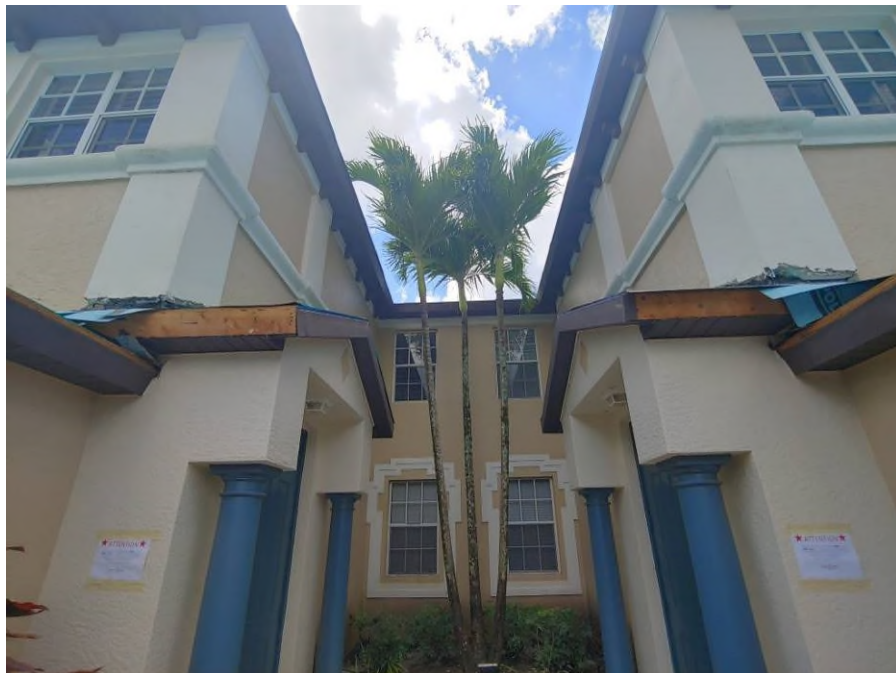
**Photograph #14: Fascia repair was in progress on building 21800.**

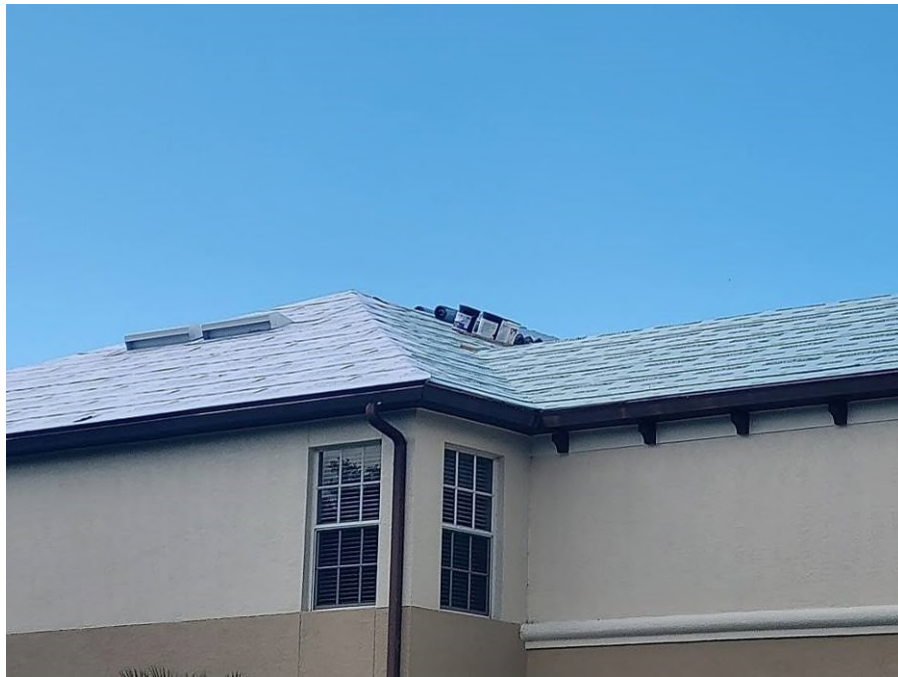
**Photograph #15: Second layer of underlayment installation was in progress on building 21800.**

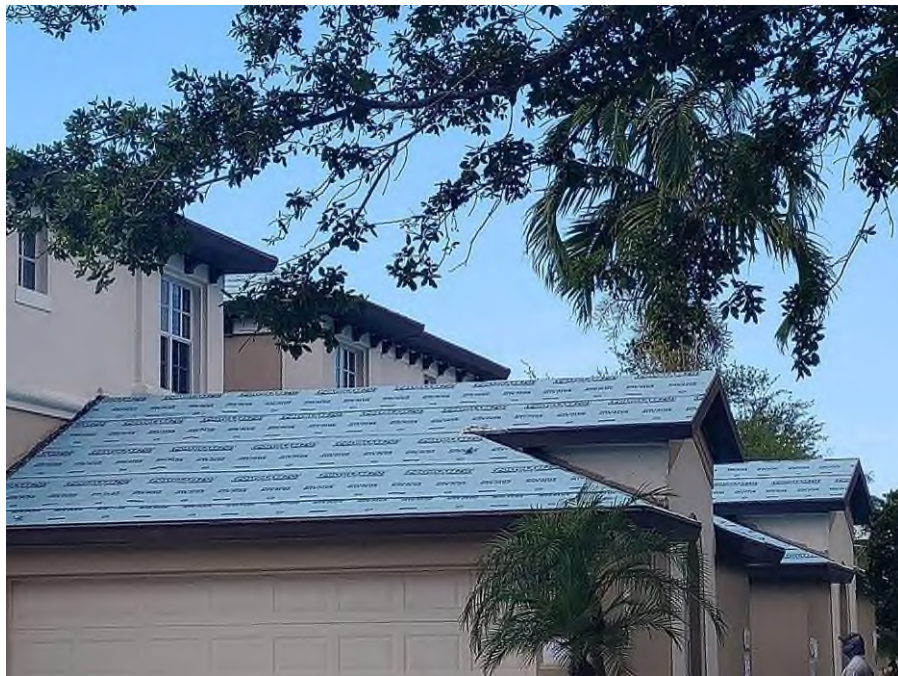
**Photograph #16: Polystick MTS Plus underlayment installation was completed on building 21800.**

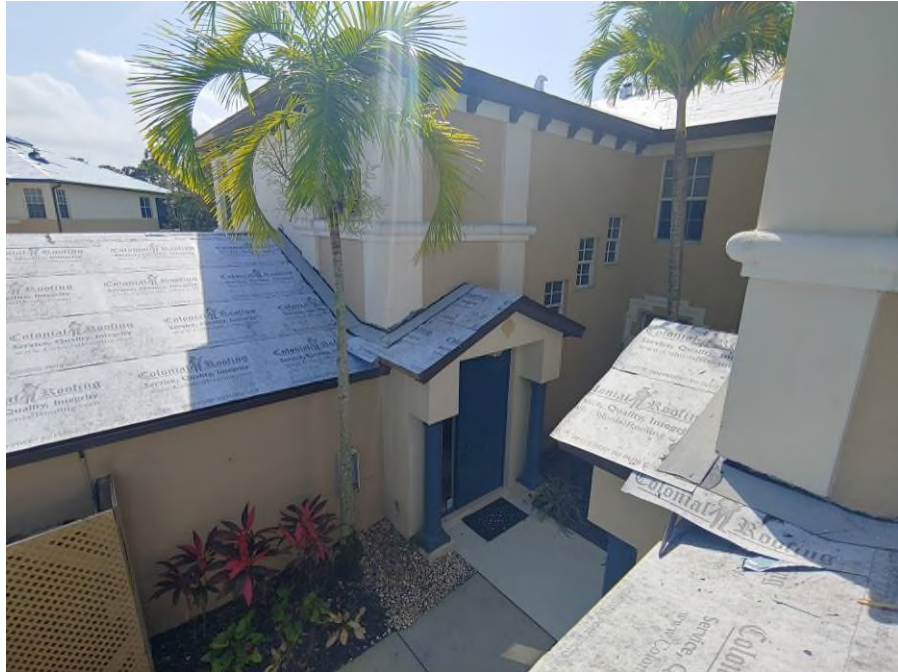
**Photograph #1: Second layer of underlayment installation was completed on building 7840.**

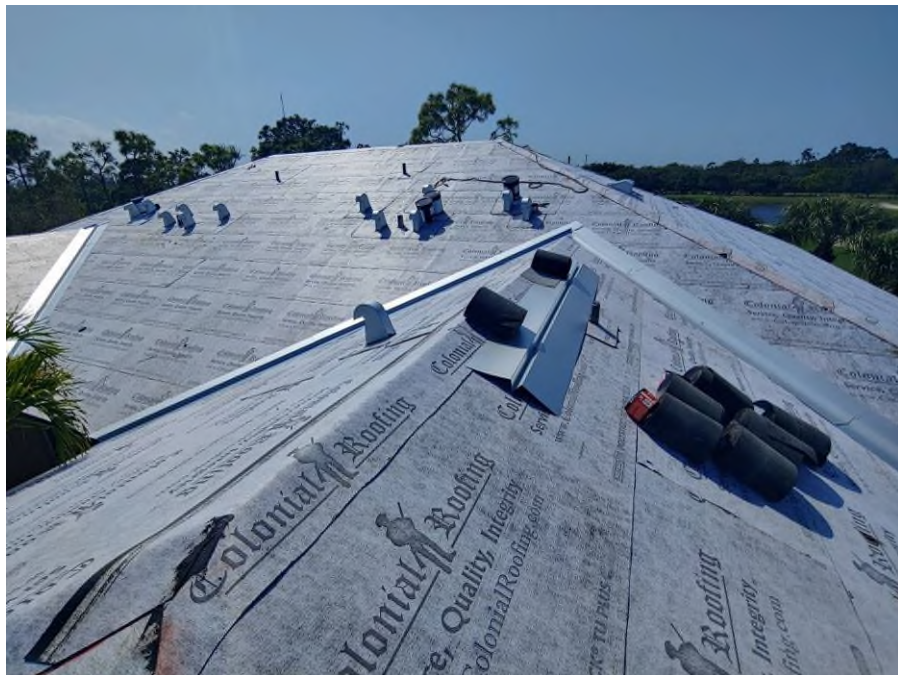
**Photograph #2: Exhaust vent installations were in progress on building 7840.**

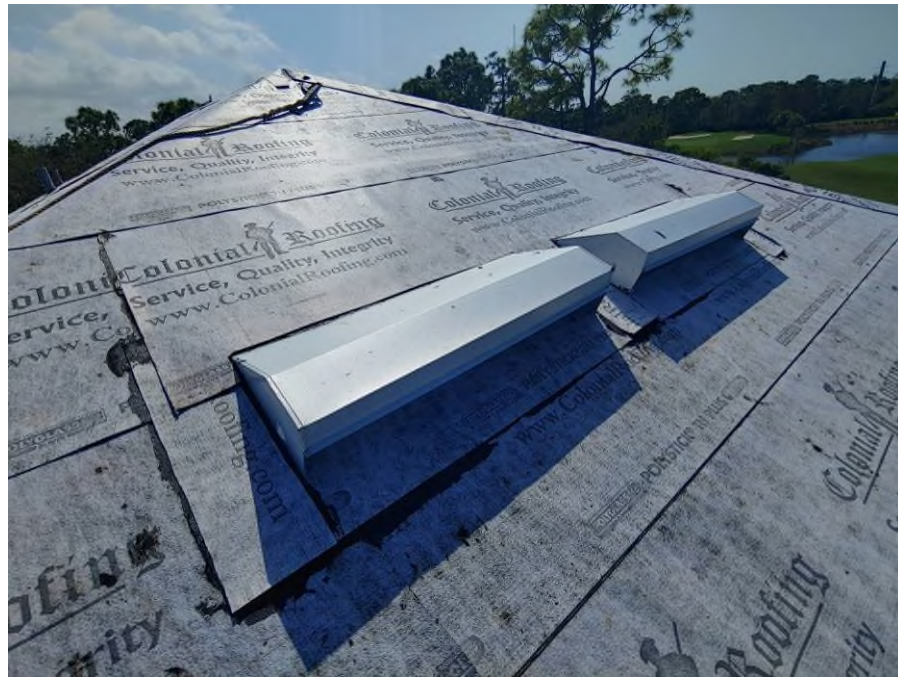
**Photograph #3: Exhaust vent installations were in progress on building 7840.**

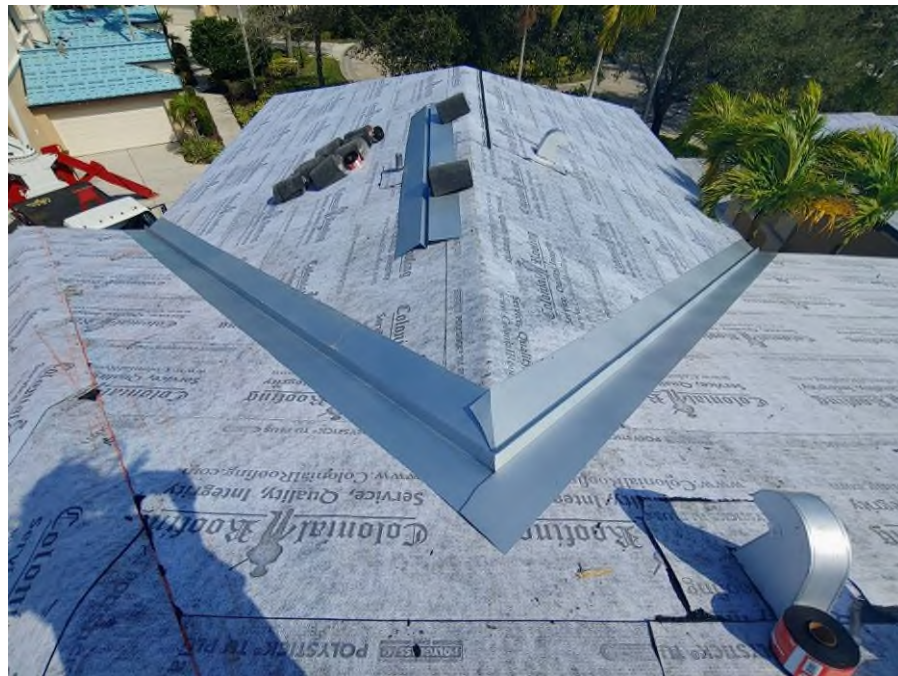
**Photograph 4: V-crimp metal Valley flashing installation was in progress on building 7840.**

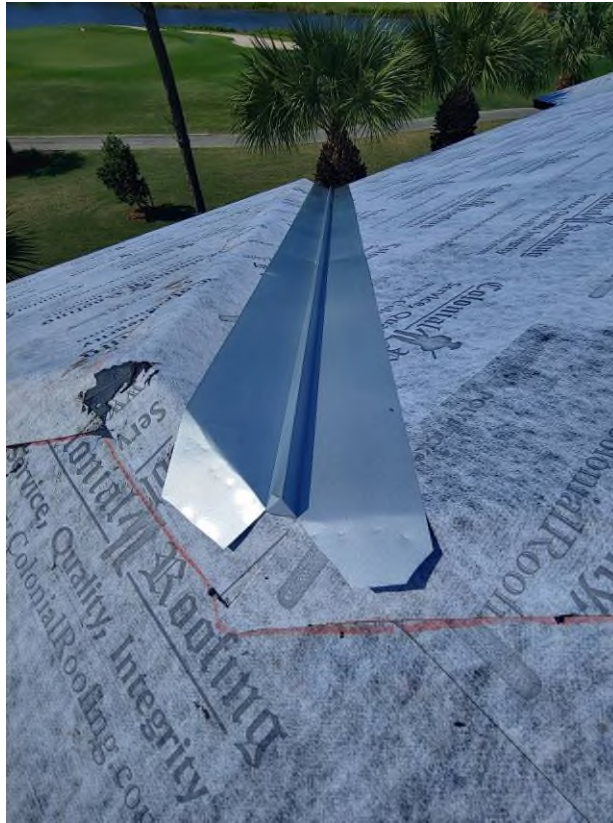
**Photograph #5: V-crimp metal Valley flashing installation was in progress on building 7840.**

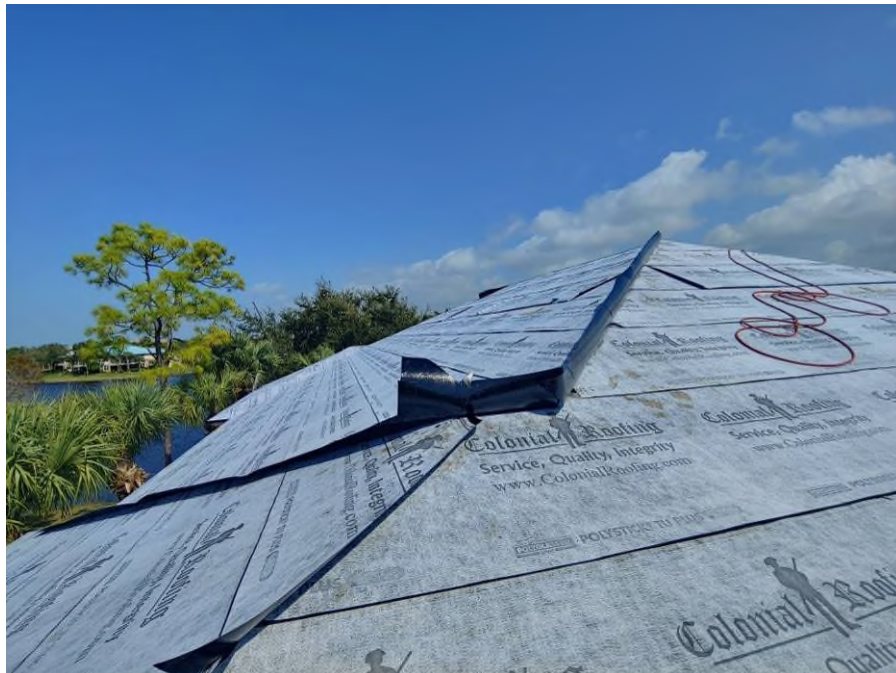
**Photograph #6: Second layer of underlayment installation was in progress on building 7841.**

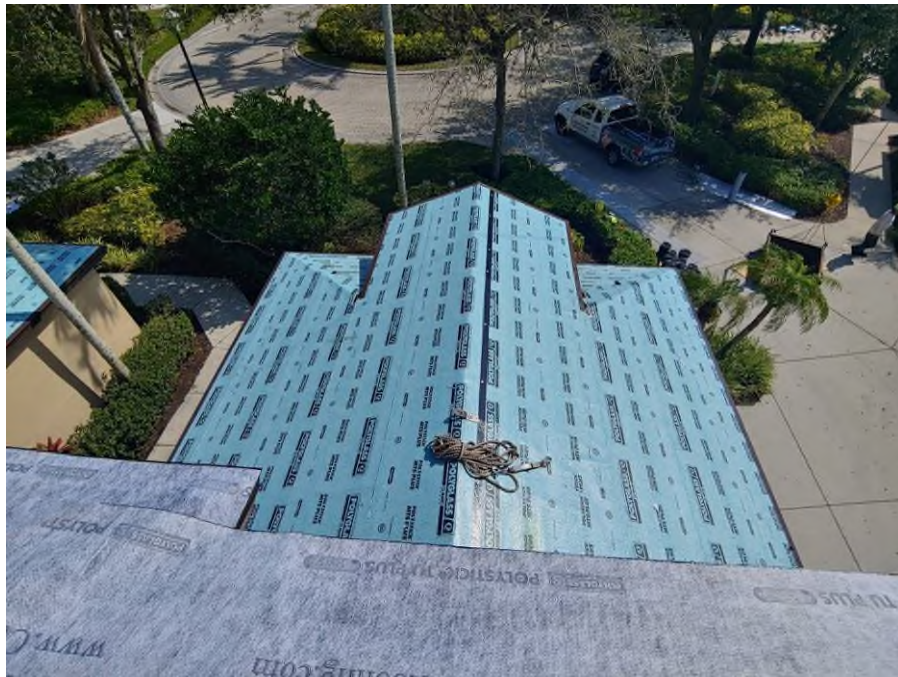
**Photograph #7: Polystick MTS Plus underlayment installation was completed on building 7841.**

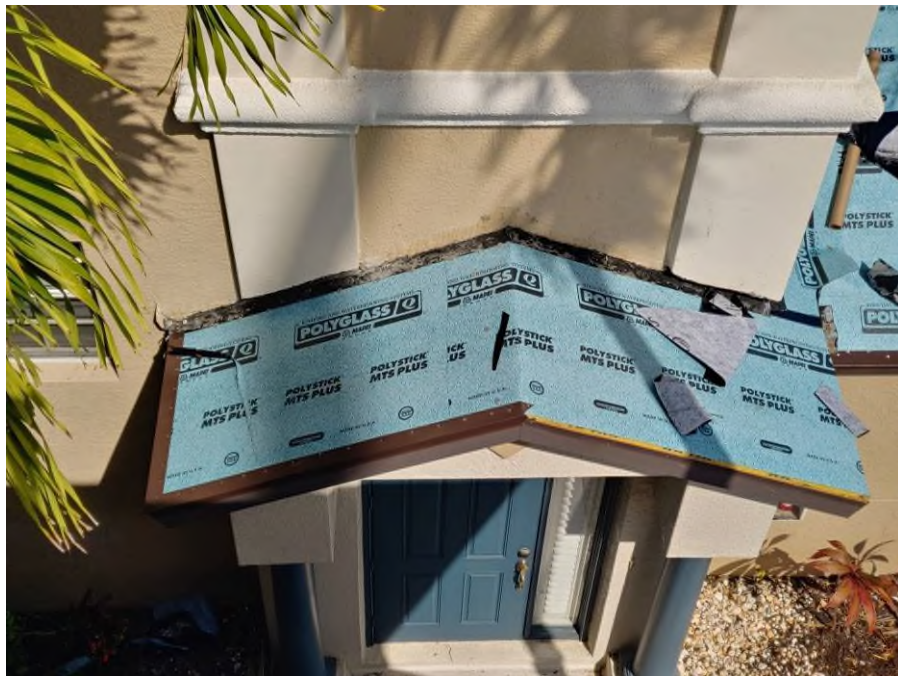
**Photograph #8: Drip-edge flashing installation was in progress on building 7841.**

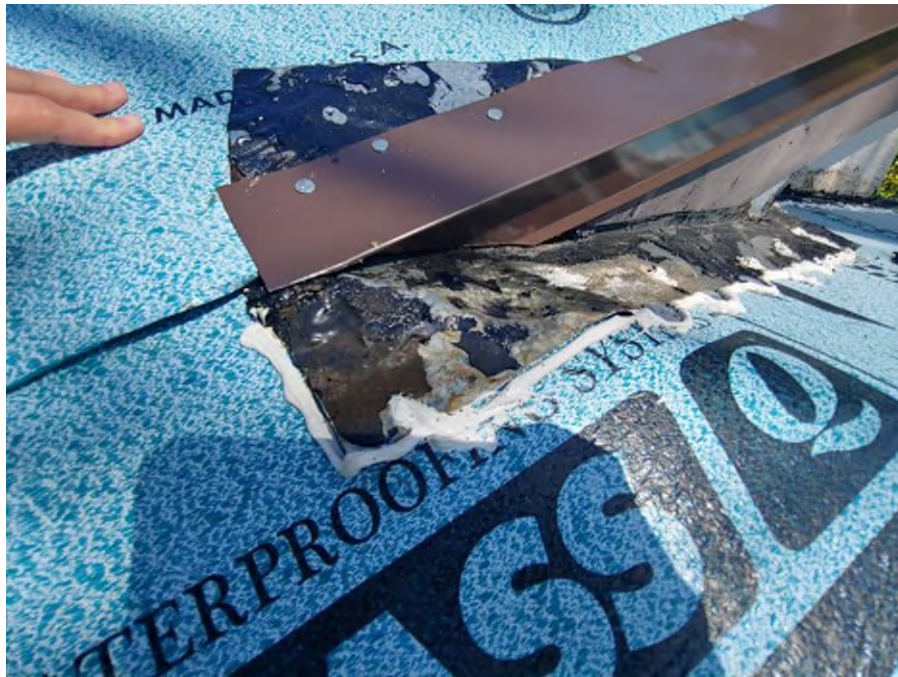
- o Exhaust vent installations were in progress on buildings 7840 and 7850.
  - o Contractor must address sealant application on the metal flashing on building 7841.

**Photograph #9: Contractor must address sealant application on the metal flashing on building 7841.**

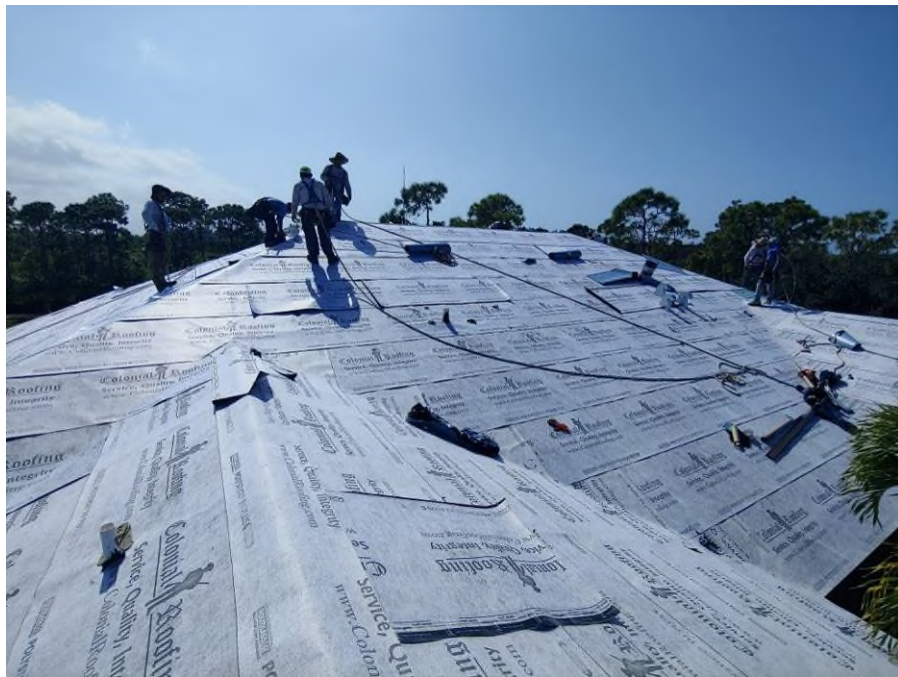
**Photograph #10: Second layer of underlayment installation was in progress on building 7850.**

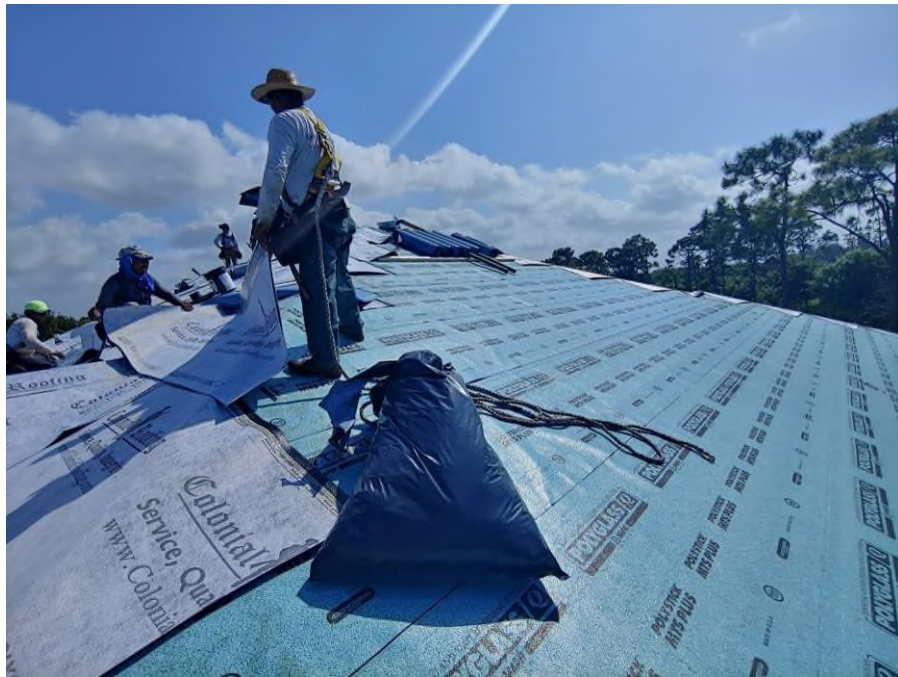
**Photograph #11: Polystick MTS Plus underlayment installation was completed on building 7850.**

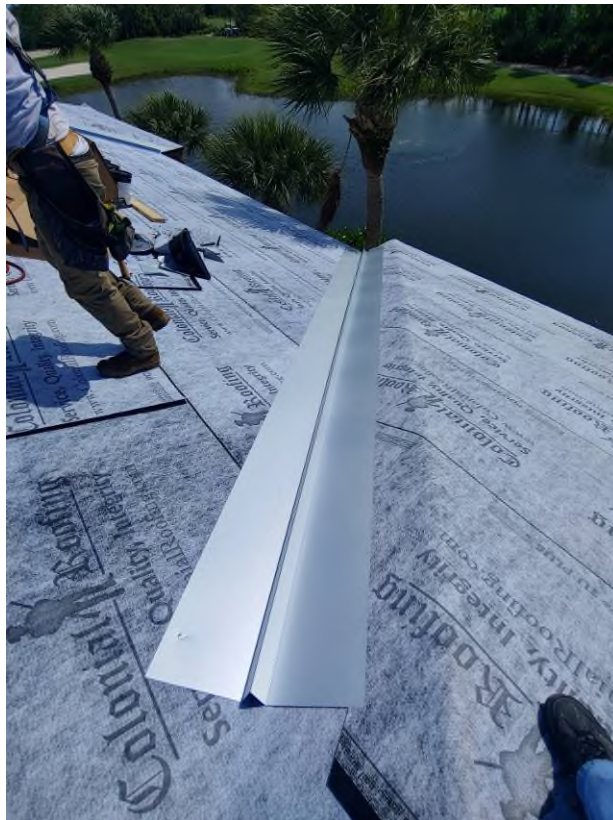
**Photograph 12: V-crimp metal Valley flashing installation was in progress on building 7850.**

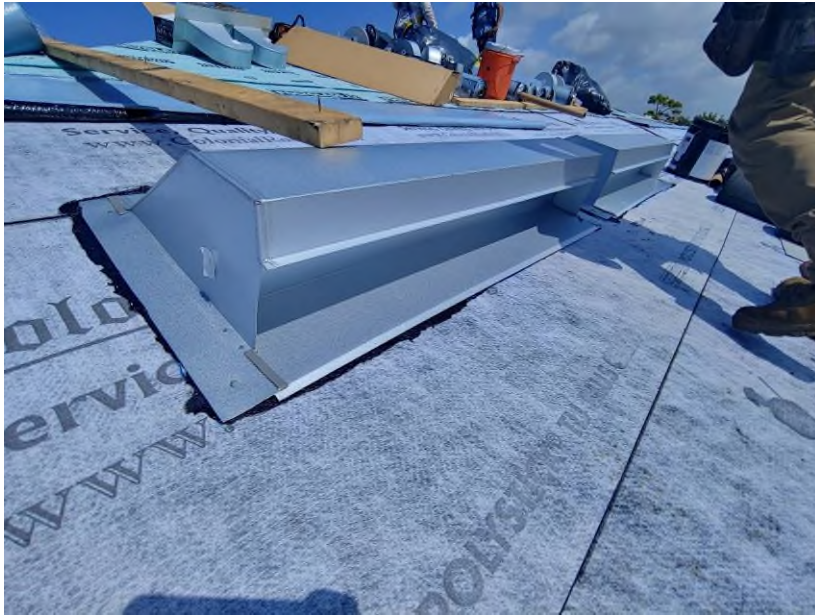
**Photograph #13: Exhaust vent installations were in progress on building 7850.**

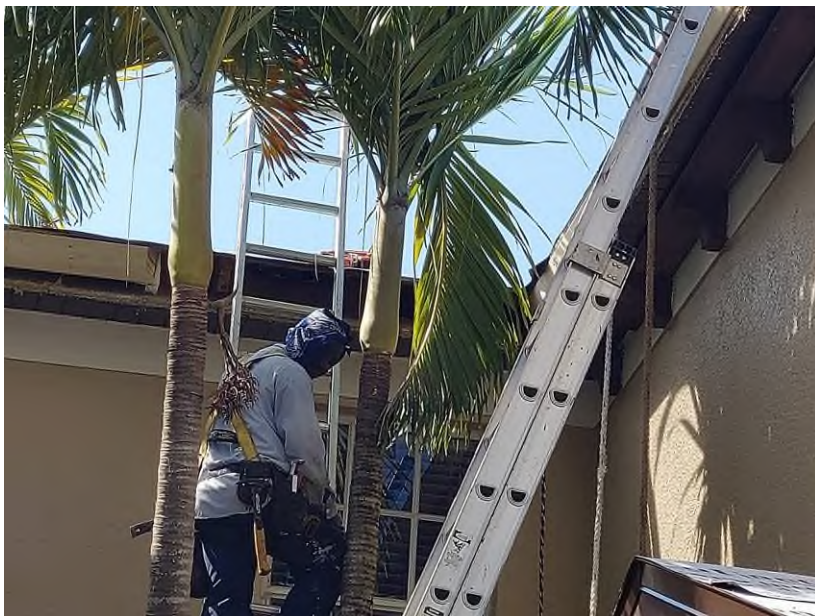
**Photograph #14: Fascia repair was in progress on building 21710.**

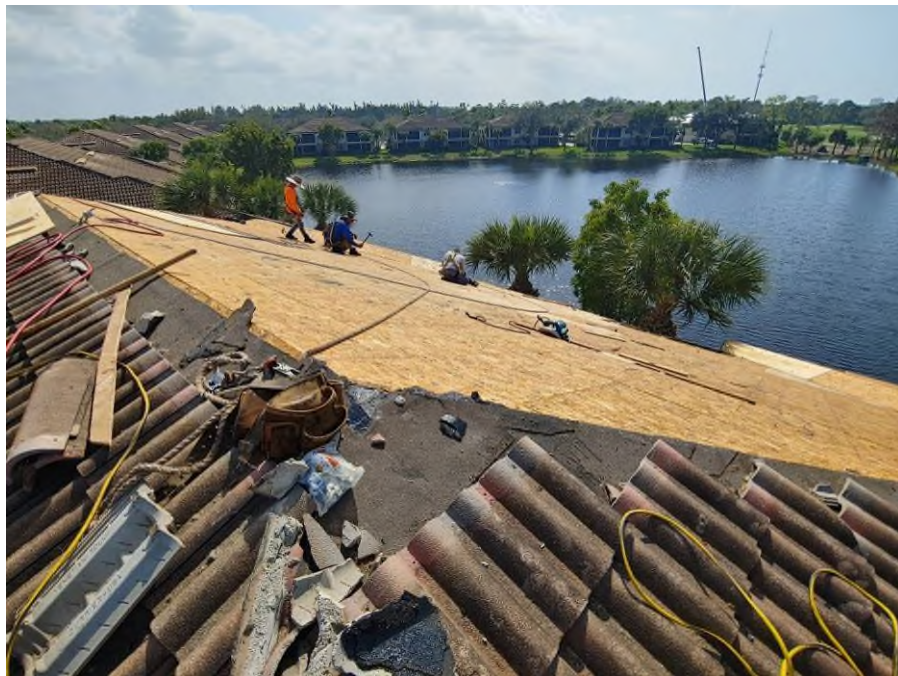
**Photograph #16: Roof tile removal was in progress on building 21720.**

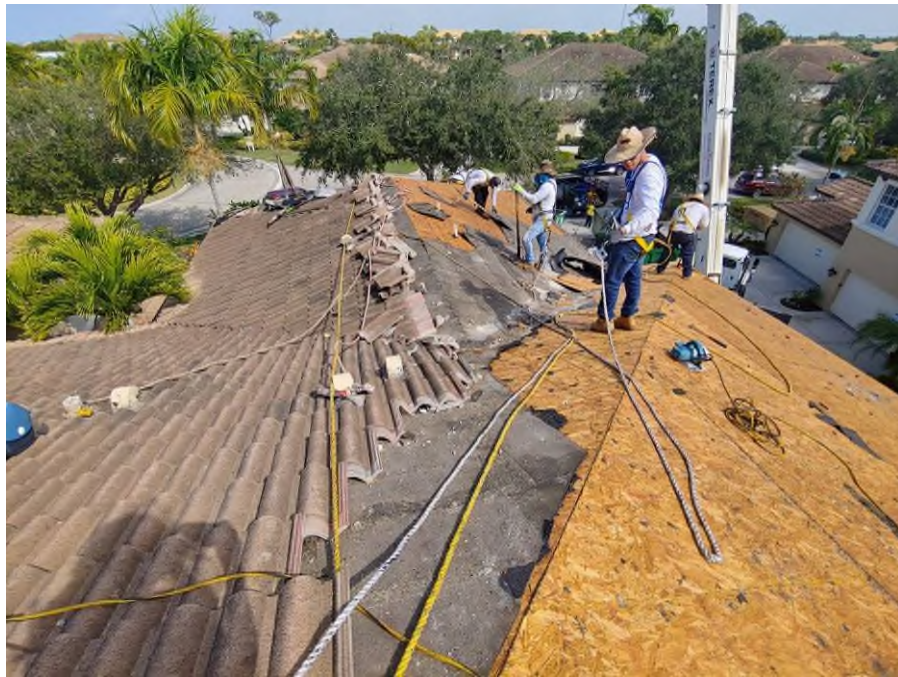
**Photograph #17: Roof tile removal was in progress on building 21720.**

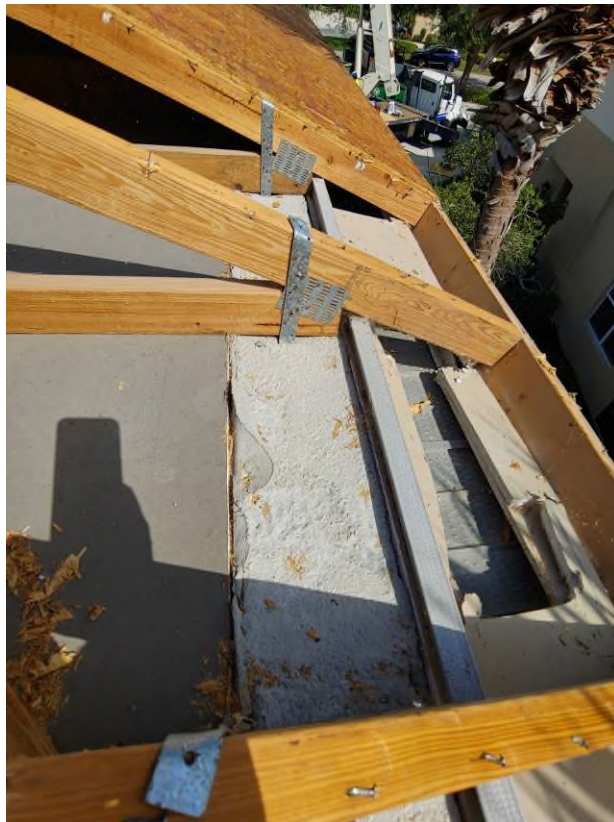
- Building 21720
  - o Roof tile removal was in progress.
  - o Existing strap clips on trusses have the required minimum quantity of nails. Installation of new hurricane truss anchor straps (HGAM10) is not required.

**Photograph #18: Existing strap clips on trusses have the required minimum quantity of nails on building 21720.**

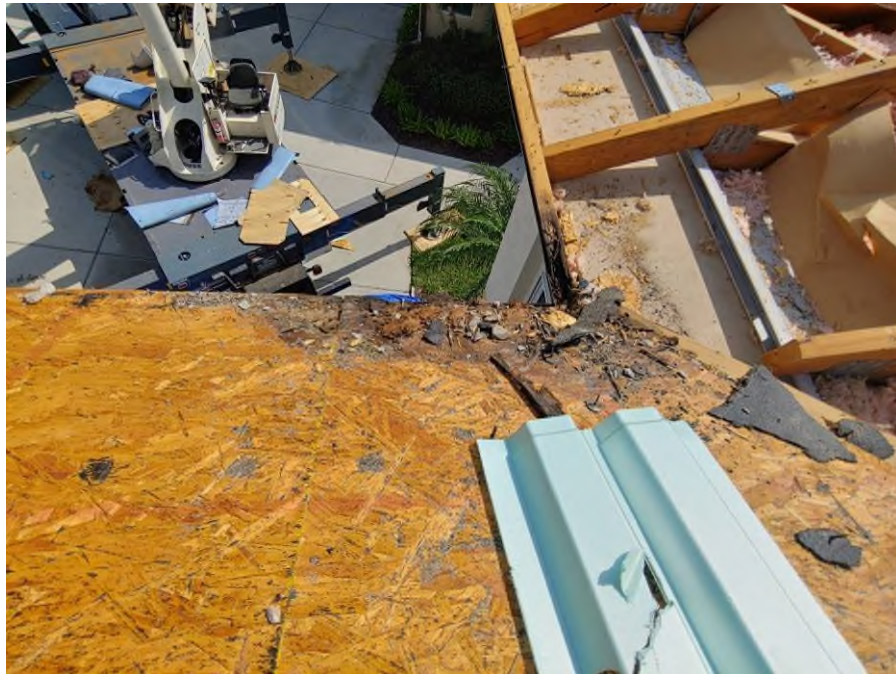
- o Rotten plywood sheathing was observed.

**Photograph #20: Rotten plywood sheathing was observed on building 21720.**
