Uniform Mitigation Verification Inspection Form

Inspection Date: 6-2-2020		
Owner Information		
Owner Name: Palmetto Dunes Pelican Sound Condominium Association Inc.		Contact Person:
Address: 7881 Classic Court Units 101,102,201,202		Home Phone:
City: Estero	Zip: 33928	Work Phone:
County: Lee		Cell Phone:
Insurance Company:		Policy #:
Year of Home: 2001	# of Stories: 2	Email:

RE: Palmetto Dunes Condominium
7881 Classic Court
Estero, FL 33928
Roofing Restoration
KEG File #20RN-0085
Wind Mitigation
Permit # 1721368-0

DATE	March 18, 2020	JOB NO.	20RN-0085
Palmetto Dunes CAI – Roofing Project			
LOCATION	Palmetto Dunes Drive		
CONTRACTOR	EnviroStruct, LLC	Palmetto Dunes CAI	
WEATHER	Sunny	TEMP.	82° F
		Time	12:00PM
PRESENT AT SITE	Rahmin Bahar, EnviroStruct (ES) Teresita Nazario-Acosta, Karins Engineering Group (KEG)

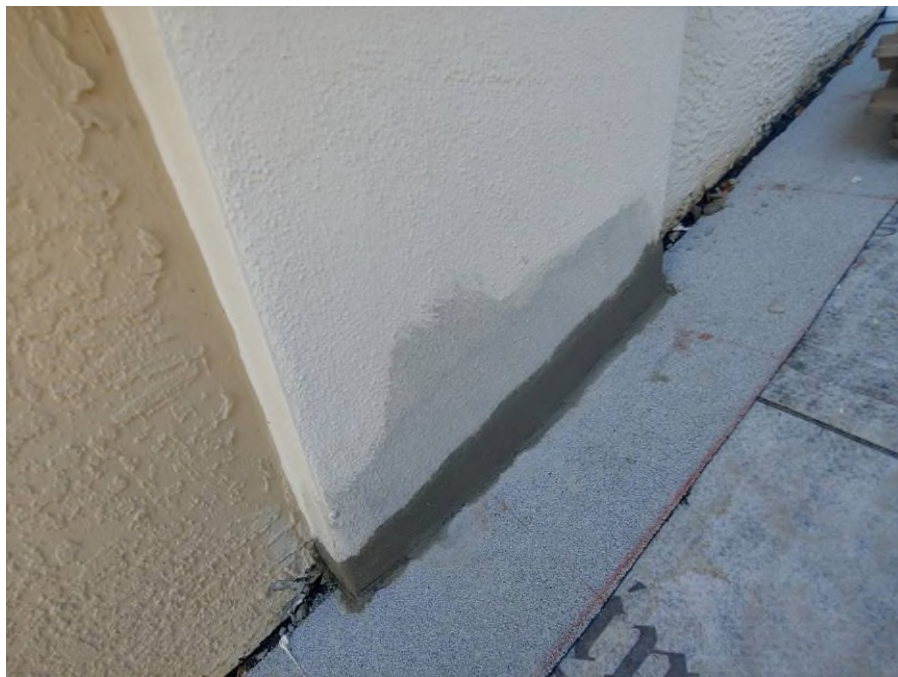
Photograph #2: Stucco application was completed on the columns at building 7840.

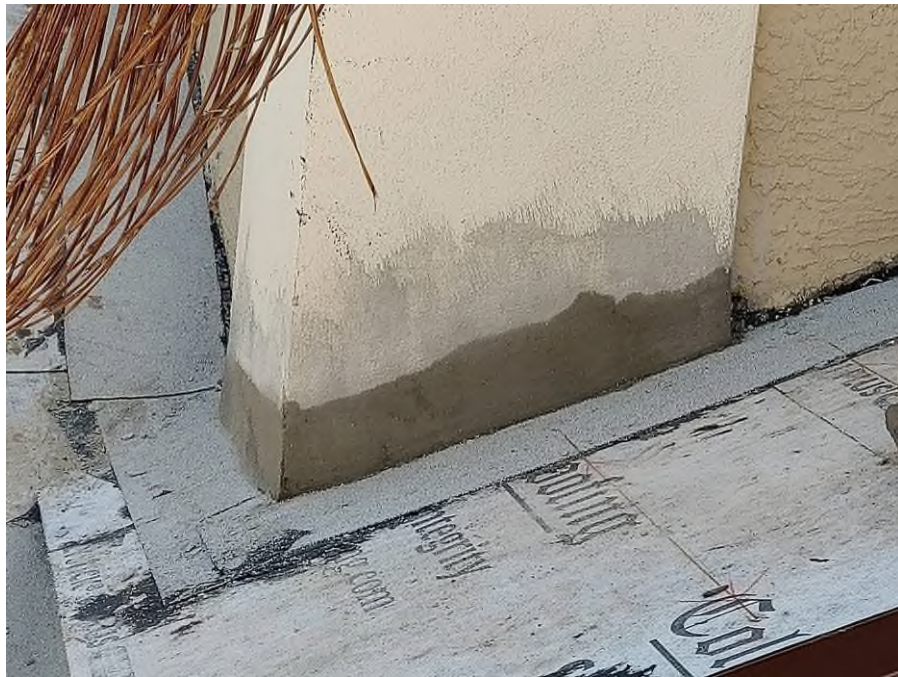
Photograph #3: Stucco application was completed on the columns at building 7840.

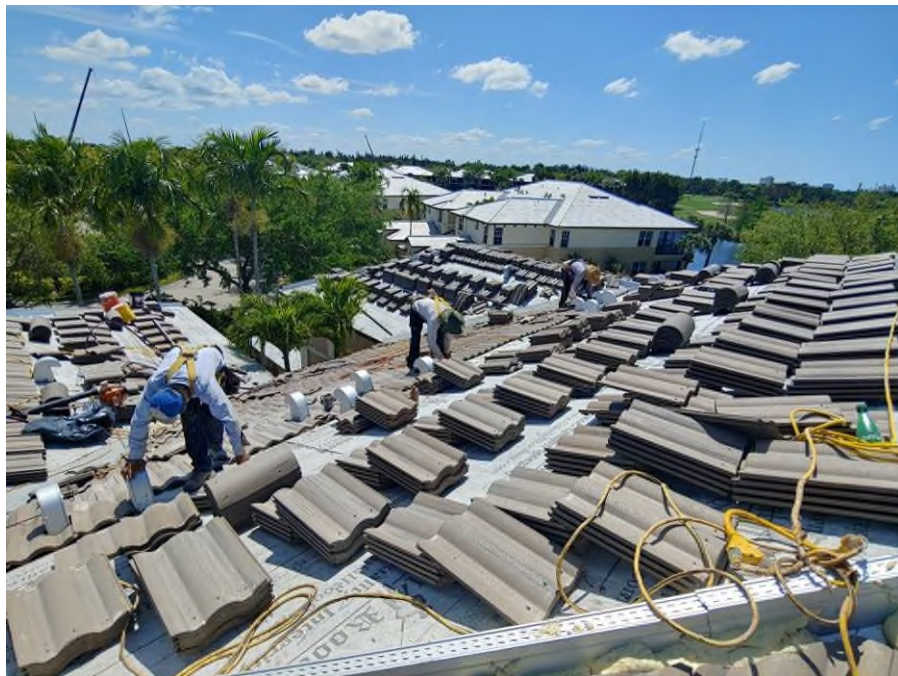
Photograph #4: Roof field tile installations with polyurethane foam adhesive was in progress on building 21700.

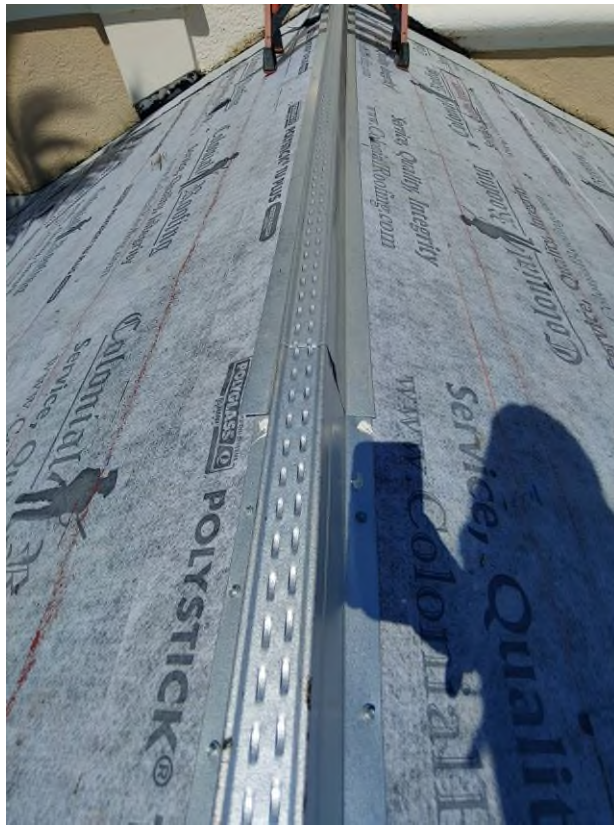
Photograph #9: Hip/ridge metal channel installations were in progress on building 7881.

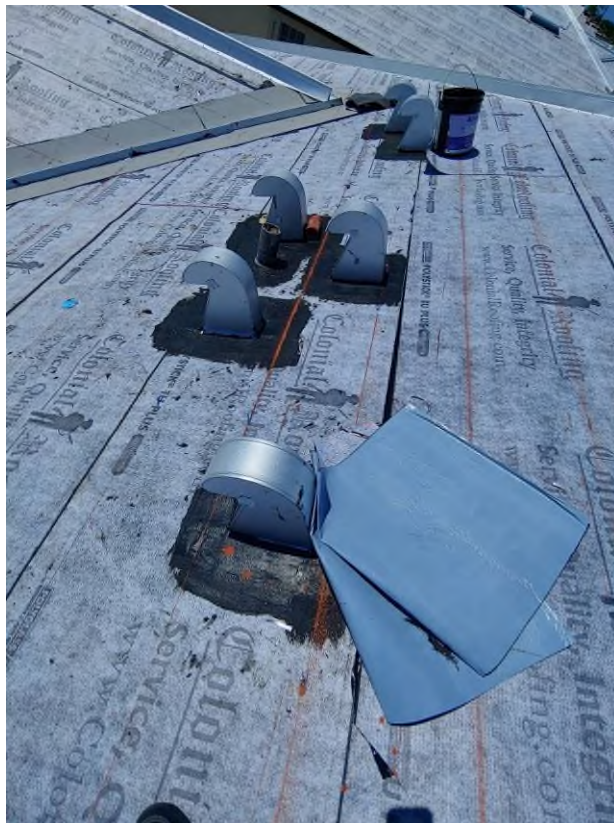
Photograph #10: Pipe and exhaust vent installations were in progress on building 7881.

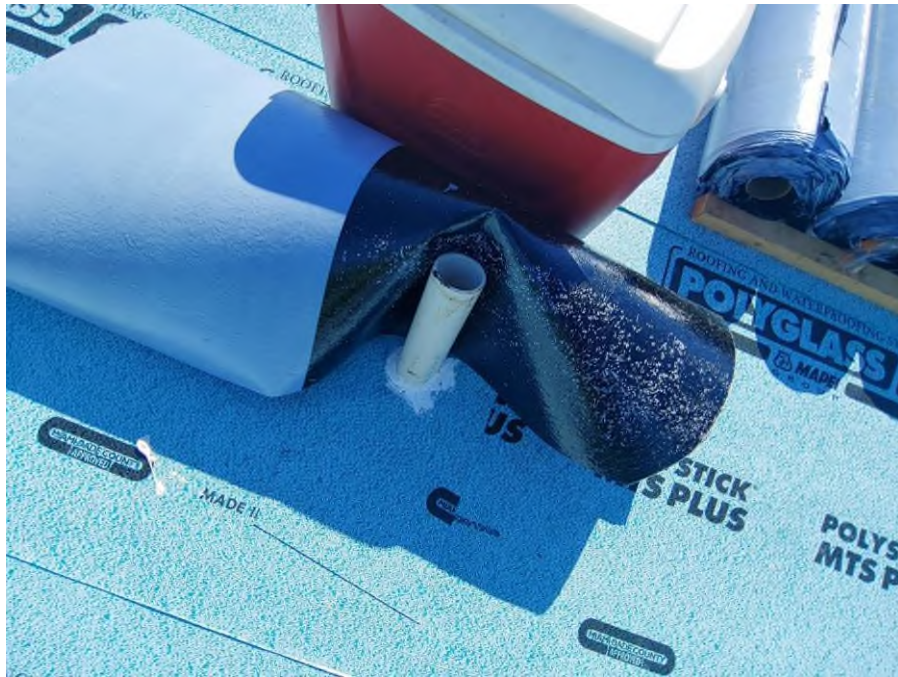
Photograph #13: Pipe installations were in progress on building 7890.

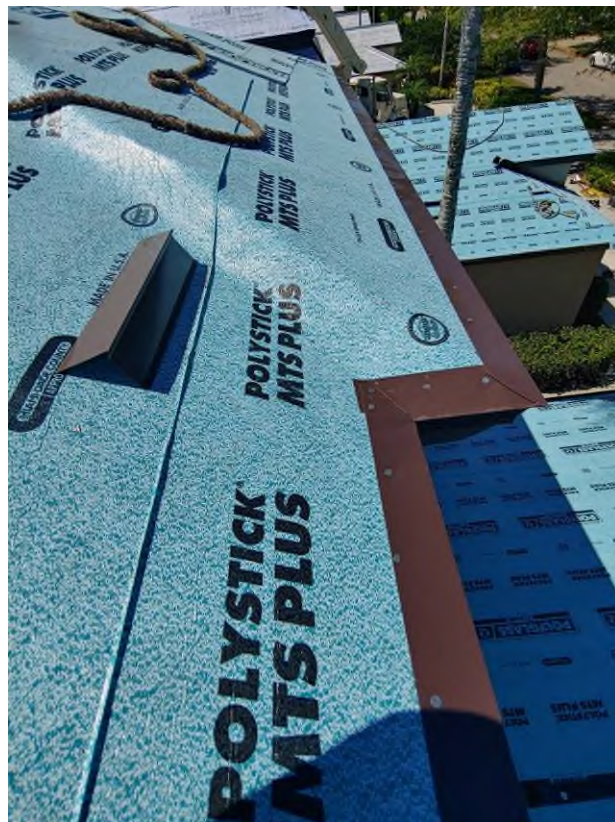
Photograph #14: Drip edge installation was in progress on building 7890.

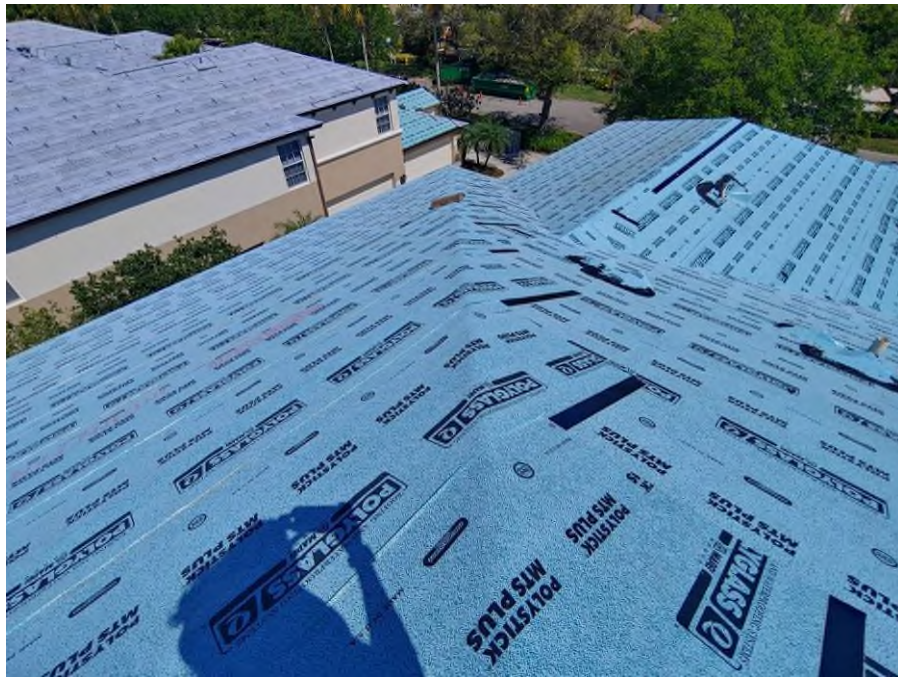
Photograph #19: Polystick MTS Plus underlayment installation was completed on building 21770.

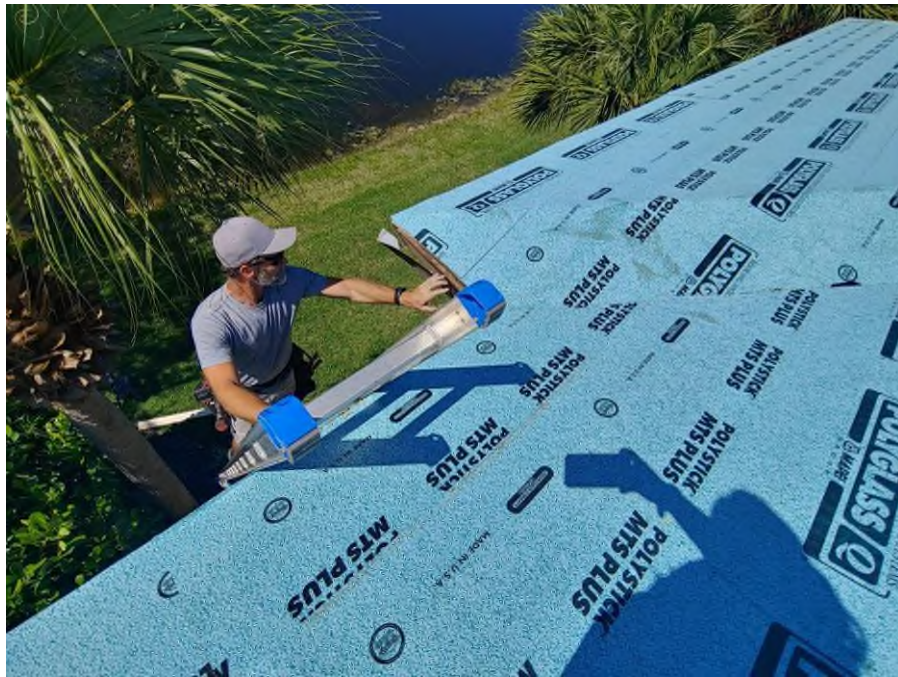
Photograph #21: Fascia repair was observed on building 21770.

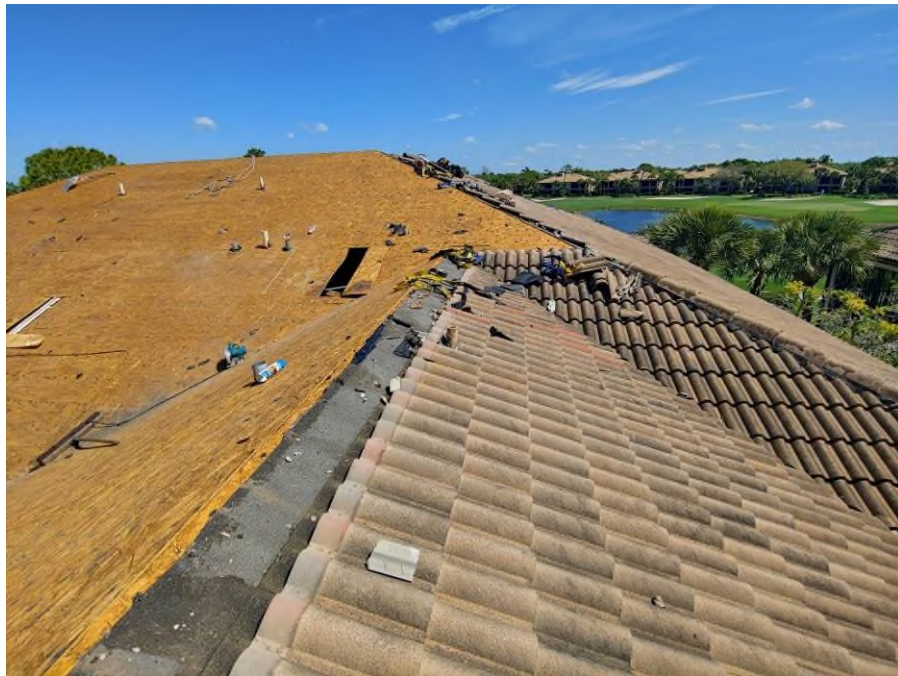
Photograph #22: Roof tile removal was in progress on building 21761.

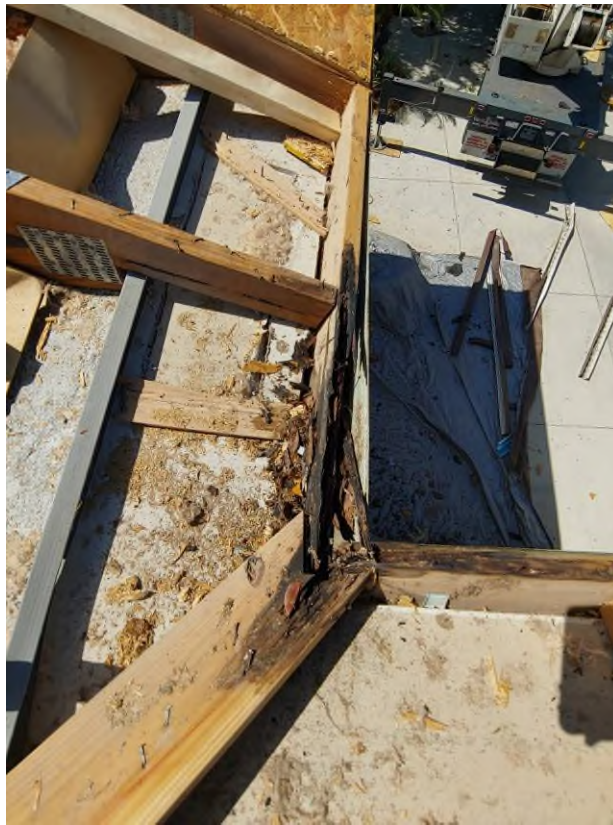
Photograph #25: Rotten fascia and trusses were observed on building 21761.

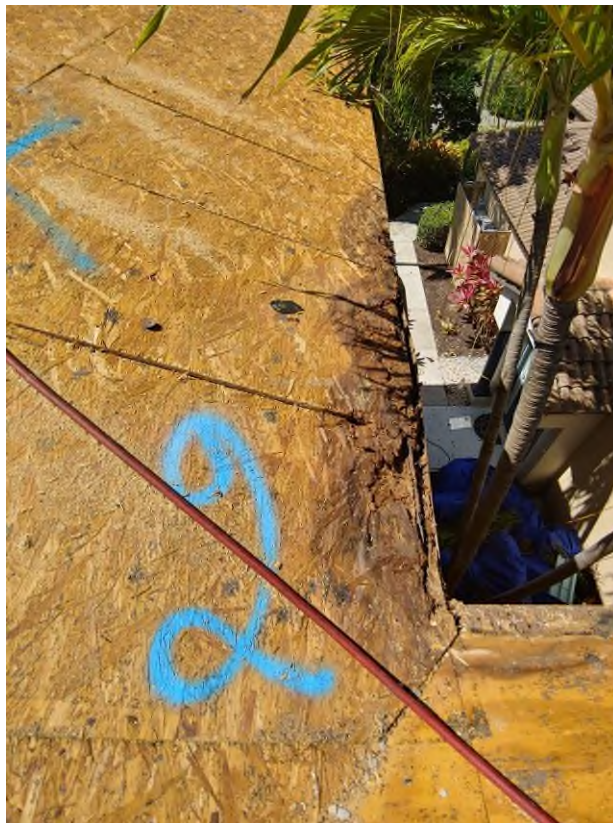
Photograph #26: Rotten fascia and plywood sheathing were observed on building 21761.

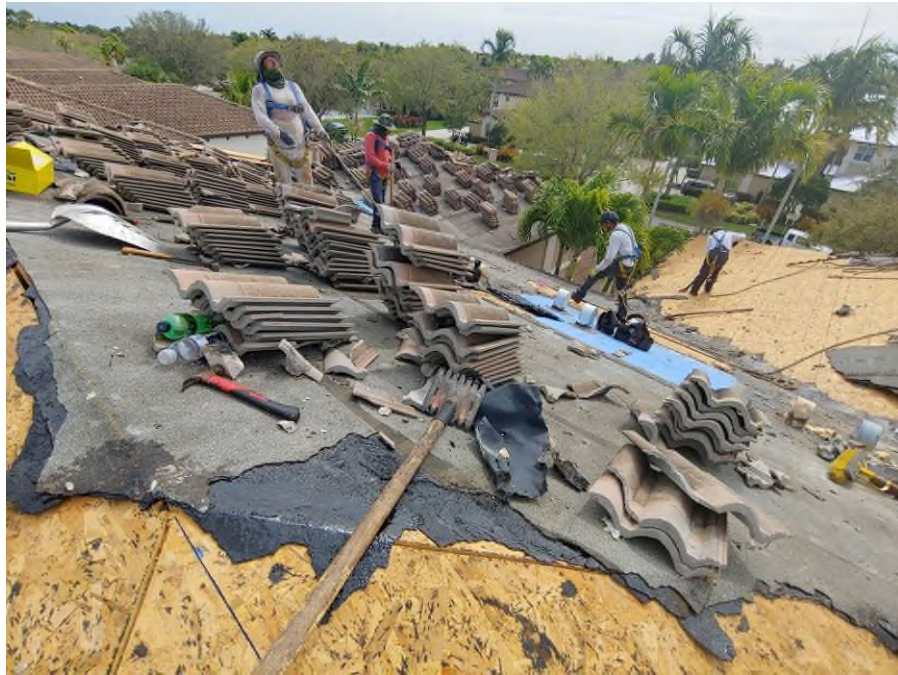
Photograph #1: Roof tile removal was in progress on building 7881.

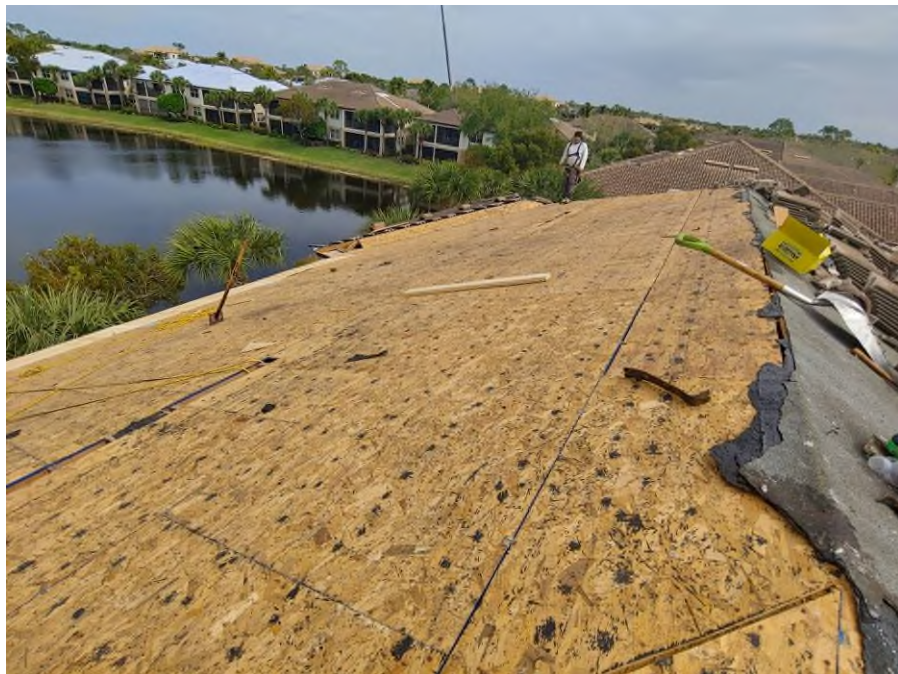
Photograph #2: Roof tile removal was in progress on building 7881.

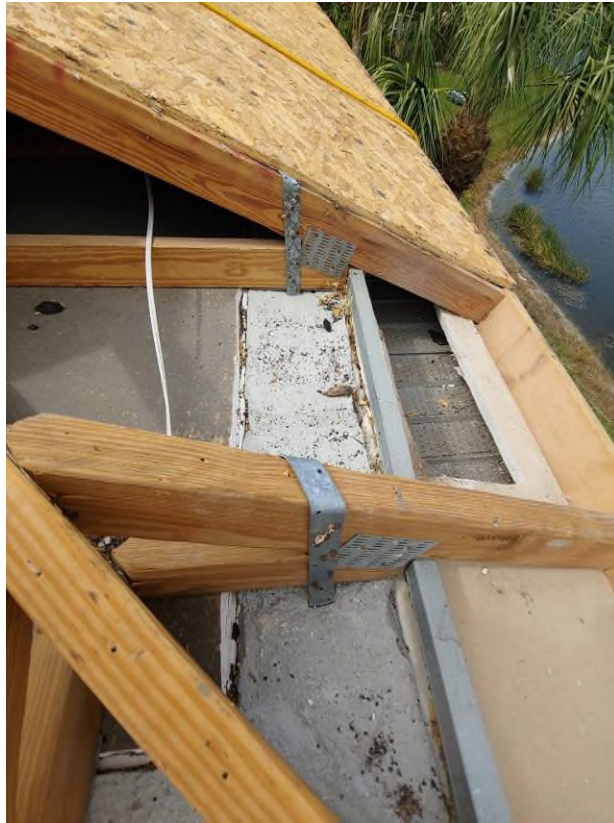
Photograph #3: Existing strap clips on the trusses have the required minimum quantity of nails on building 7881.

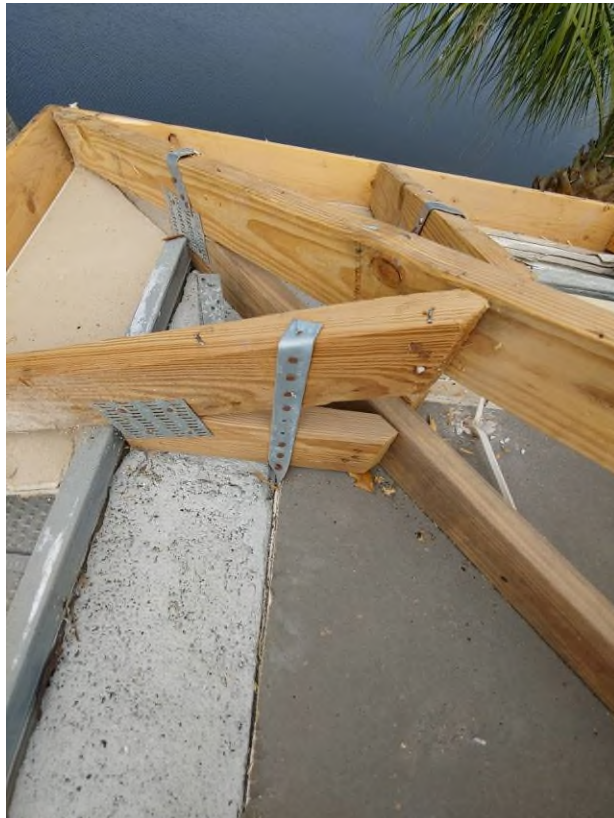
Photograph #4: Existing strap clips on the trusses have the required minimum quantity of nails on building 7881.

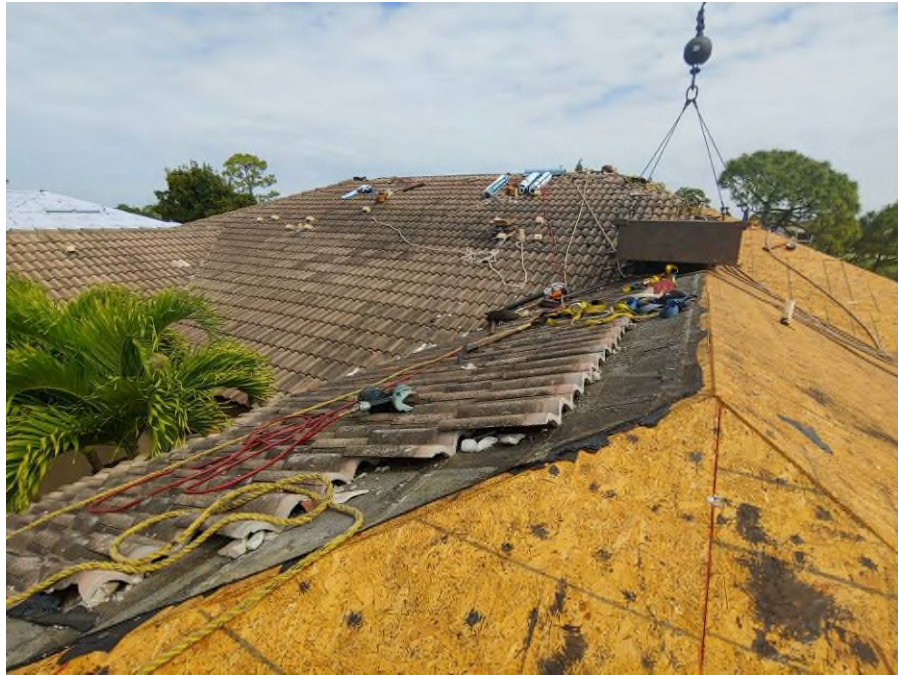
Photograph #5: Roof tile removal was in progress on building 21751.

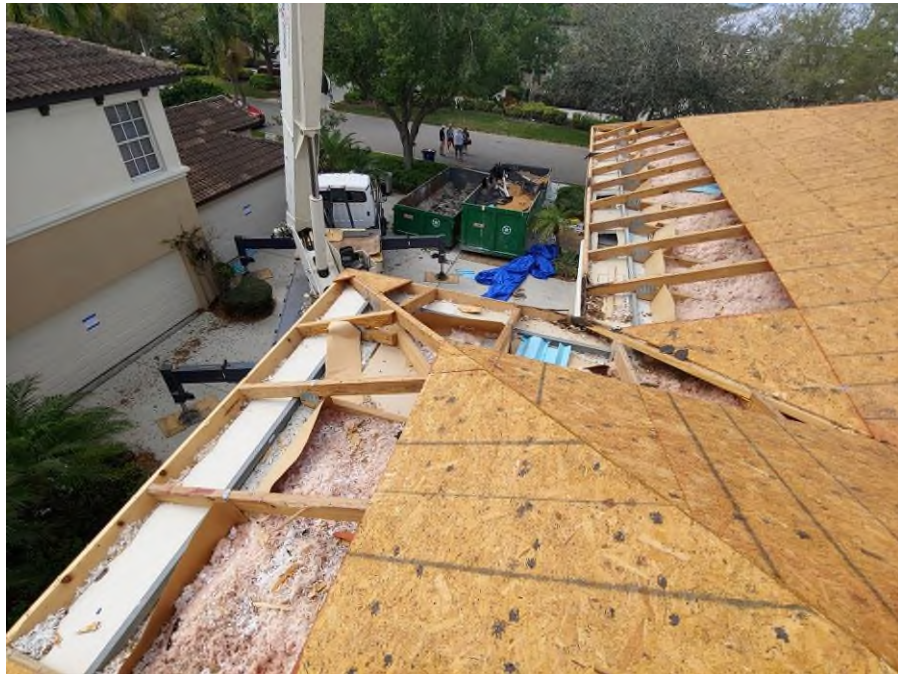
Photograph #6: Existing strap clips on the trusses have the required minimum quantity of nails on building 21751.

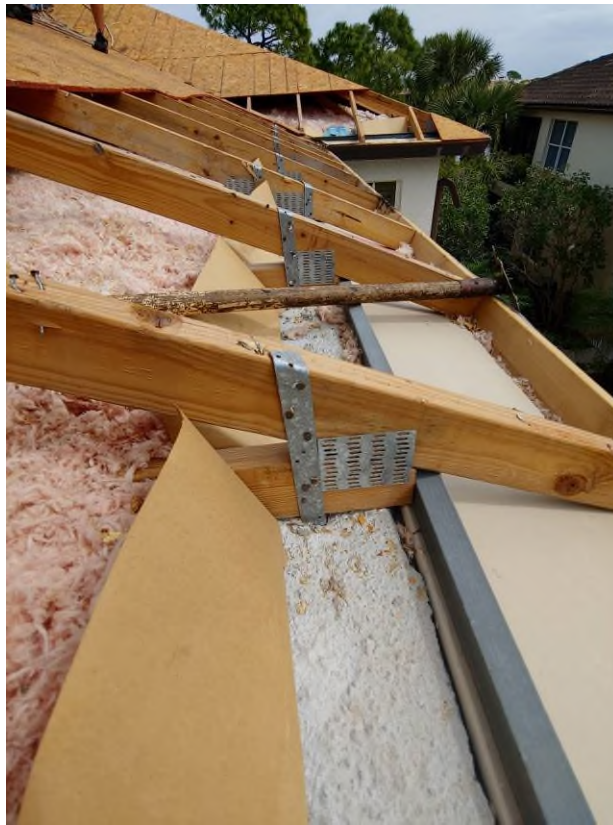
Photograph #7: Existing strap clips on the trusses have the required minimum quantity of nails on building 21751.

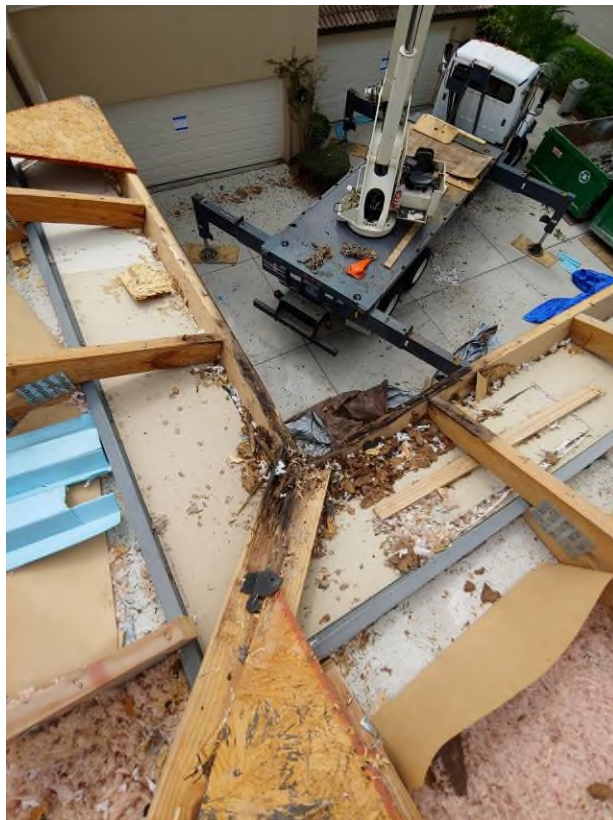
Photograph #8: Rotten fascia and trusses were observed on building 21751.

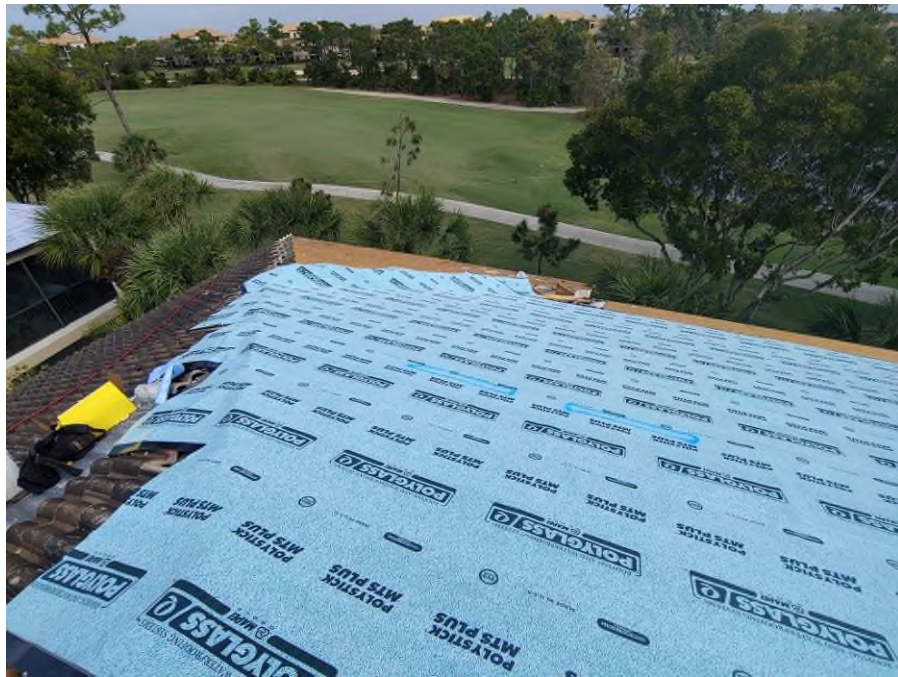
Photograph #9: Polystick MTS Plus underlayment installation was in progress on building 21751.

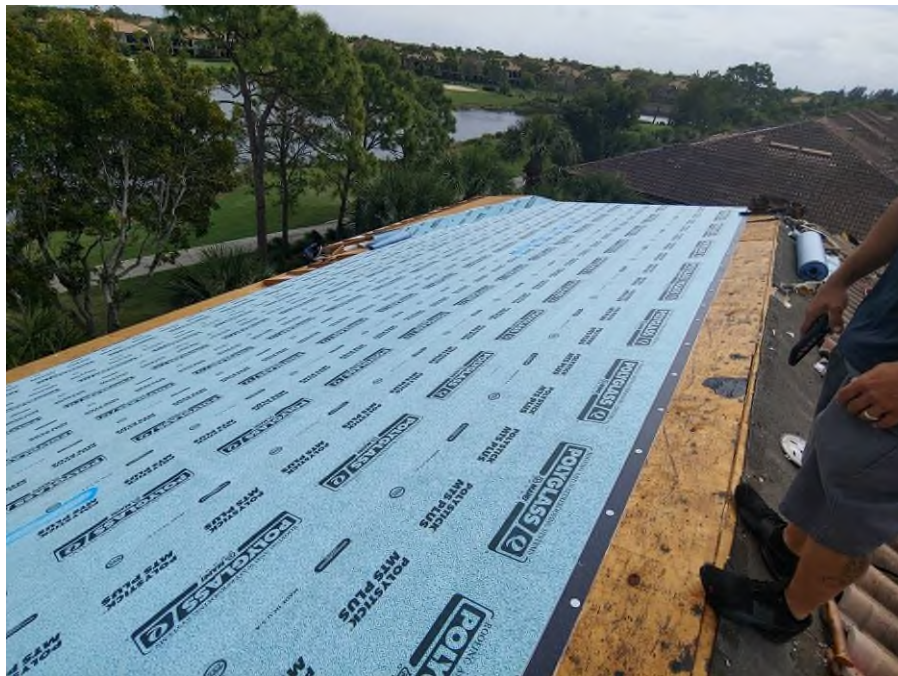
Photograph #10: Polystick MTS Plus underlayment installation was in progress on building 21751.
