# Uniform Mitigation Verification Inspection Form

**RE: Palmetto Dunes Condominium**  
**21831 Palmetto Dunes Drive**  
**Estero, FL 33928**  
**Roofing Restoration**  
KEG File #20RN-0085  
**Wind Mitigation**  
**Permit # 1722049-0**

| DATE | April 22, 2020 | JOB NO. | 20RN-0085 |

REPORT: FR # 28

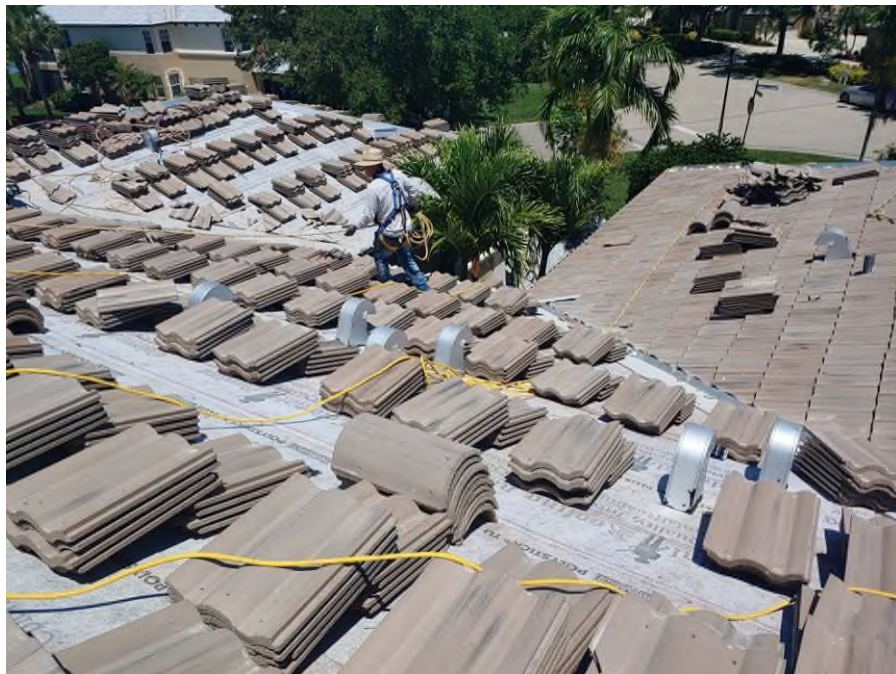
**Photograph #2: Roof field tile installation with polyurethane foam adhesive was in progress on building 21800.**

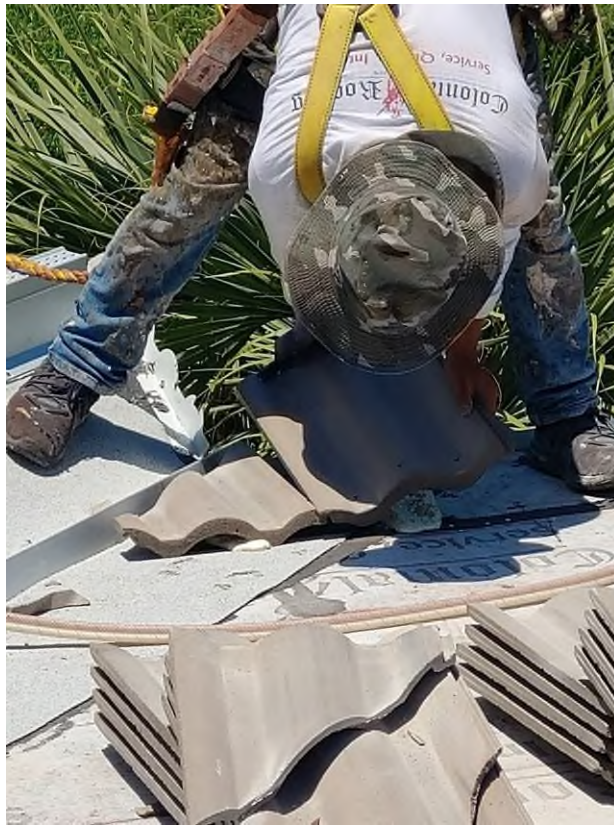
**Photograph #3: Roof field tile installation with polyurethane foam adhesive was in progress on building 21800.**

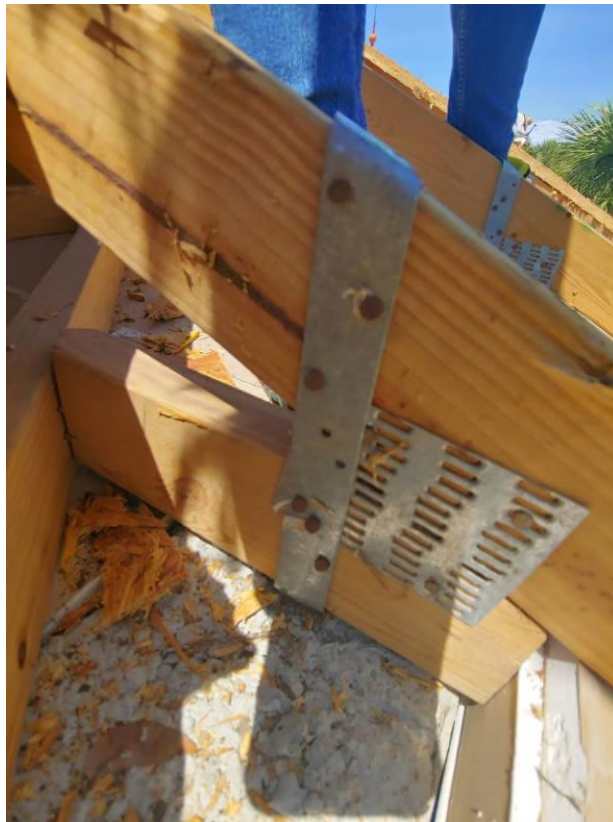
**Photograph #6: Existing strap clips on the trusses have the required minimum of 5 nails on building 21831.**

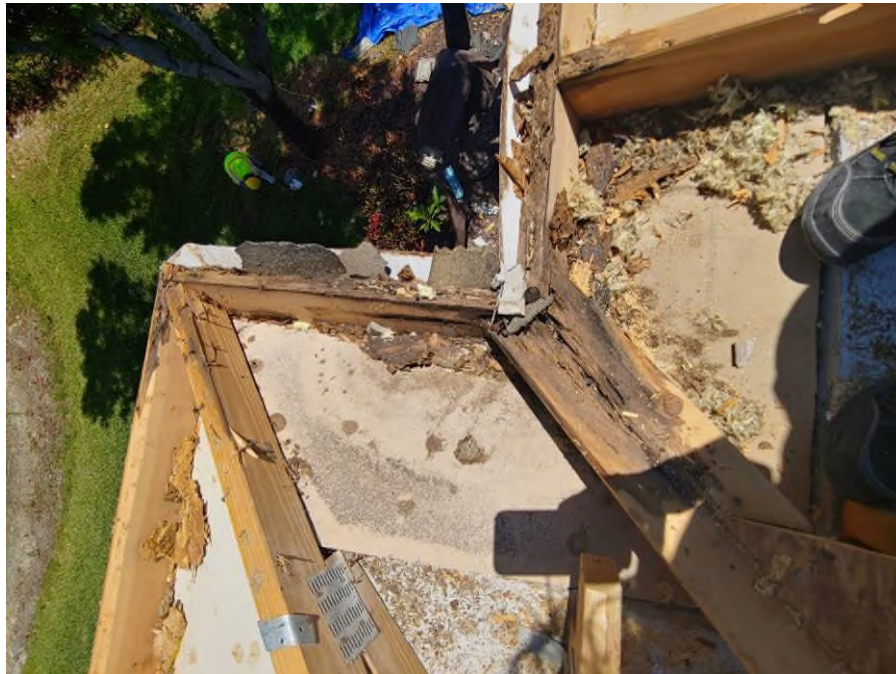
**Photograph #8: Rotten fascia and truss were observed on building 21831.**

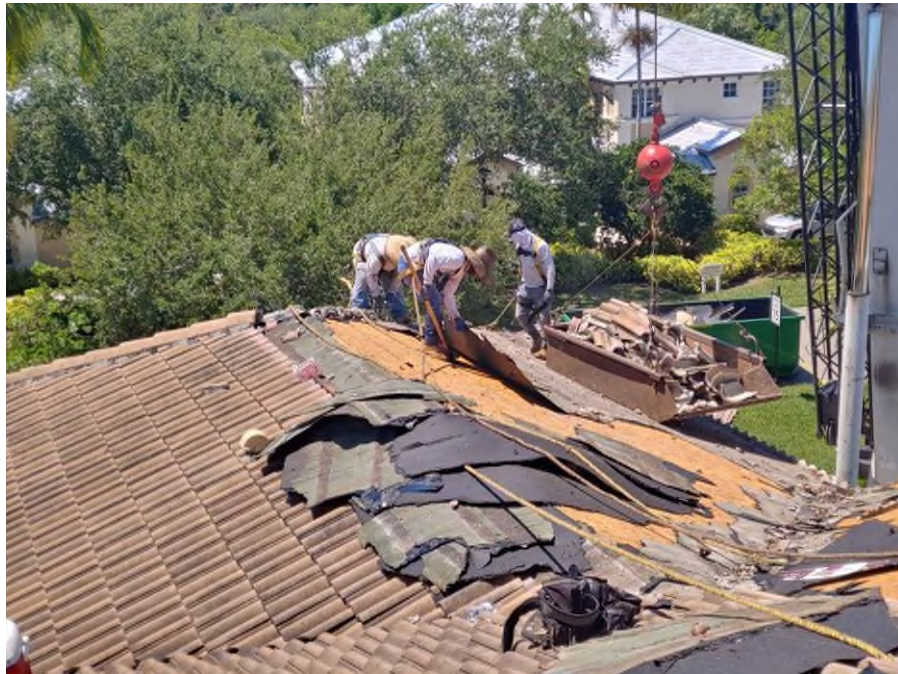
**Photograph #10: Roof tile removal was in progress on building 21841.**

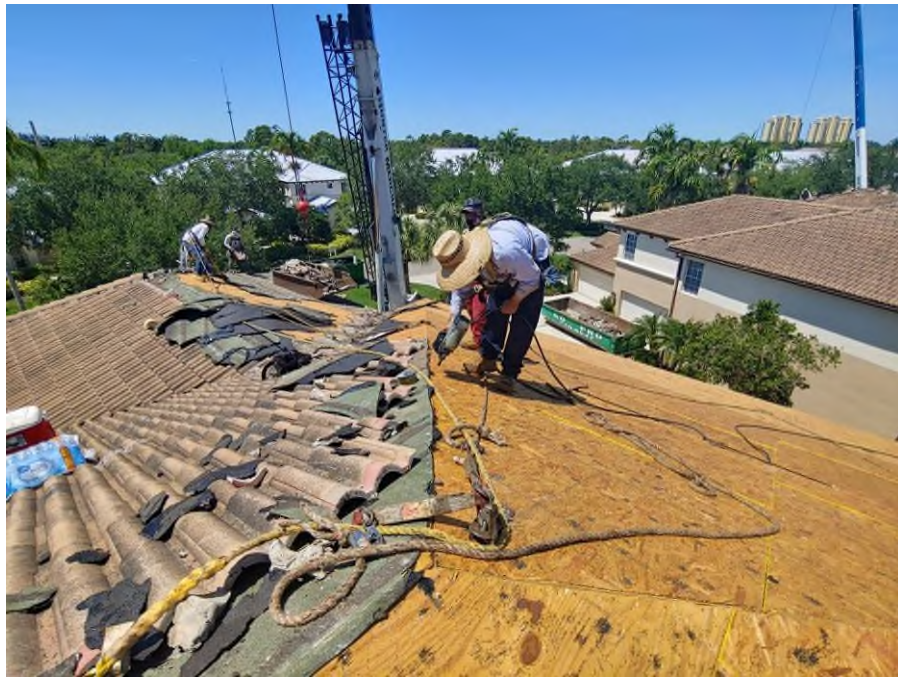
**Photograph #11: Re-nail pattern at the plywood sheathing was in progress on building 21841.**

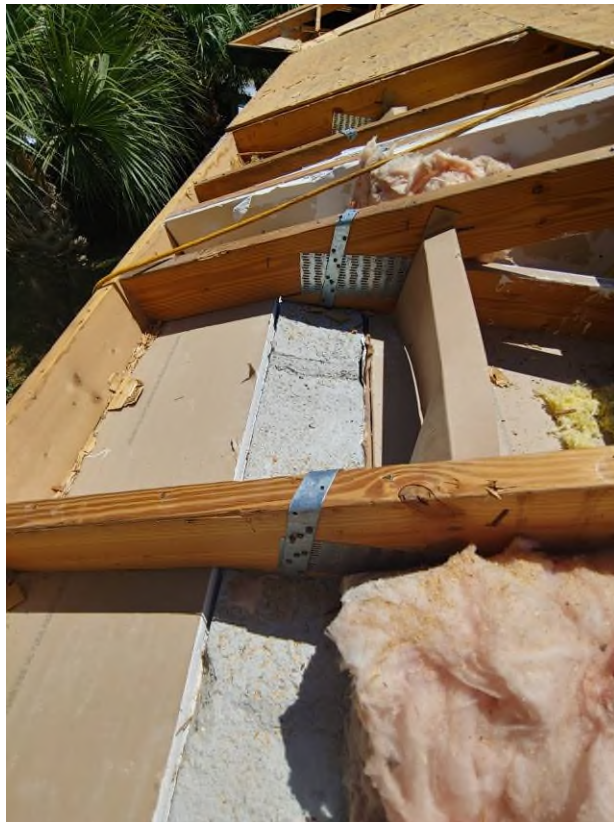
**Photograph #12: Existing strap clips on the trusses have the required minimum of 5 nails on building 21841.**

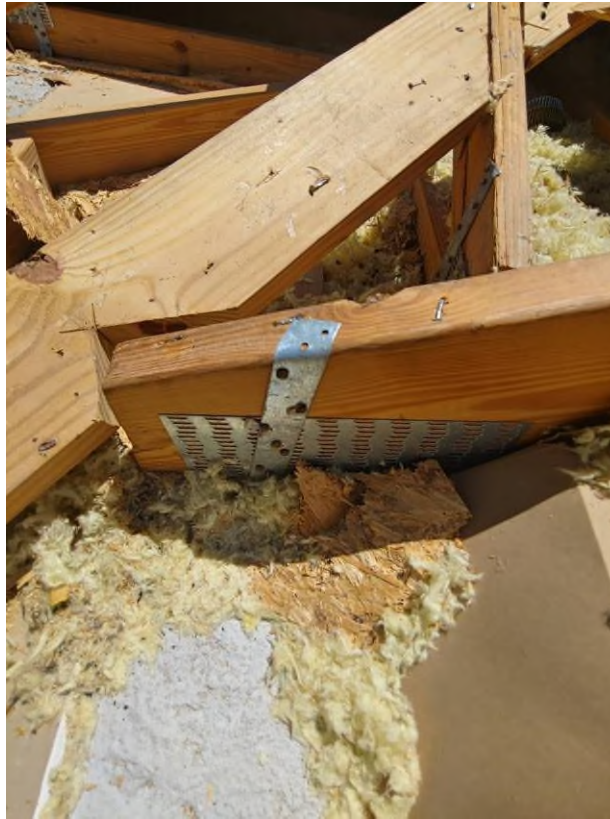
**Photograph #13: Existing strap clips on the trusses have the required minimum of 5 nails on building 21841.**

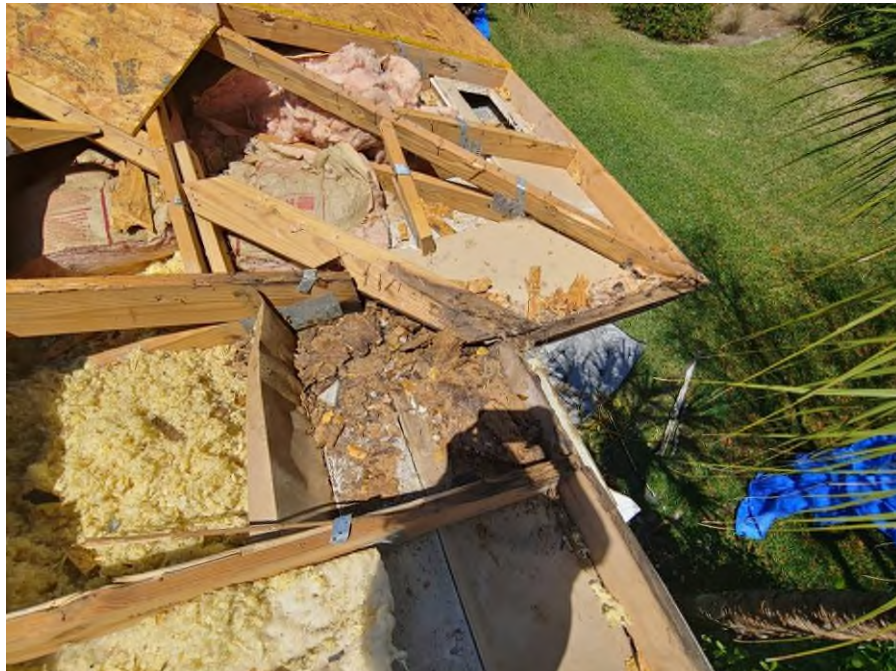
**Photograph #14: Rotten fascia and truss were observed on building 21841.**

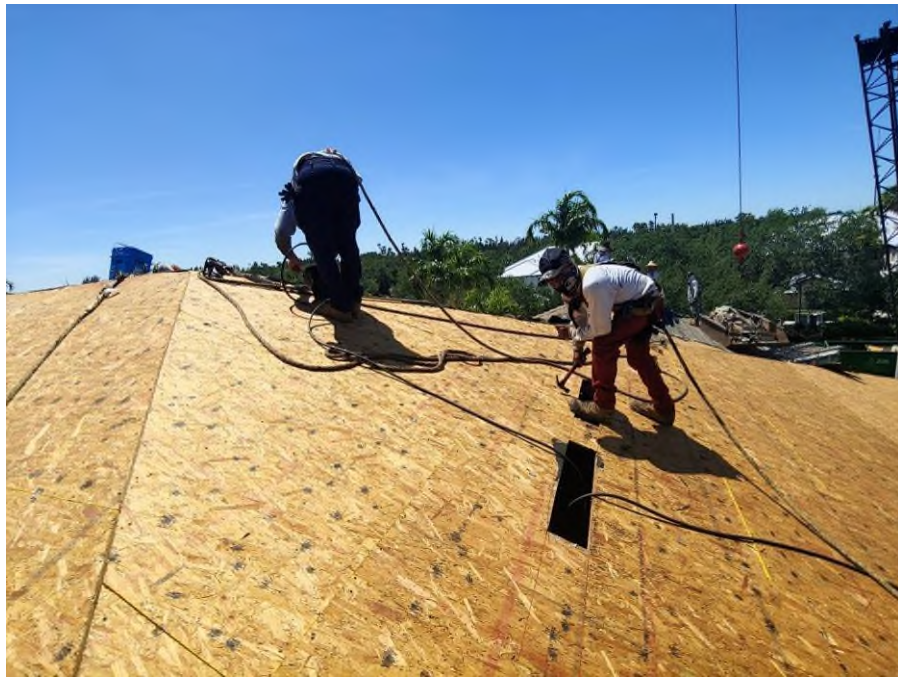
**Photograph #15: Re-nail pattern at the plywood sheathing was in progress on building 21841.**

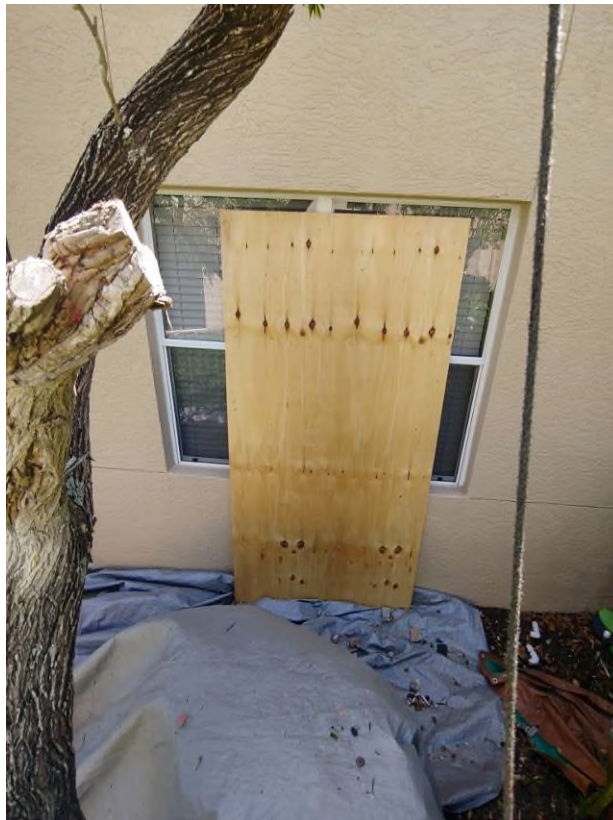
**Photograph #16: Window protection installation was observed on building 21841.**
