Uniform Mitigation Verification Inspection Form

Inspection Date: 06-25-2020		
Owner Information		
Owner Name: Palmetto Dunes Pelican Sound Condominium Association Inc.		Contact Person:
Address: 21711 Palmetto Dunes Drive Units 101,102,201,202		Home Phone:
City: Estero	Zip: 33928	Work Phone:
County: Lee		Cell Phone:
Insurance Company:		Policy #:
Year of Home: 2001	# of Stories: 2	Email:

DATE	March 30, 2020	JOB NO.	20RN-0085
Palmetto Dunes CAI – Roofing Project			
LOCATION	Palmetto Dunes Drive		
CONTRACTOR	EnviroStruct, LLC	Palmetto Dunes CAI	
WEATHER	Sunny	TEMP. 88° F	Time 2:30PM
PRESENT AT SITE	Rahmin Bahar, EnviroStruct (ES) Teresita Nazario-Acosta, Karins Engineering Group (KEG)

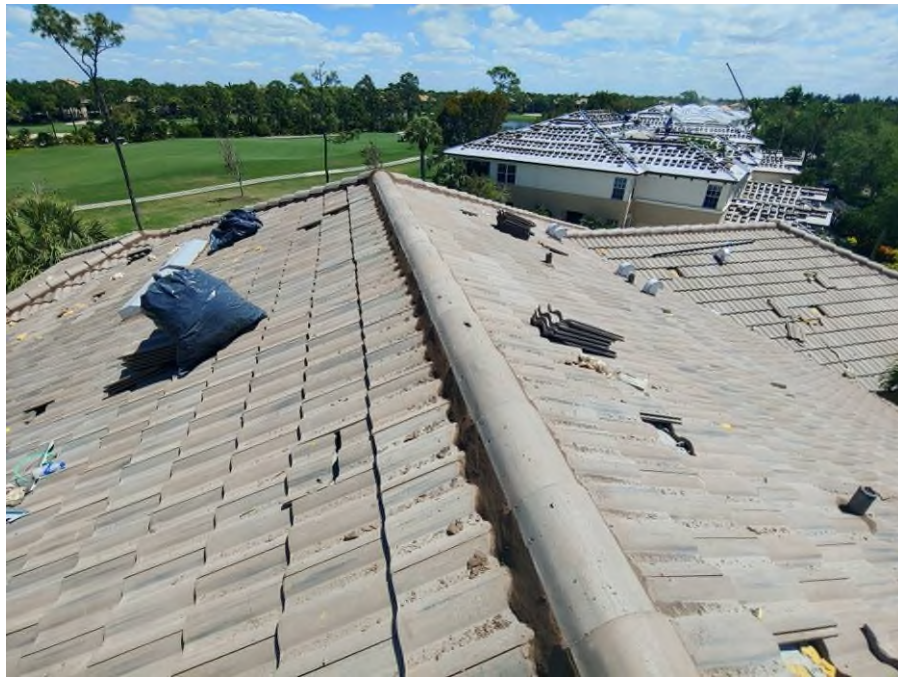
Photograph #5: Roof field, ridge and hip tile installations with polyurethane foam adhesive were in progress on building 21711.

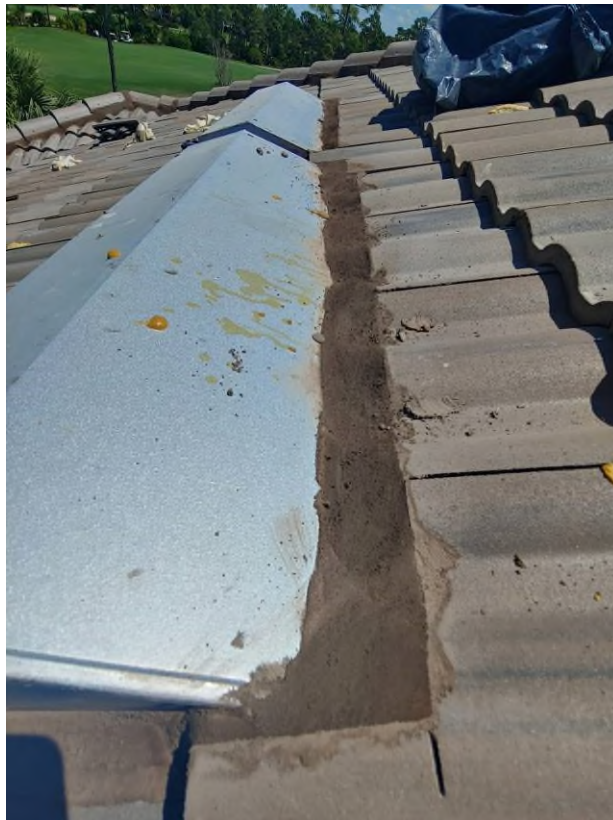
Photograph #8: Mortar adhesive application was in progress on building 21711.

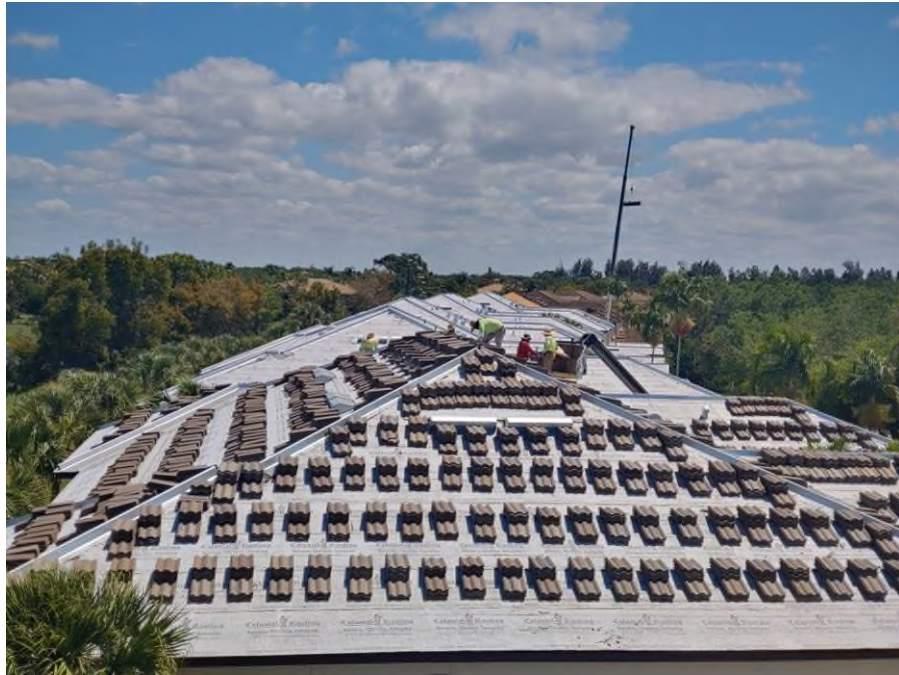
Photograph #13: Roof tiles were set into place for installation on building 21731.

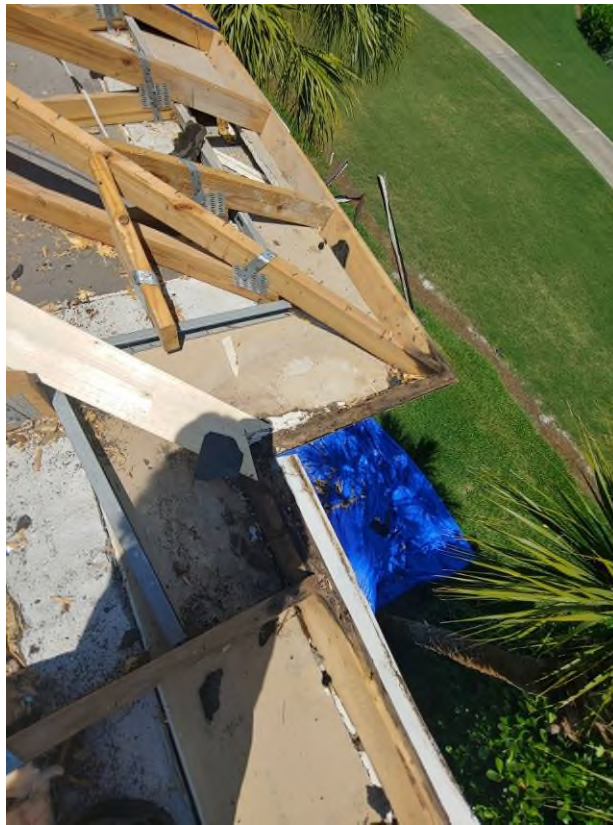
Photograph #19: Rotten fascia and truss were observed on building 21781.

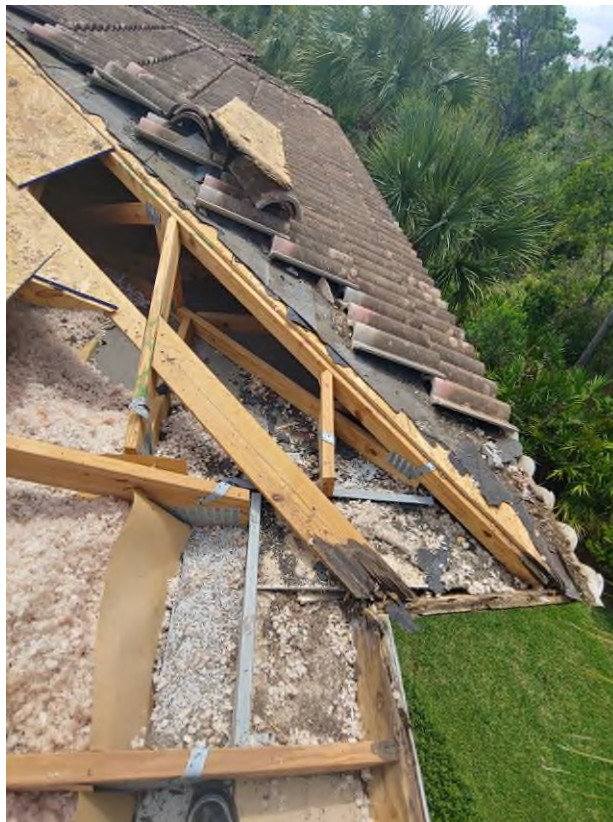
Photograph #28: Rotten fascia and truss were observed on building 21820.

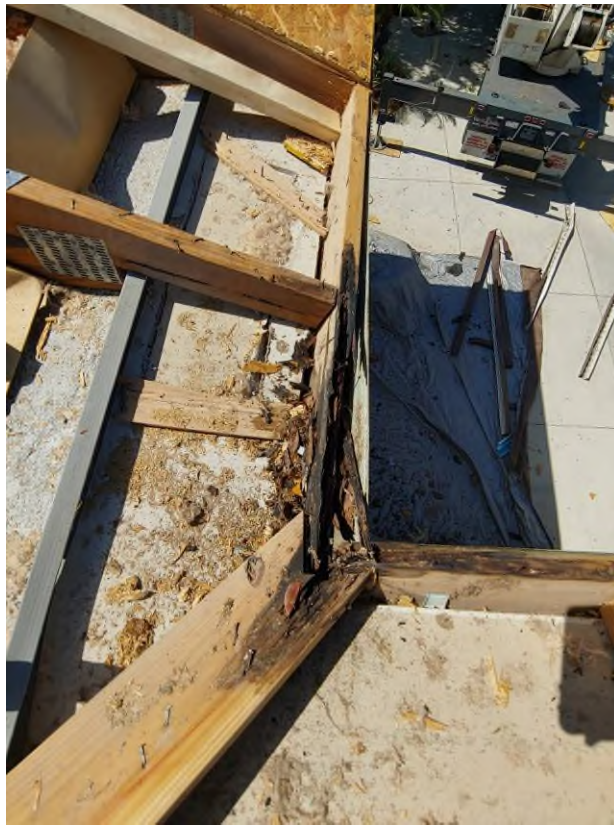
Photograph #25: Rotten fascia and trusses were observed on building 21761.

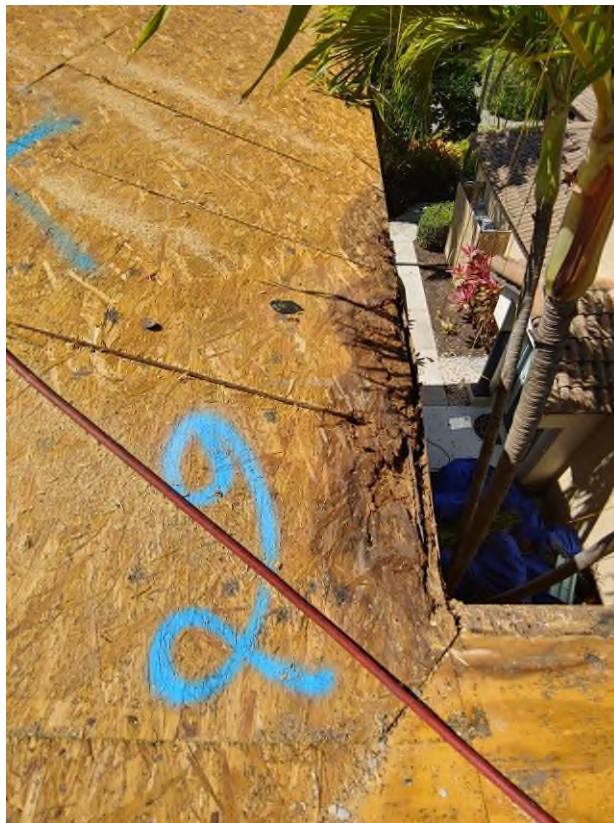
Photograph #26: Rotten fascia and plywood sheathing were observed on building 21761.

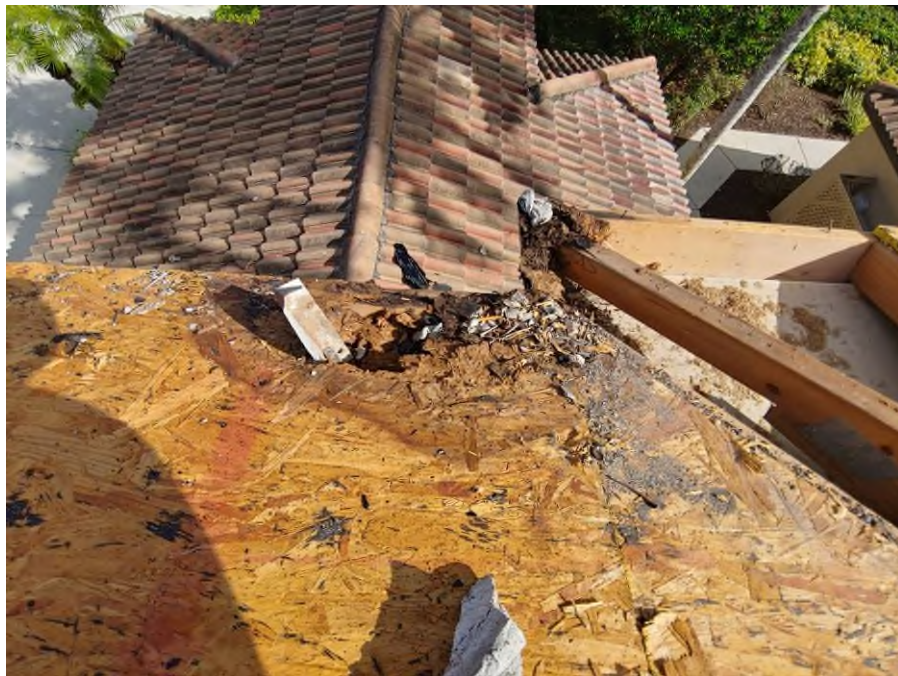
Photograph #8: Rotten plywood sheathing was observed on building 7841.

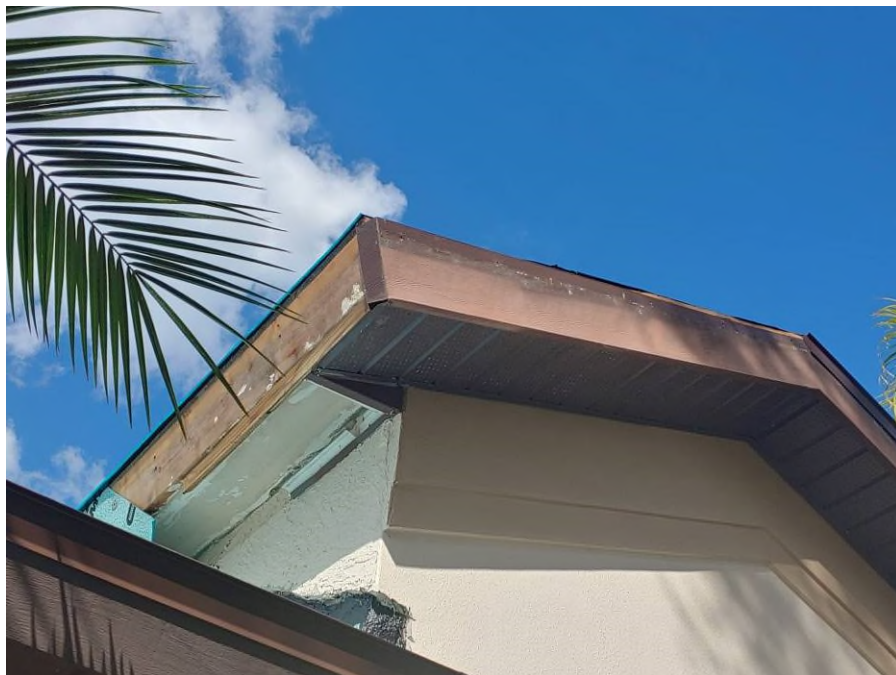
Photograph #24: Fascia repair was pending on building 21711.
