# Uniform Mitigation Verification Inspection Form

| Address: 21761 Palmetto Dunes Drive Units 101,102,201,202 | | Home Phone: |

**RE: Palmetto Dunes Condominium**  
**21761 Palmetto Dunes Drive**  
**Estero, FL 33928**  
**Roofing Restoration**  
KEG File #20RN-0085  
**Wind Mitigation**  
**Permit # 1721919-0**

| Palmetto Dunes CAI – Roofing Project | | | |

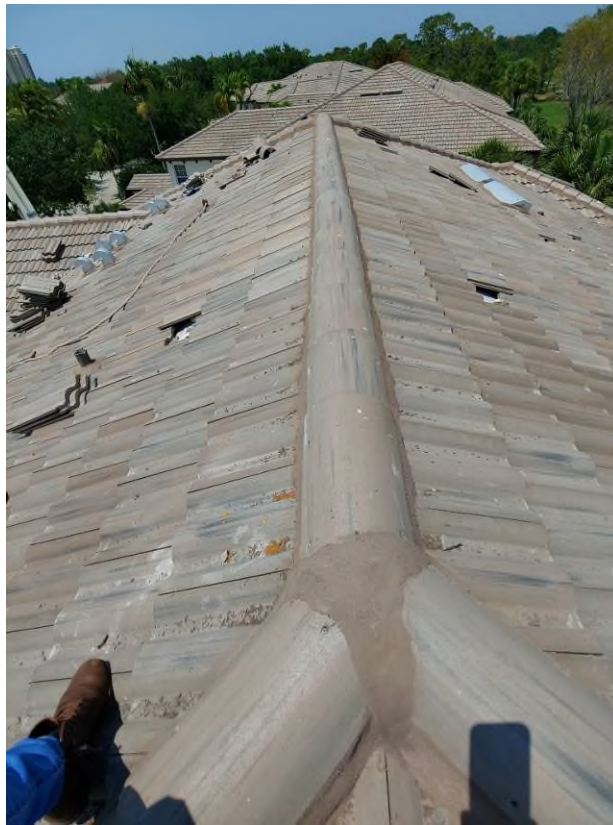
**Photograph #1: Mortar adhesive application was in progress on building 21731.**

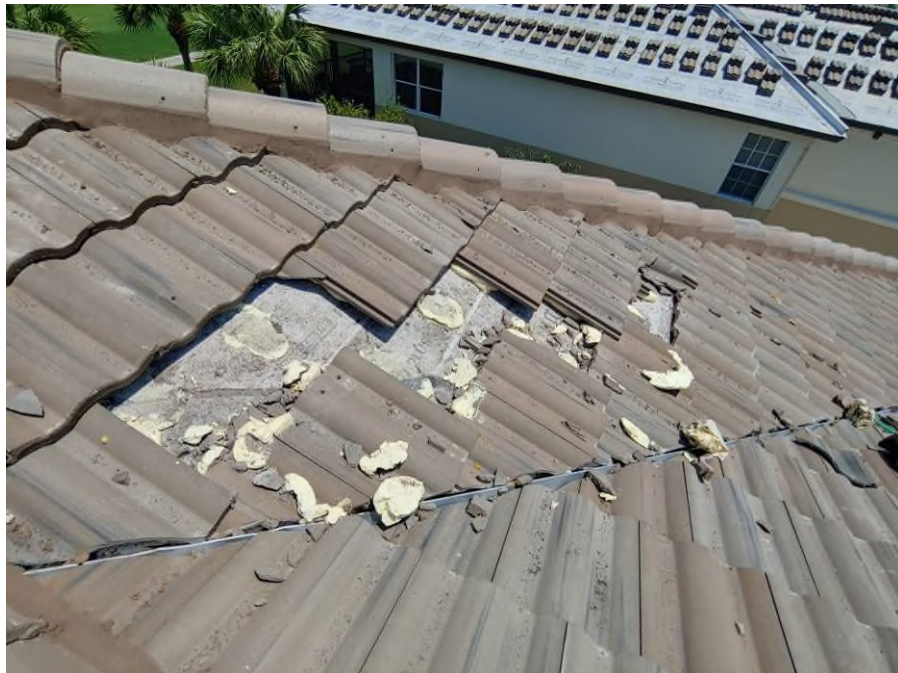
**Photograph #4: Broken field tile replacement was in progress on building 21731.**

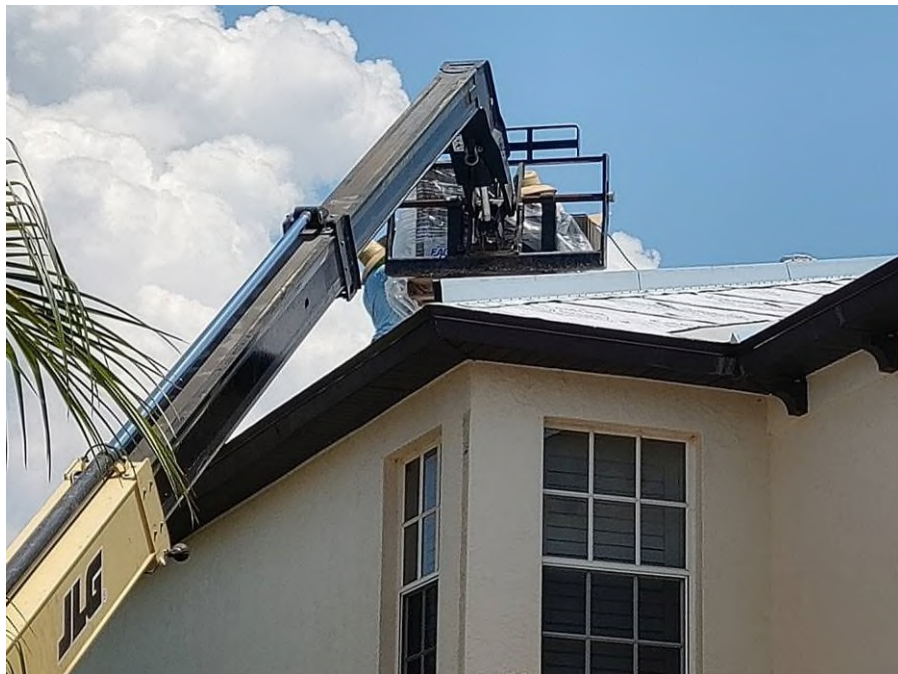
**Photograph #6: Roof tiles were set in place for installation on buildings 21751.**

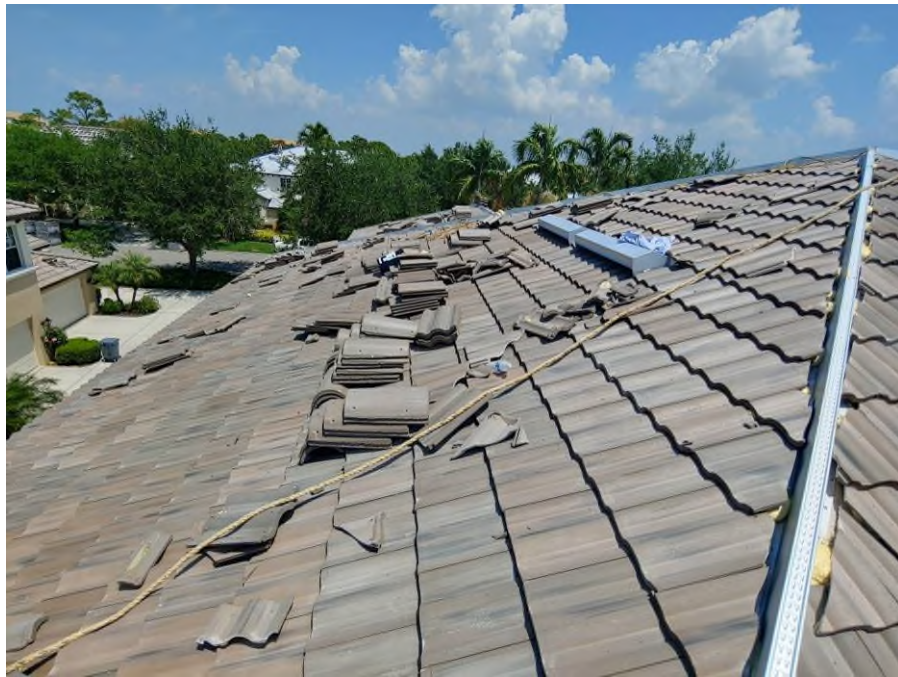
**Photograph #7: Roof field tiles with polyurethane foam adhesive were in progress on building 21760.**

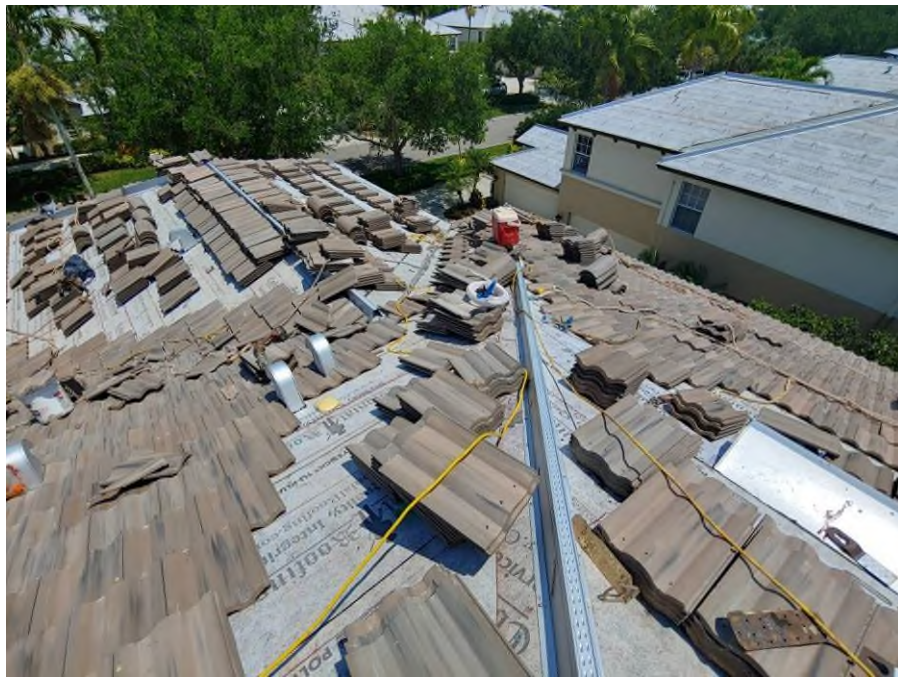
**Photograph #8: Roof field tiles with polyurethane foam adhesive were in progress on building 21760.**

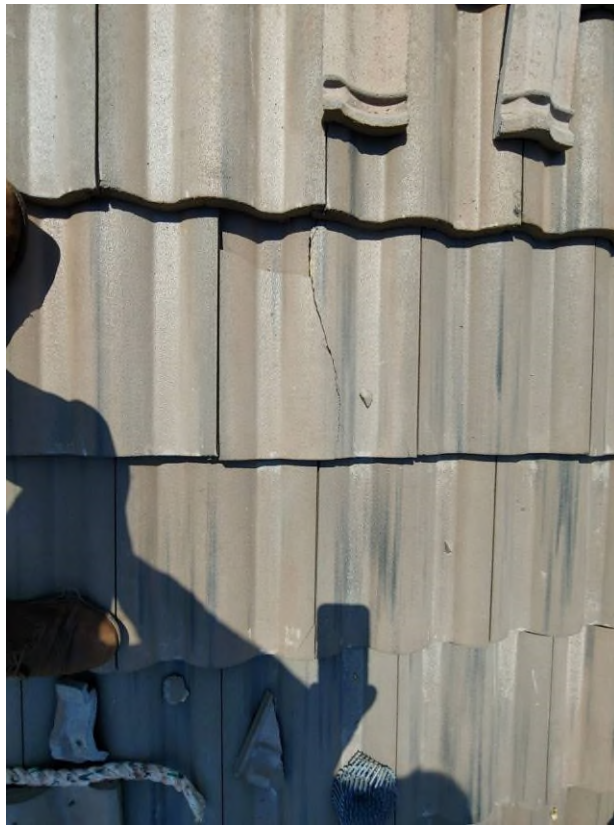
**Photograph #9: Broken field tile replacement must be addressed on building 21760.**

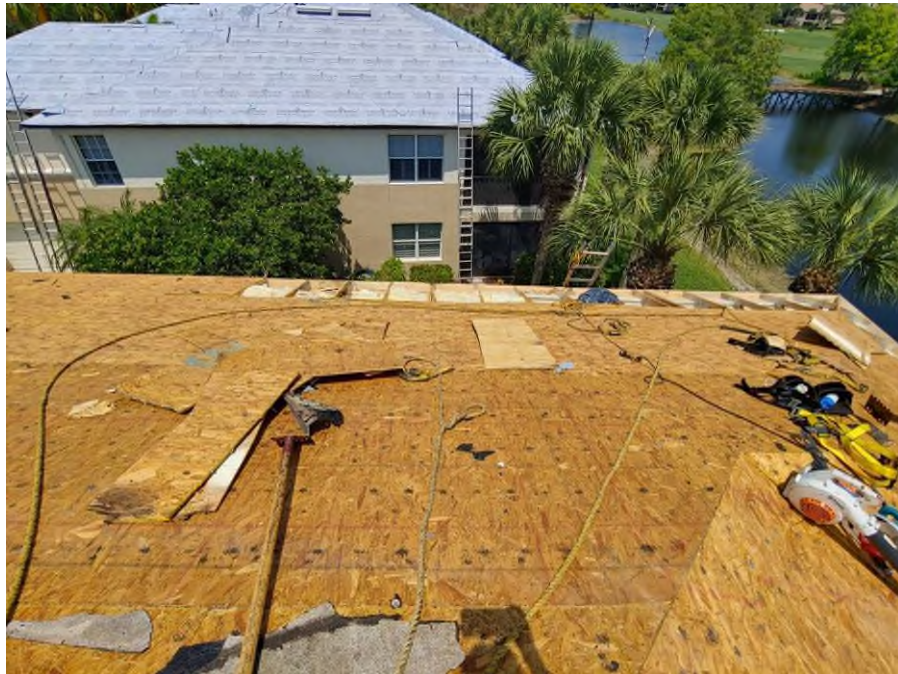
**Photograph #12: Roof tile removal was in progress on building 21811.**

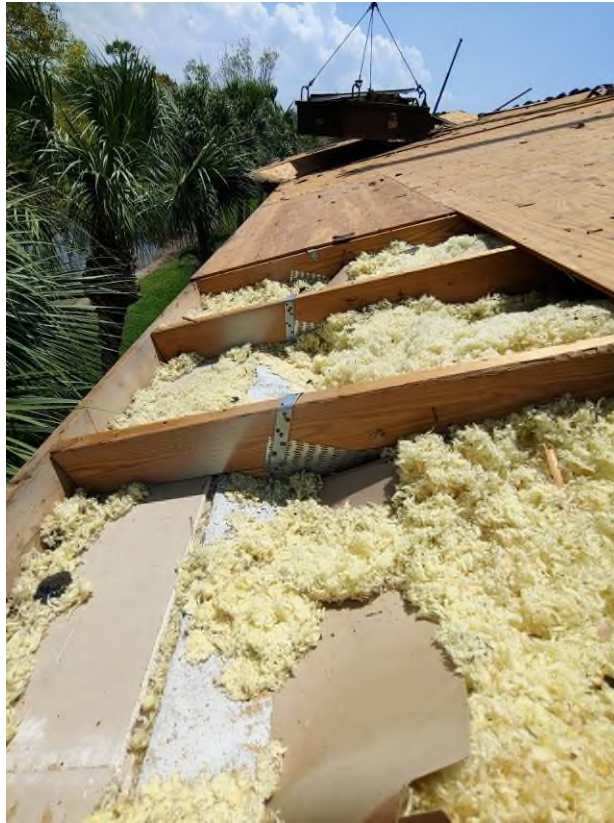
**Photograph #13: Existing strap clips on the trusses have the required minimum of 5 nails on building 21811.**

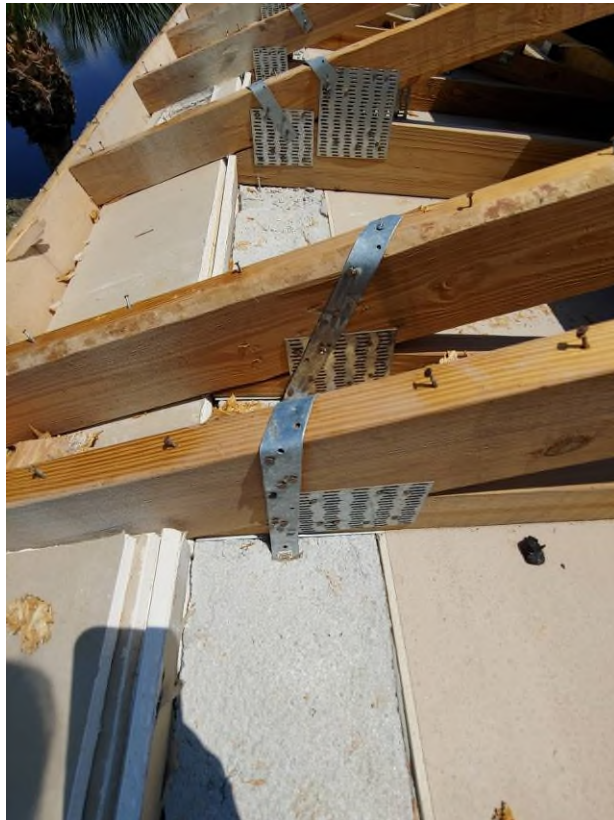
**Photograph #14: Existing strap clips on the trusses have the required minimum of 5 nails on building 21811.**

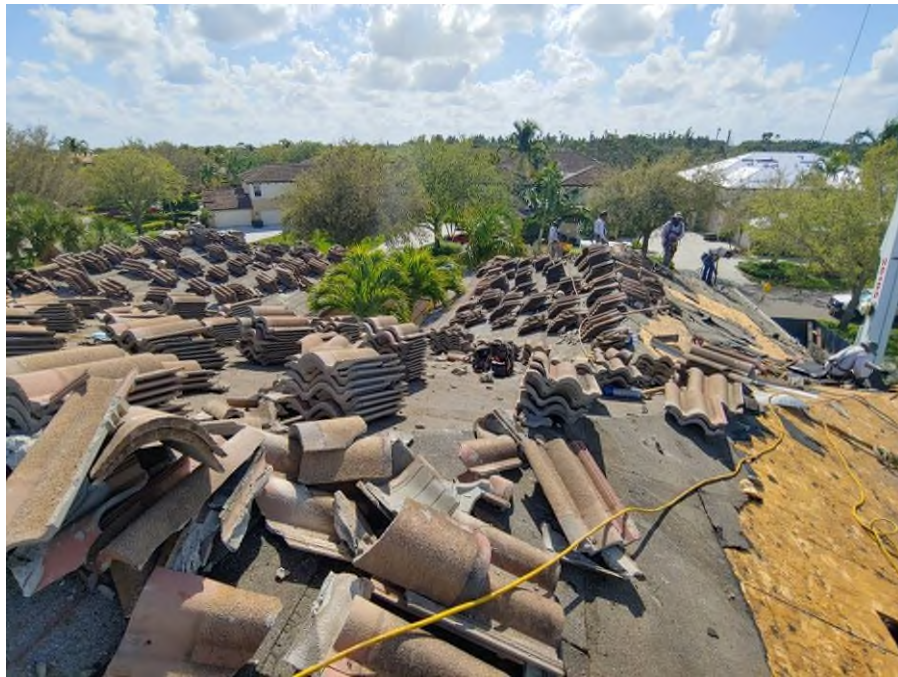
**Photograph #1: Roof tile removal was in progress on building 7891.**

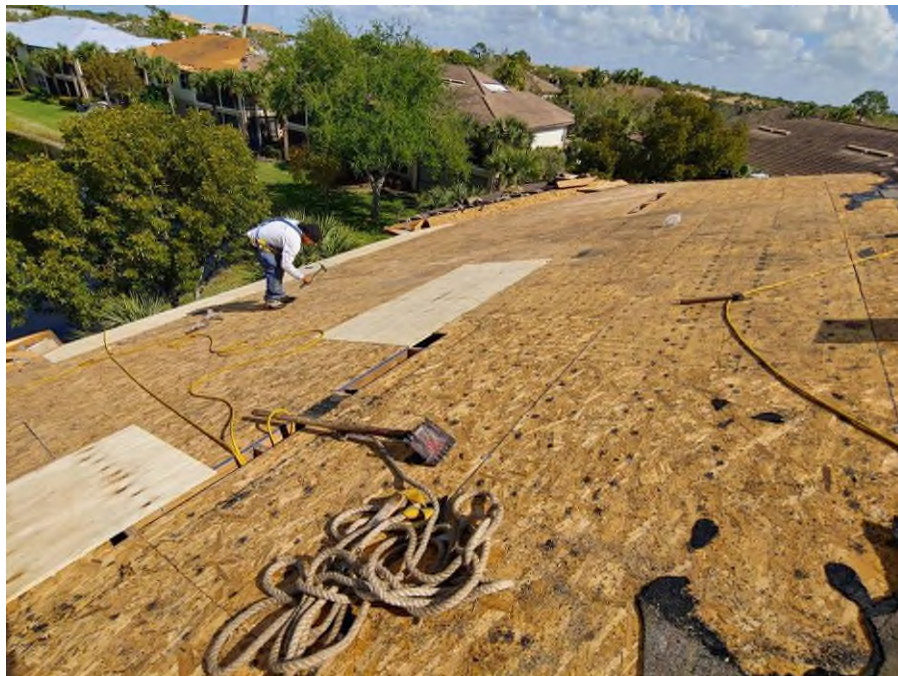
**Photograph #2: Roof tile removal was in progress on building 7891.**

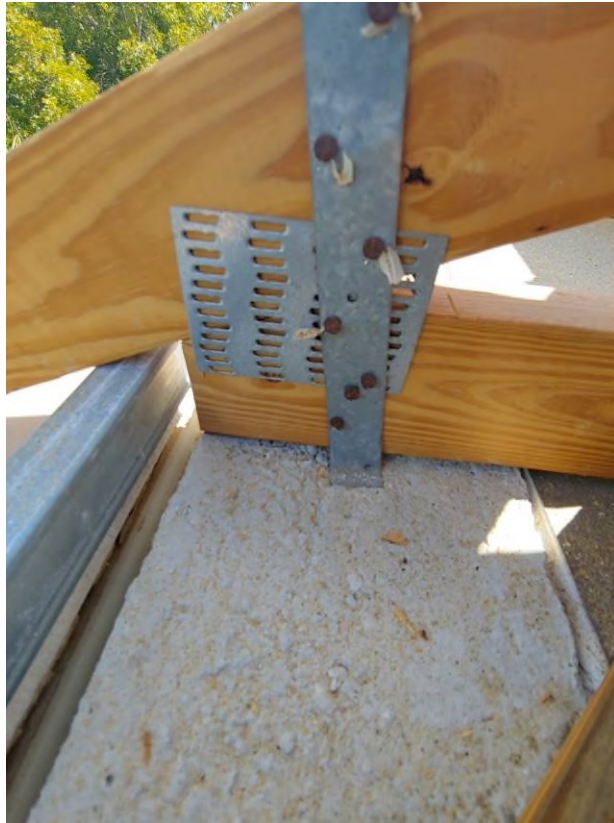
**Photograph #3: Existing strap clips on the trusses have the required minimum of nails on building 7891.**

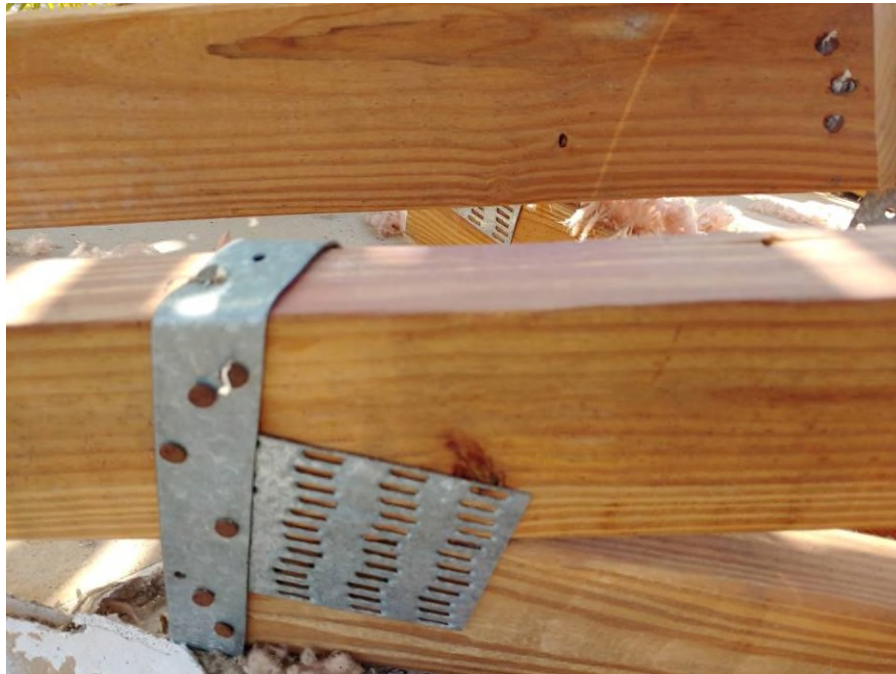
**Photograph #4: Existing strap clips on the trusses have the required minimum of nails on building 7891.**

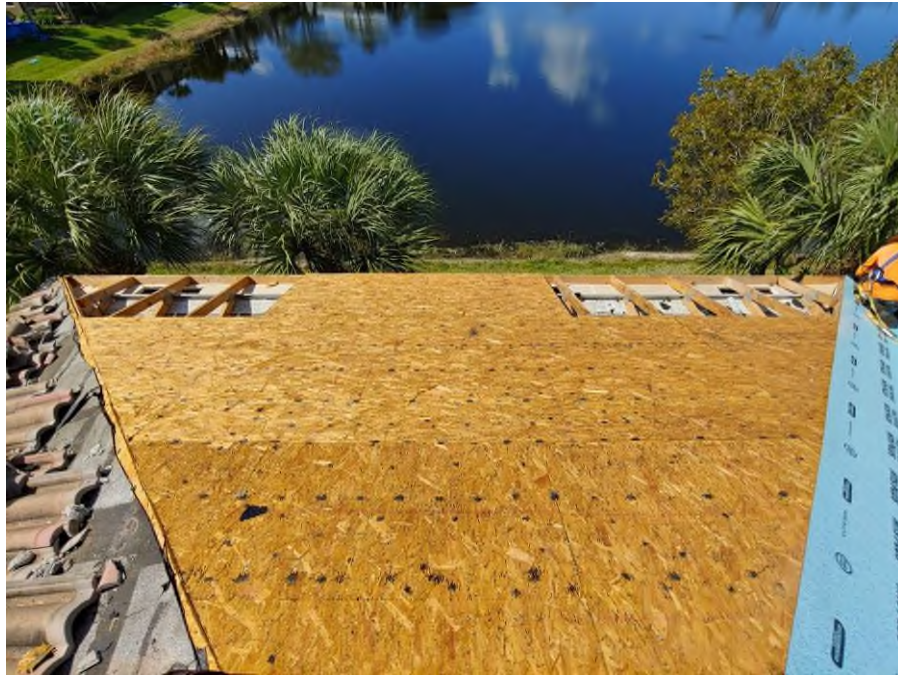
**Photograph #5: Roof tile removal was in progress on building 21760.**

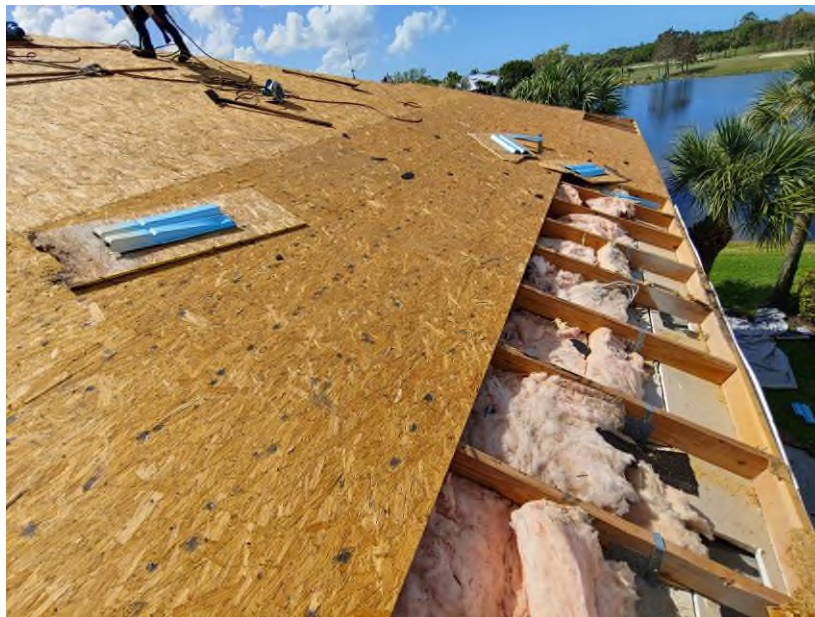
**Photograph #6: Existing strap clips on the trusses have the required minimum of nails on building 21760.**

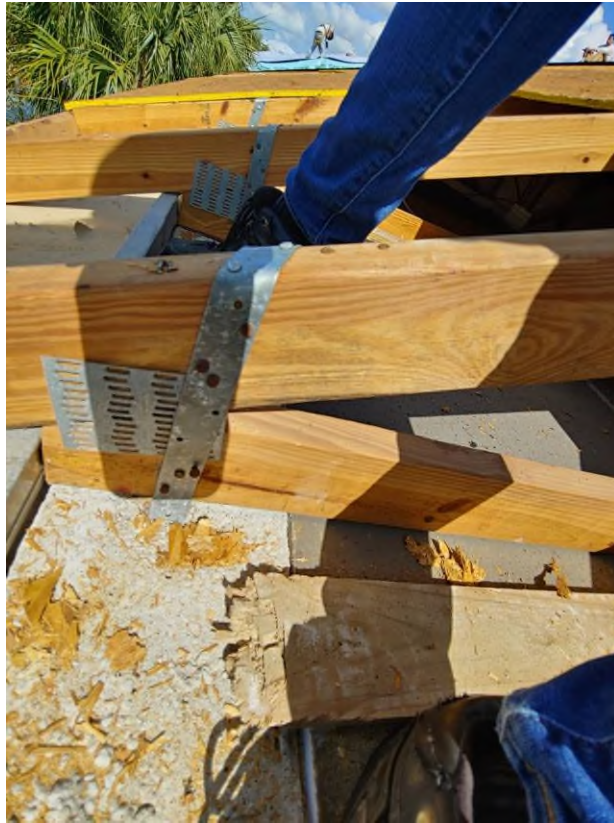
**Photograph #7: Existing strap clips on the trusses have the required minimum of nails on building 21760.**

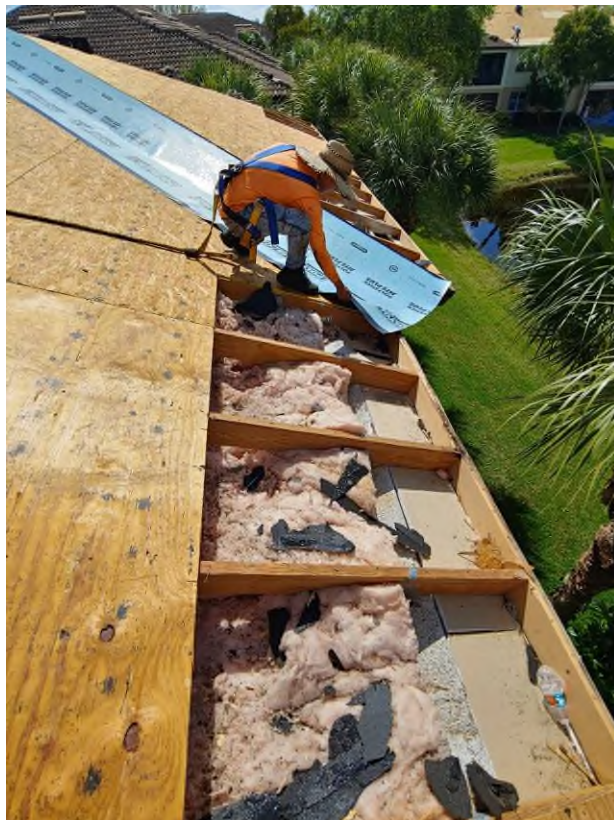
**Photograph #8: Polystick MTS underlayment installation was in progress on building 21760.**
