# Uniform Mitigation Verification Inspection Form

| Address: 7890 Classic Court Units 101,102,201,202 | | Home Phone: |

**RE: Palmetto Dunes Condominium**  
**7890 Classic Court**  
**Estero, FL 33928**  
**Roofing Restoration**  
KEG File #20RN-0085  
**Wind Mitigation**  
**Permit # 1721370-0**

| Palmetto Dunes CAI – Roofing Project | | | |

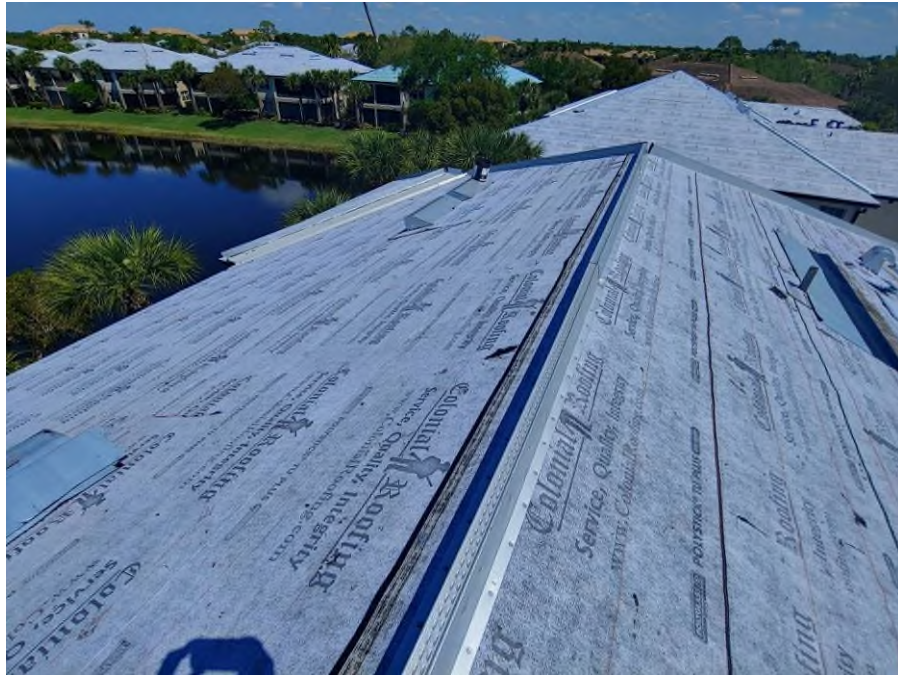
**Photograph #7: Second layer of underlayment installation was completed on building 7881.**

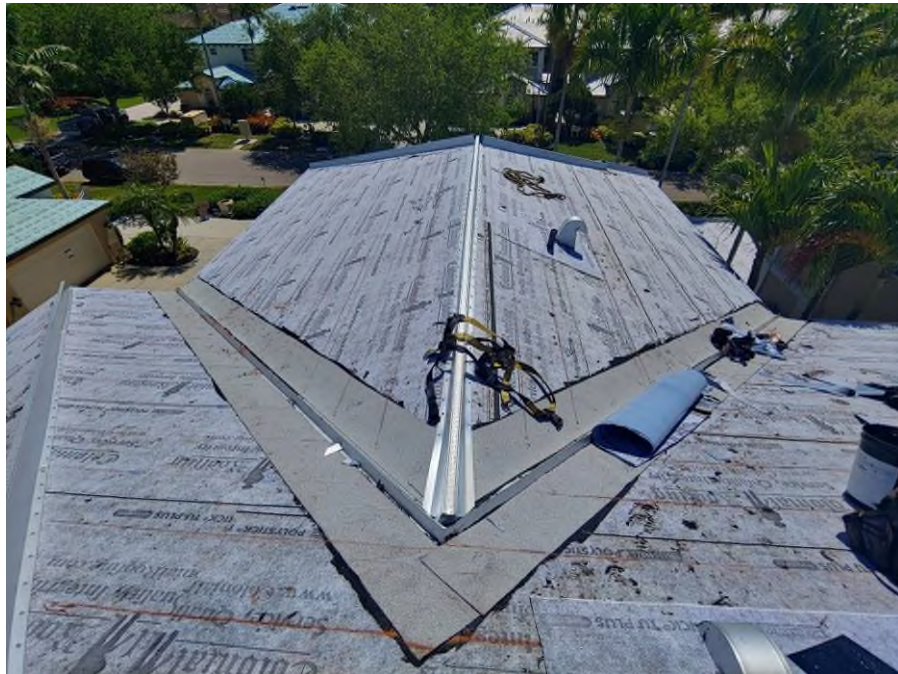
**Photograph #8: V-crimp metal valley flashing installations were in progress on building 7881.**

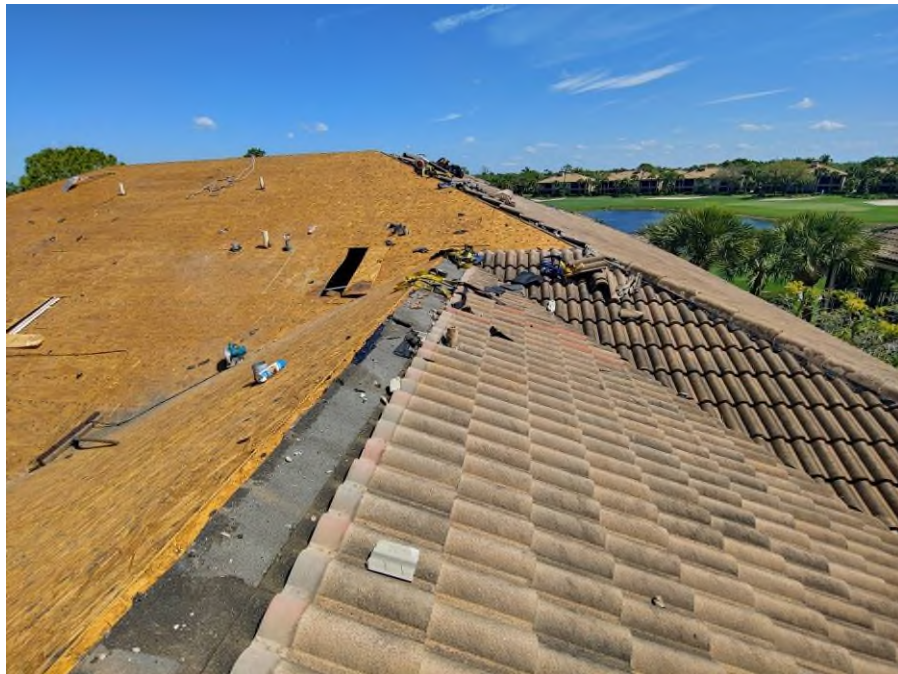
**Photograph #22: Roof tile removal was in progress on building 21761.**

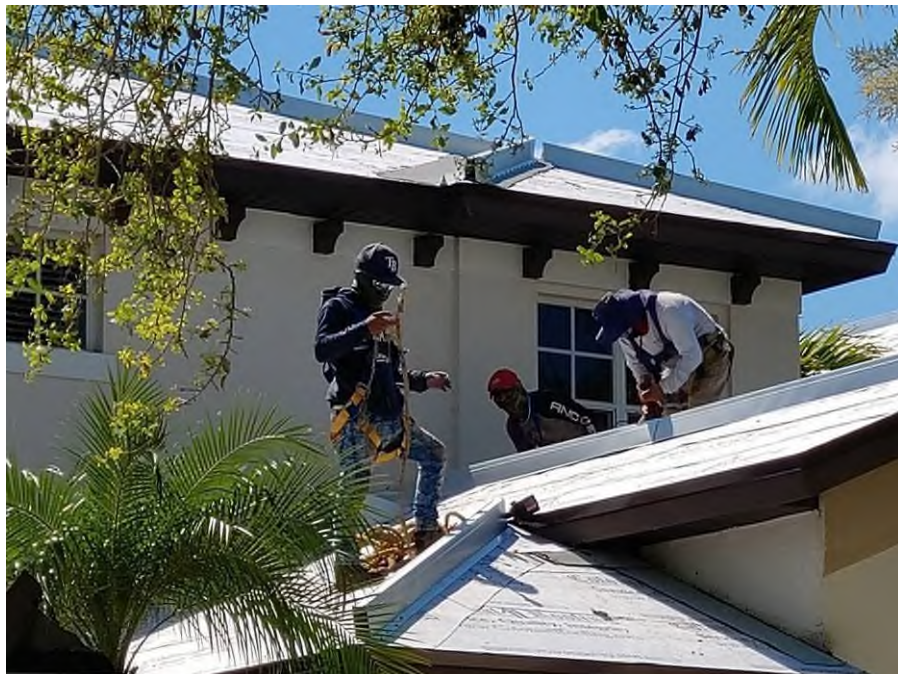
**Photograph #8: Hip/ridge metal channel installation was in progress on building 7881.**
