# Uniform Mitigation Verification Inspection Form

Inspection Date: 5-6-2020		
<b>Owner Information</b>		
Owner Name: Palmetto Dunes Pelican Sound Condominium Association Inc.		Contact Person:
Address: 7880 Classic Court Units 101,102,201,202		Home Phone:
City: Estero	Zip: 33928	Work Phone:
County: Lee		Cell Phone:
Insurance Company:		Policy #:
Year of Home: 2001	# of Stories: 2	Email:

**RE: Palmetto Dunes Condominium**  
**7880 Classic Court**  
**Estero, FL 33928**  
**Roofing Restoration**  
KEG File #20RN-0085  
**Wind Mitigation**  
**Permit # 1721367-0**

**FIELD REPORT**

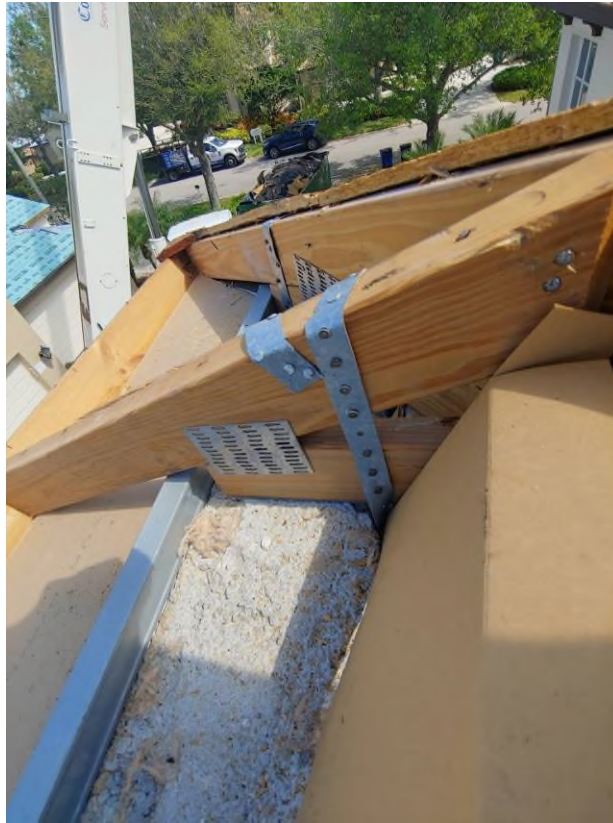
**Photograph #15: Existing strap clips on the trusses have the required minimum quantity of nails on building 21770.**

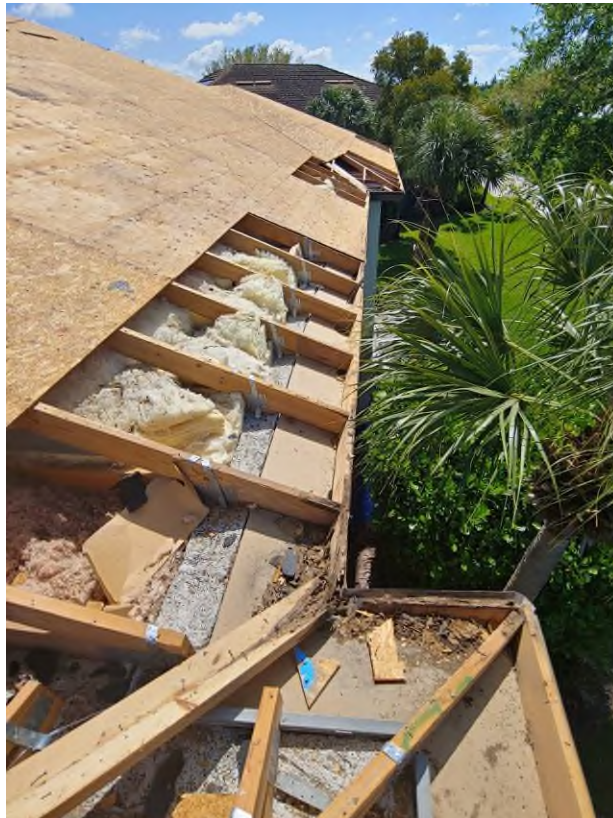
**Photograph #16: Rotten fascia and trusses were observed on building 21770.**

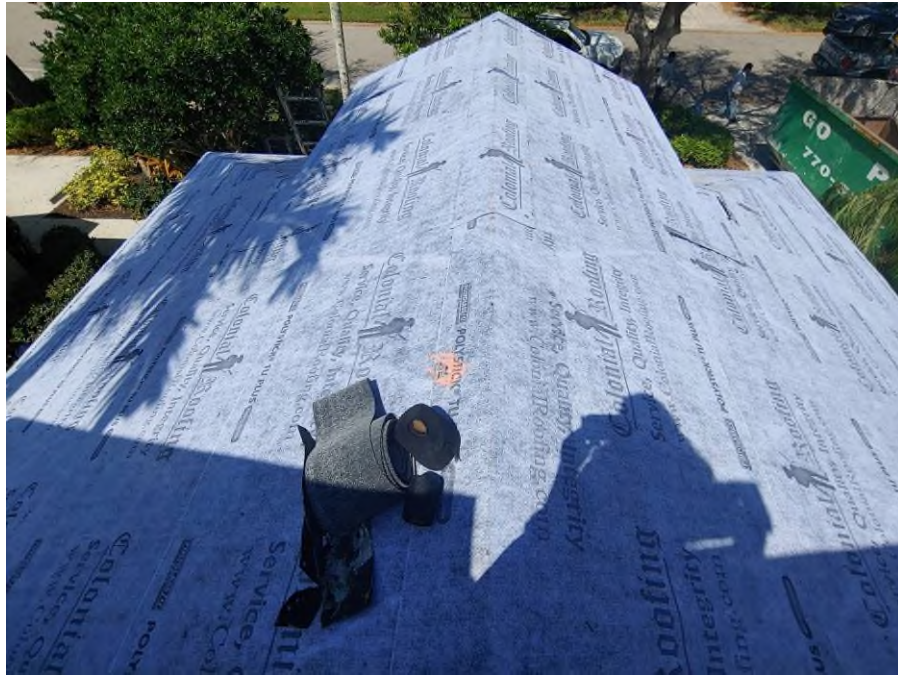
**Photography #3: Second layer of underlayment installation was in progress on building 7870.**

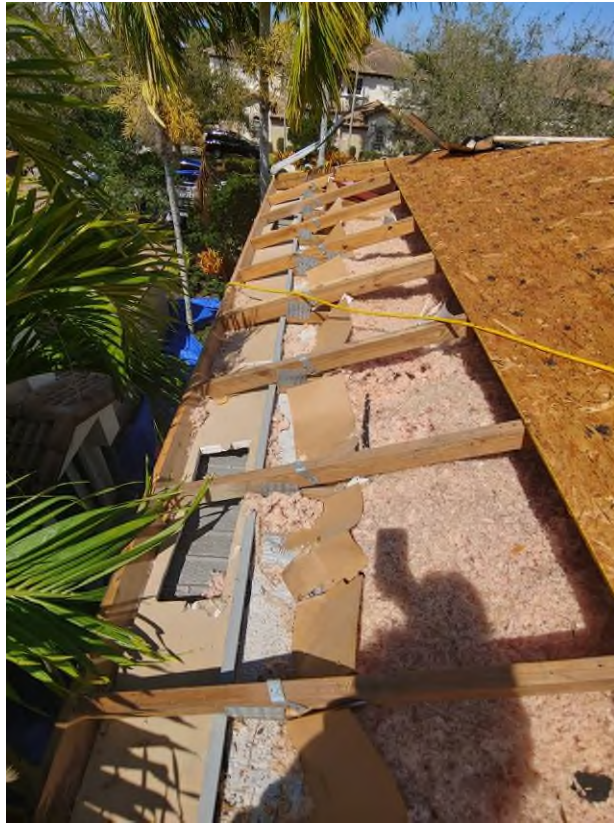
**Photography #5: Existing strap clips on the trusses have the required minimum quantity of nails on building 7880.**

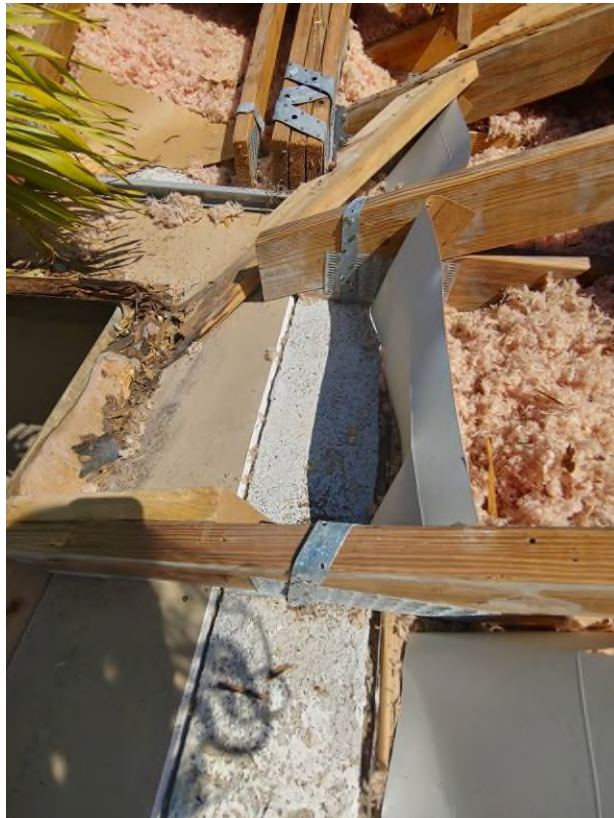
**Photography #6: Existing strap clips on the trusses have the required minimum quantity of nails on building 7880.**

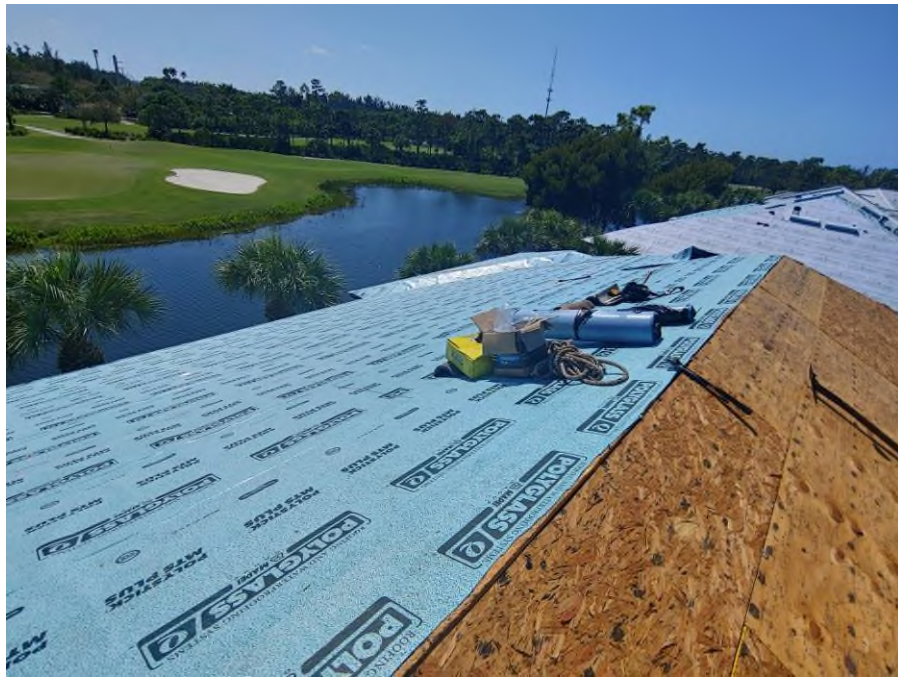
**Photography #7: Polystick MTS Plus underlayment installation was in progress on building 7880.**

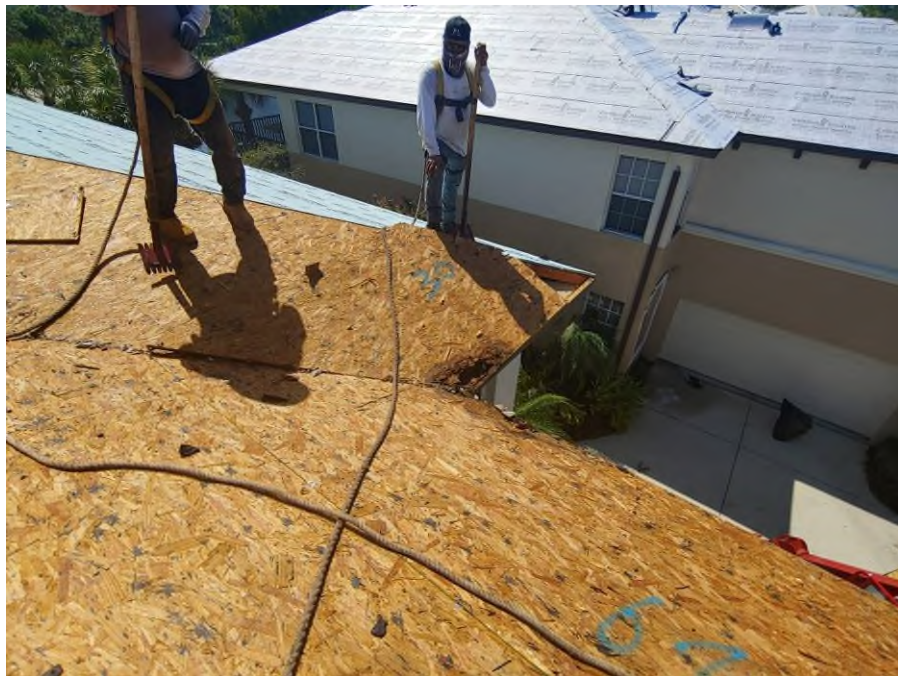
**Photography #8: Rotten plywood sheathing was observed on building 7880.**

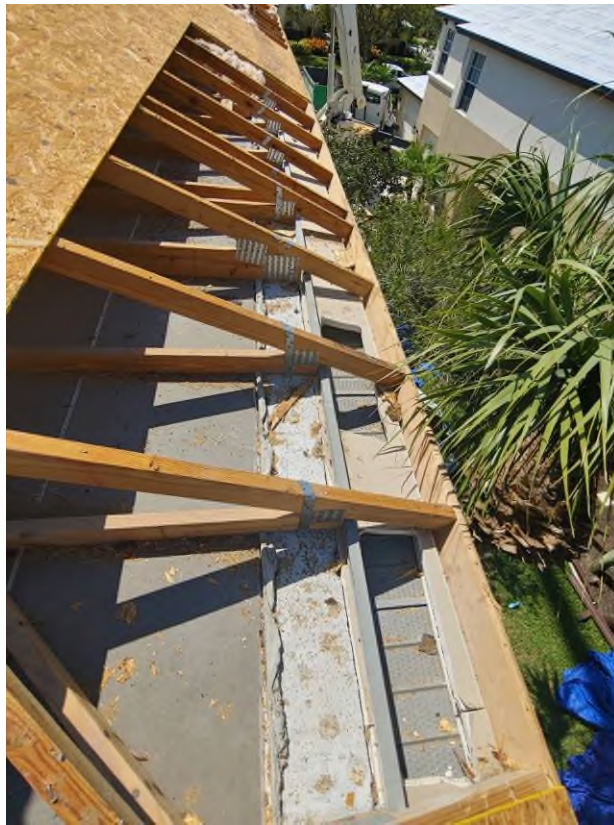
**Photography #11: Existing strap clips on the trusses have the required minimum quantity of nails on building 21741.**

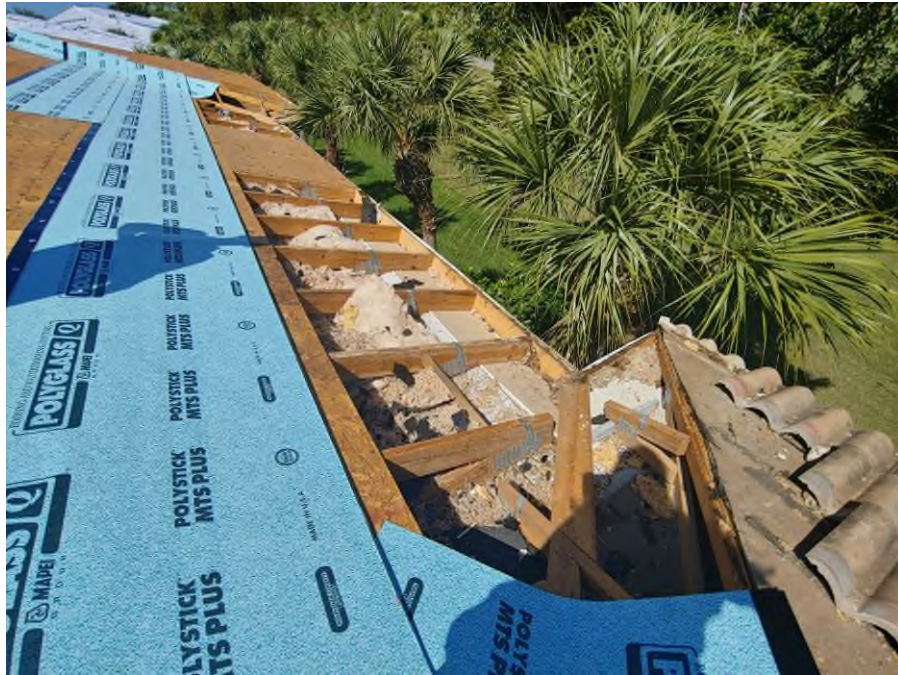
**Photography #13: Polystick MTS Plus underlayment installation was in progress on building 21741.**

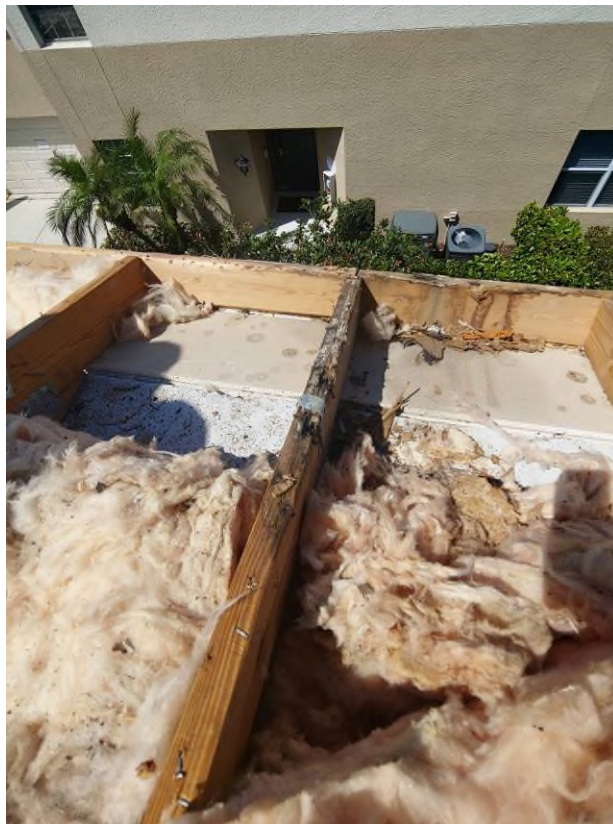
**Photography #14: Rotten fascia and truss were observed on building 21741.**
