Uniform Mitigation Verification Inspection Form

Inspection Date: 6-20-2020		
Owner Information		
Owner Name: Palmetto Dunes Pelican Sound Condominium Association Inc.		Contact Person:
Address: 21830 Palmetto Dunes Drive Units 101,102,201,202		Home Phone:
City: Estero	Zip: 33928	Work Phone:
County: Lee		Cell Phone:
Insurance Company:		Policy #:
Year of Home: 2001	# of Stories: 2	Email:

RE: Palmetto Dunes Condominium
21830 Palmetto Dunes Drive
Estero, FL 33928
Roofing Restoration
KEG File #20RN-0085
Wind Mitigation
Permit # 1721794-0

DATE	April 08, 2020	JOB NO.	20RN-0085
Palmetto Dunes CAI – Roofing Project			
LOCATION	Palmetto Dunes Drive		
CONTRACTOR	EnviroStruct, LLC	Palmetto Dunes CAI	
WEATHER	Sunny	TEMP.	84° F
		Time	12:00PM
PRESENT AT SITE	Rahmin Bahar, EnviroStruct (ES) Teresita Nazario-Acosta, Karins Engineering Group (KEG)

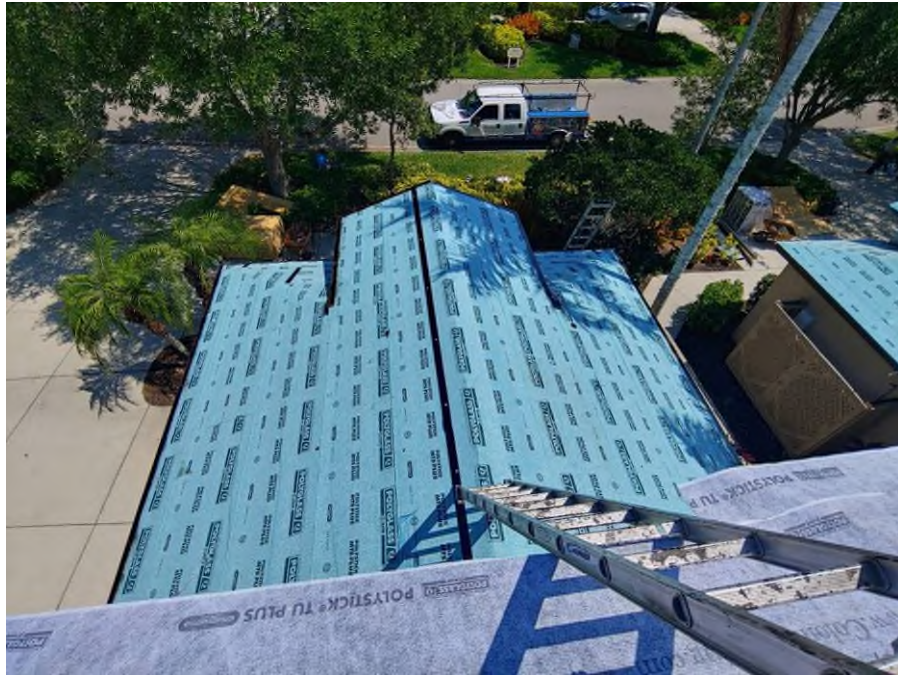
Photograph #1: Polystick MTS Plus underlayment installation was completed on building 21830.

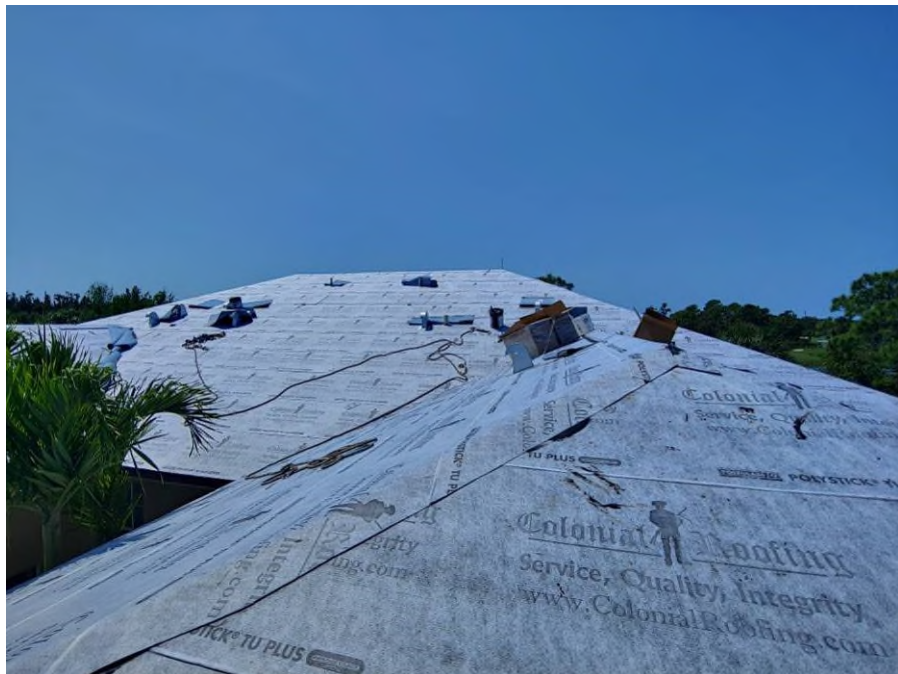
Photograph #2: Second layer of underlayment installation was in progress on building 21830.

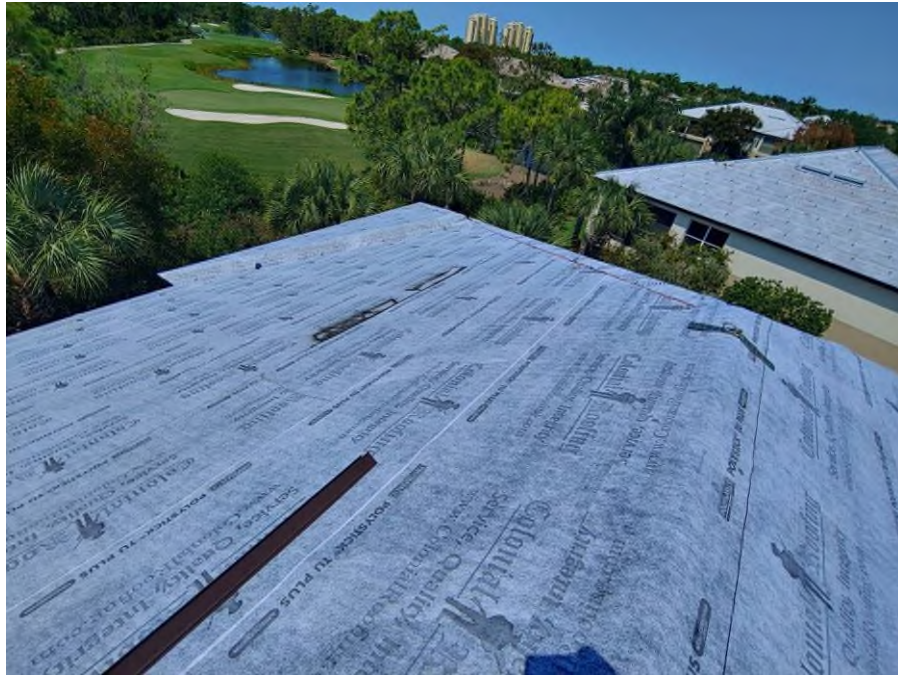
Photograph #3: Second layer of underlayment installation was in progress on building 21830.

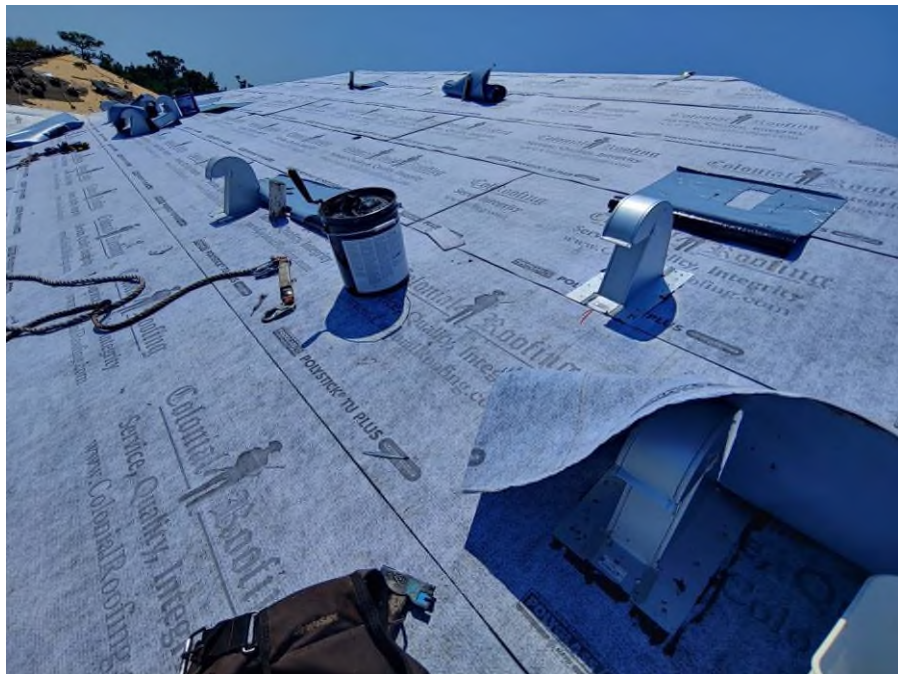
Photograph #4: Exhaust vent installations were in progress on building 21830.

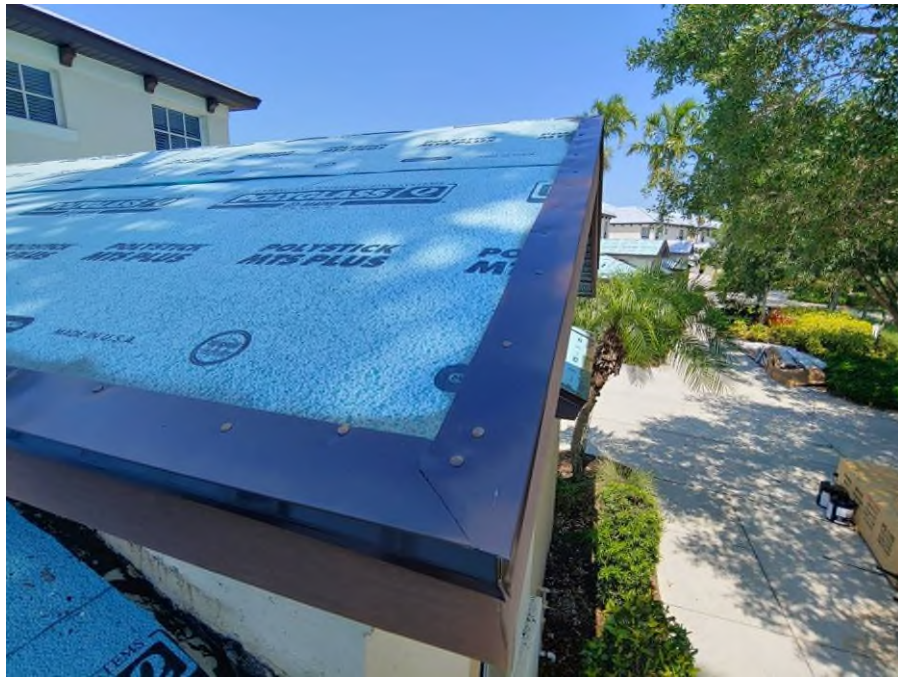
Photograph #5: Drip edge flashing installation was completed on building 21830.

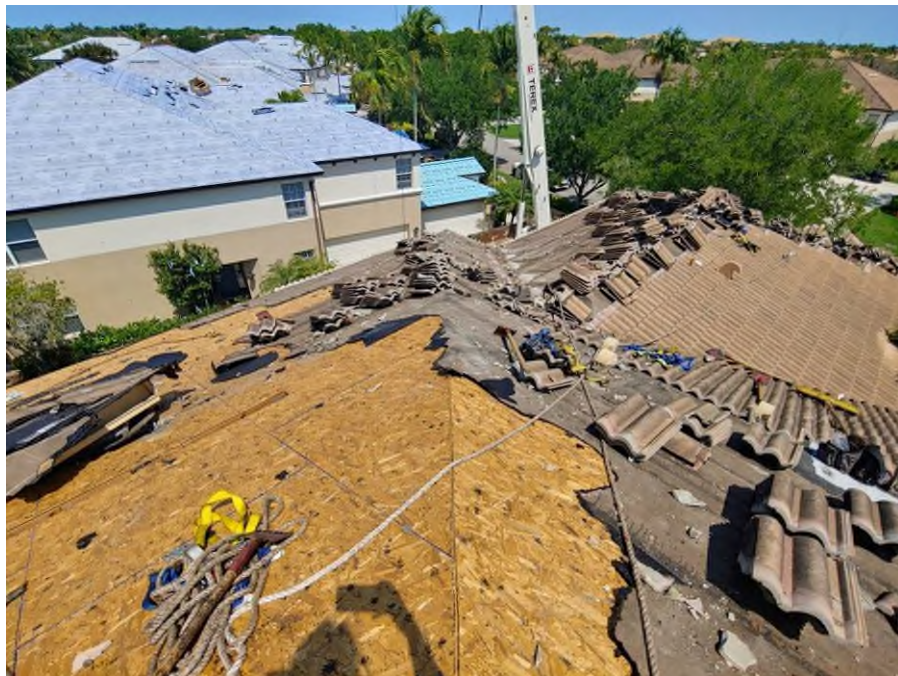
Photograph #6: Roof tile removal was in progress on building 21840.

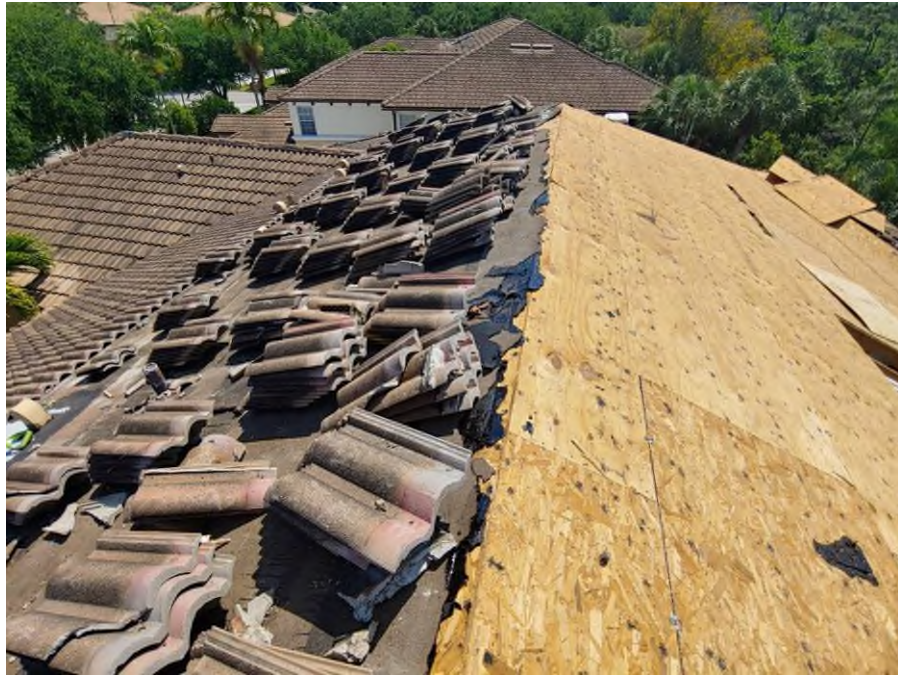
Photograph #7: Roof tile removal was in progress on building 21840.

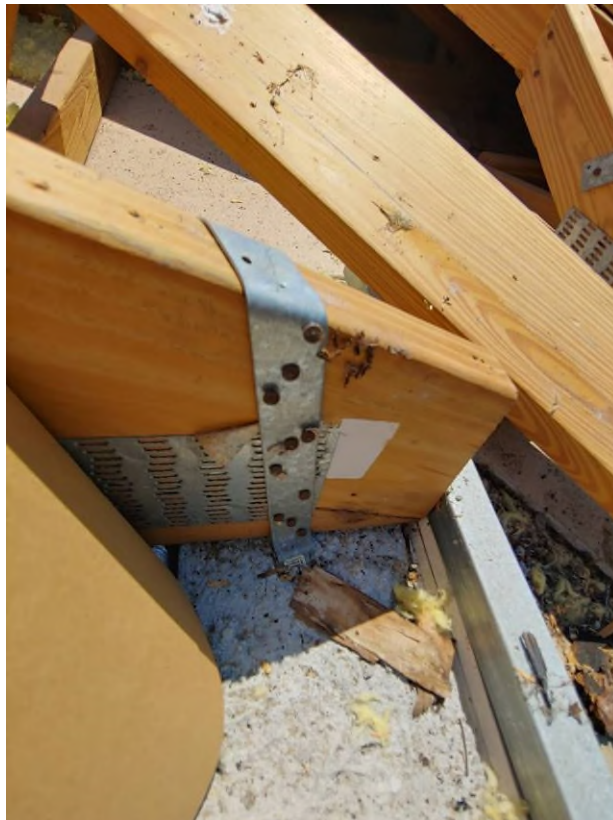
Photograph #8: Existing strap clips on the trusses have the required minimum quantity of 5 nails on building 21840.

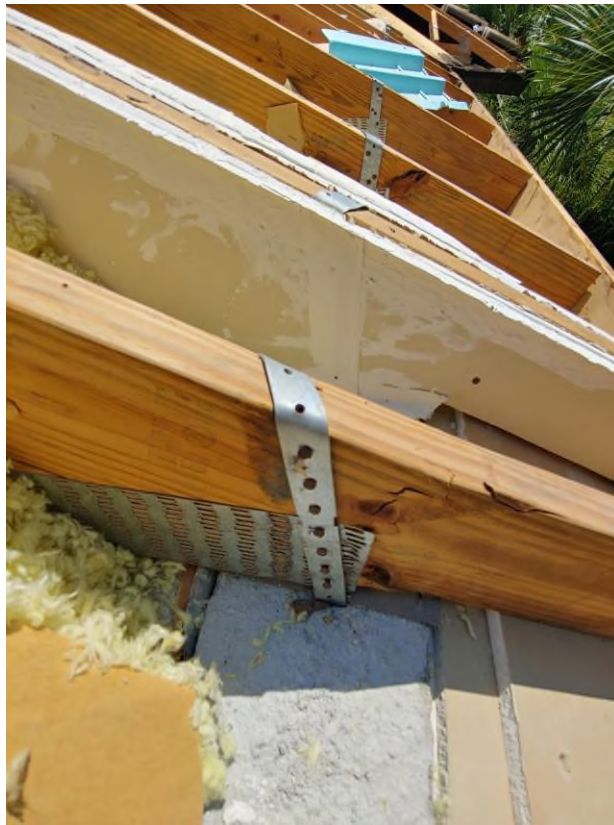
Photograph #9: Existing strap clips on the trusses have the required minimum quantity of 5 nails on building 21840.

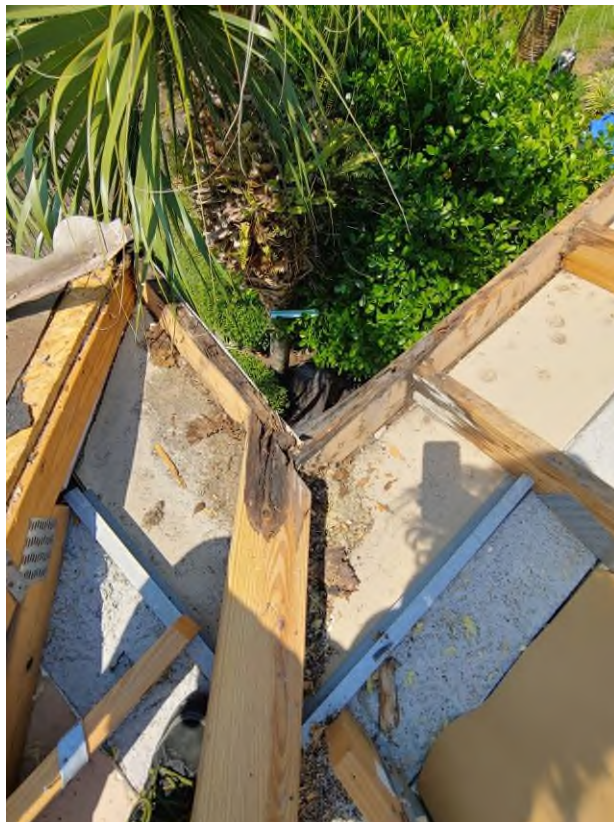
Photograph #10: Rotten fascia, truss and plywood sheathing were observed building 21840.

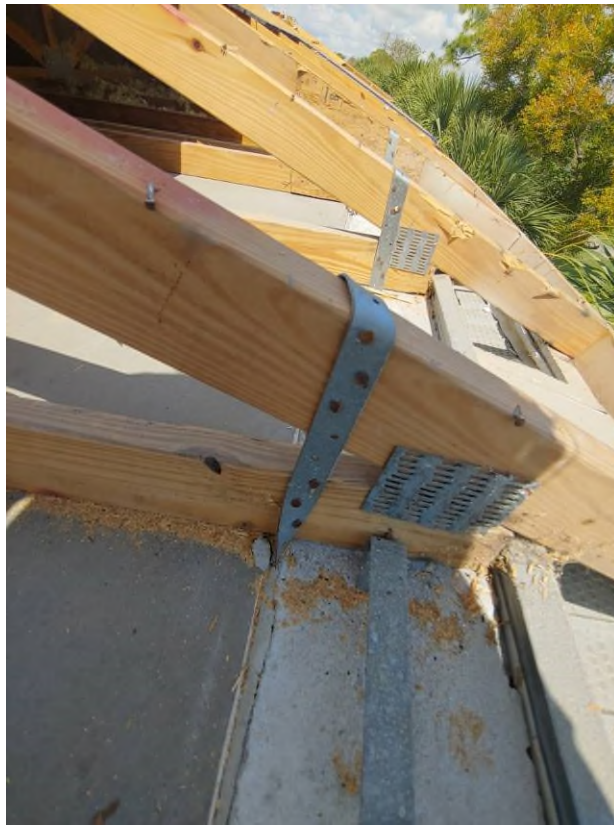
Photograph #3: Existing strap clips on the trusses have the required minimum of 5 nails on building 21791.

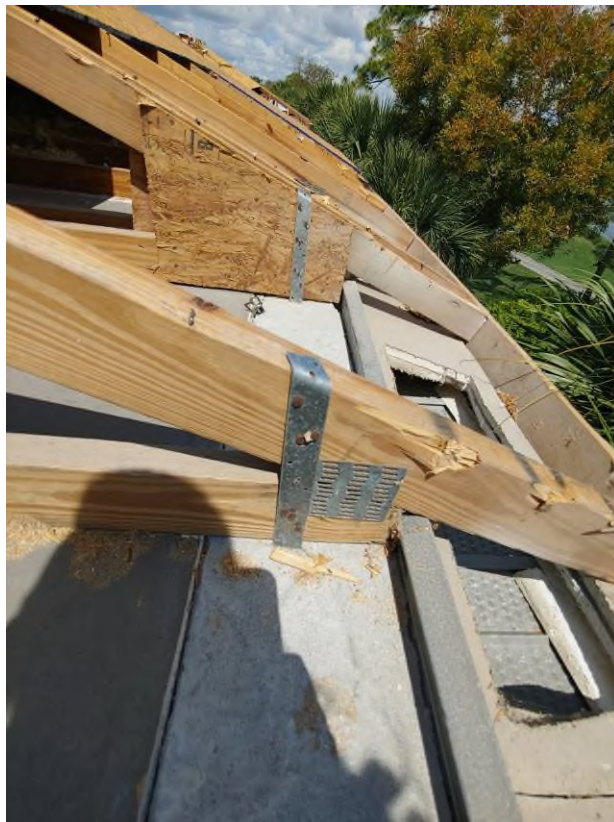
Photograph #4: Existing strap clips on the trusses have the required minimum of 5 nails on building 21791.

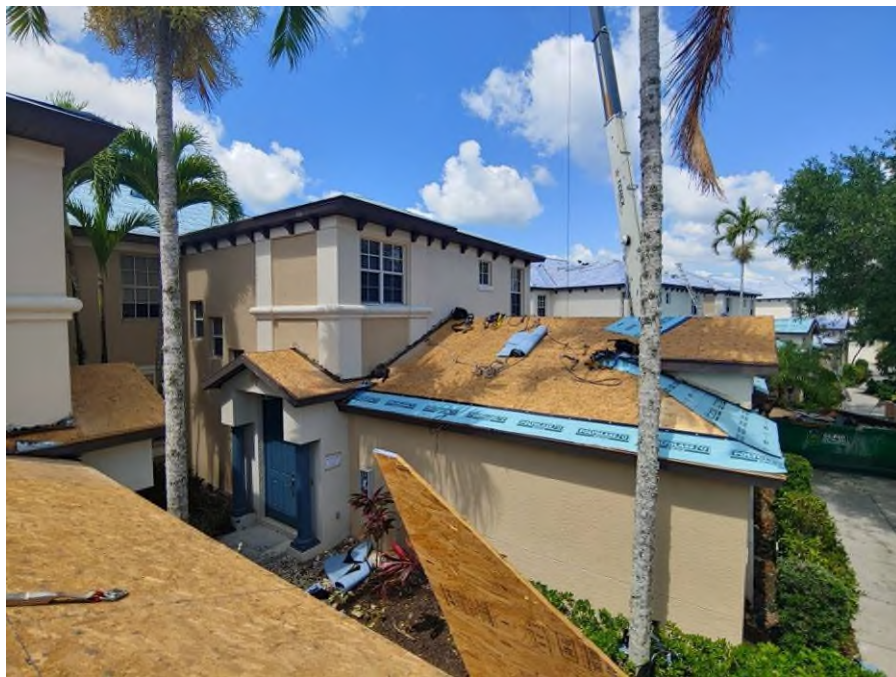
Photograph #10: Polystick MTS Plus underlayment installation was in progress on building 21830.

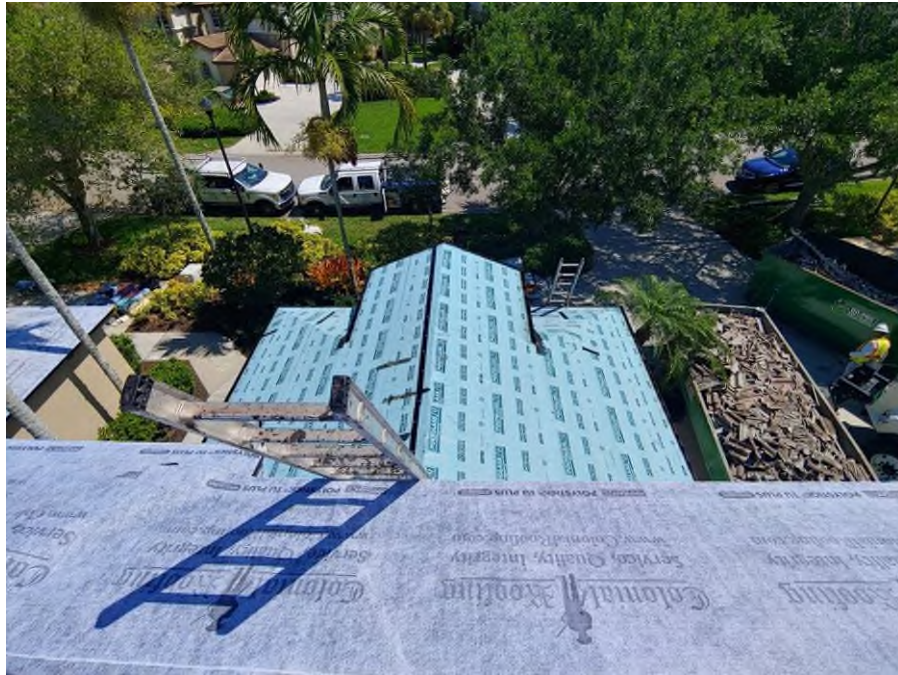
Photograph #1: Polystick MTS Plus underlayment installation was completed on building 21820.

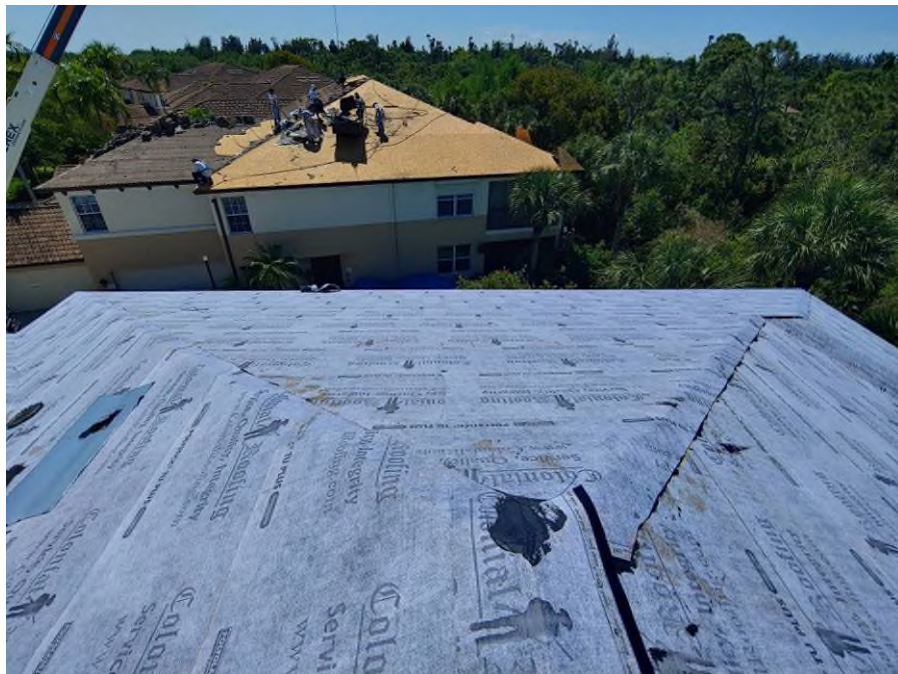
Photograph #2: Second layer of underlayment was in progress on building 21820.

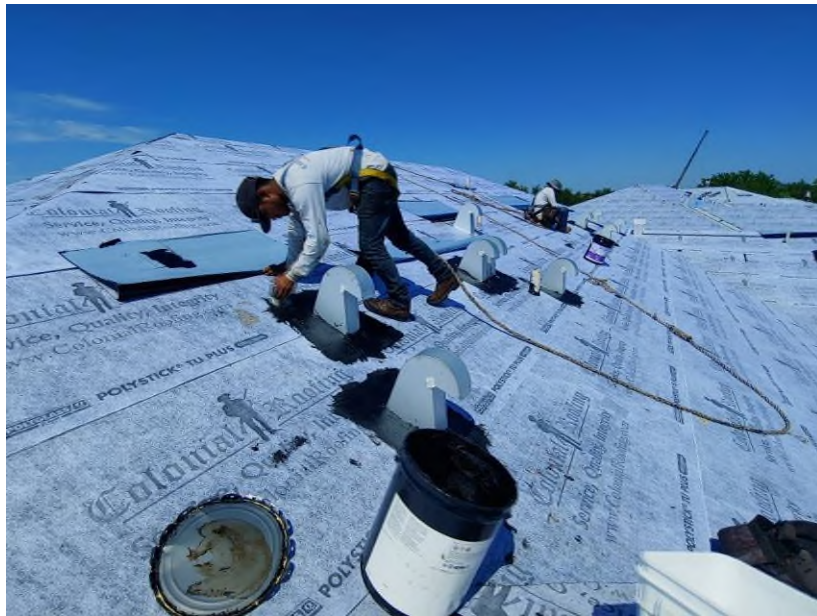
Photograph #3: Asphalt plastic roofing cement application was in progress surrounding the exhaust vents on building 21820.

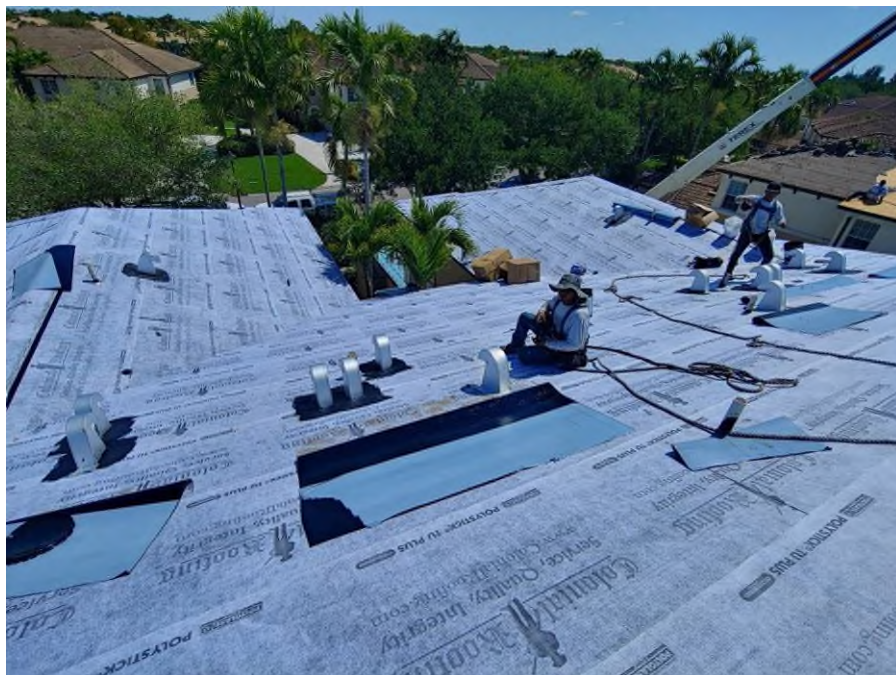
Photograph #4: Asphalt plastic roofing cement application was in progress surrounding the exhaust vents on building 21820.

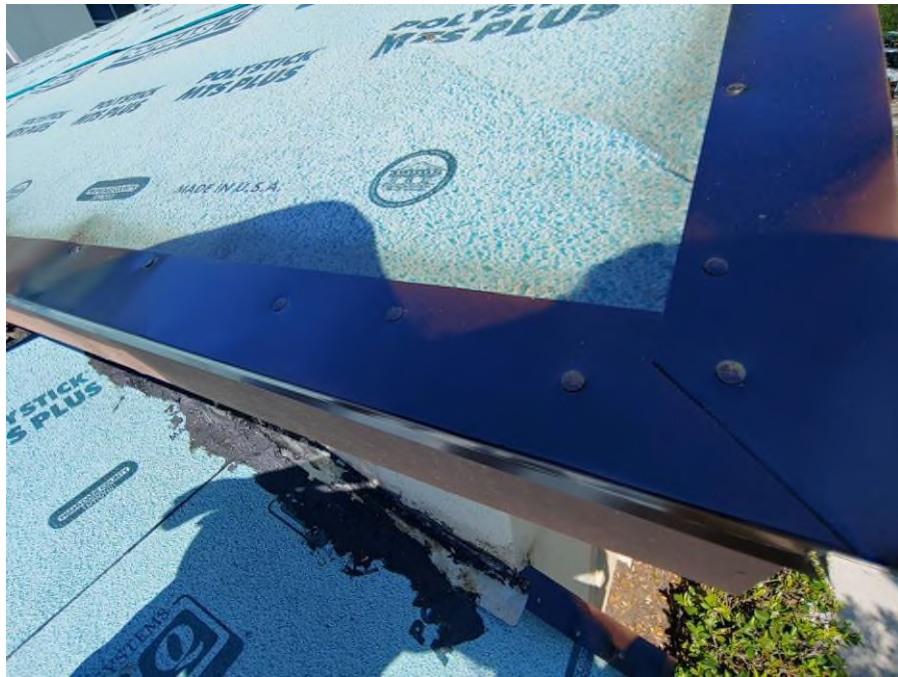
Photograph #5: Drip-edge flashing installation was in progress on the garage roof on building 21820.

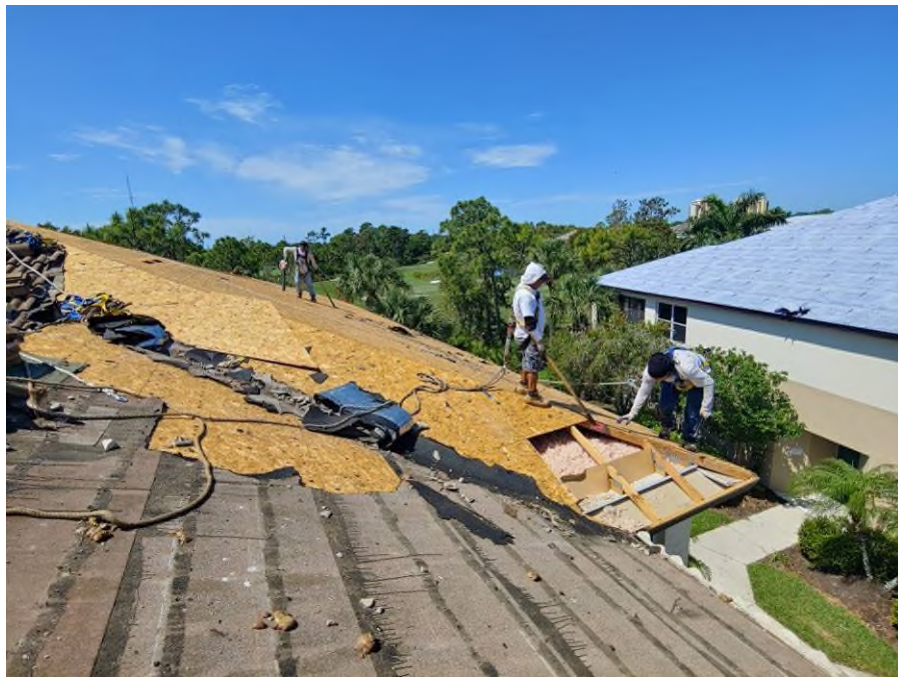
Photograph #6: Roof tile removal was in progress on building 21830.

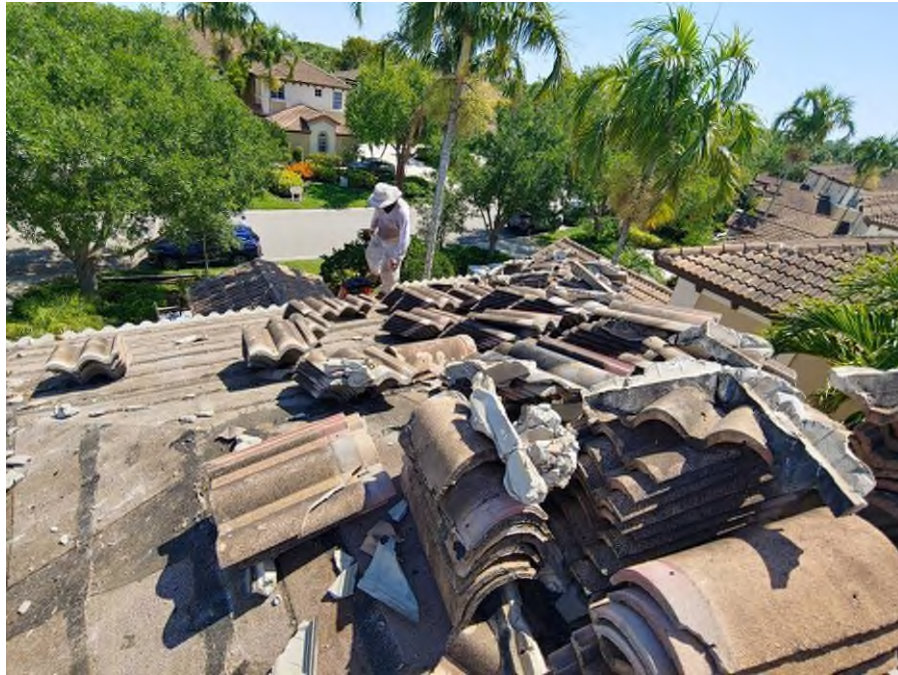
Photograph #7: Roof tile removal was in progress on building 21830.

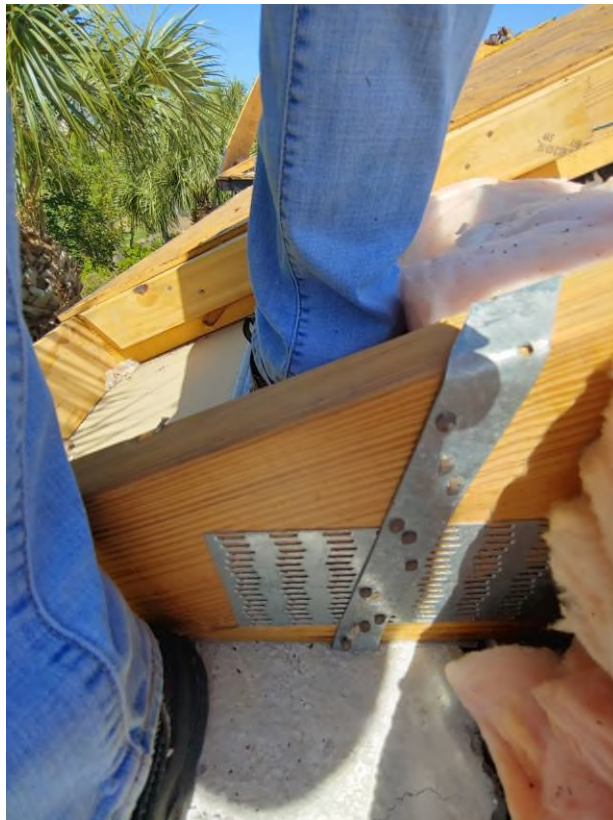
Photograph #8: Existing strap clips on the trusses have the required minimum quantity of 5 nails on building 21830.

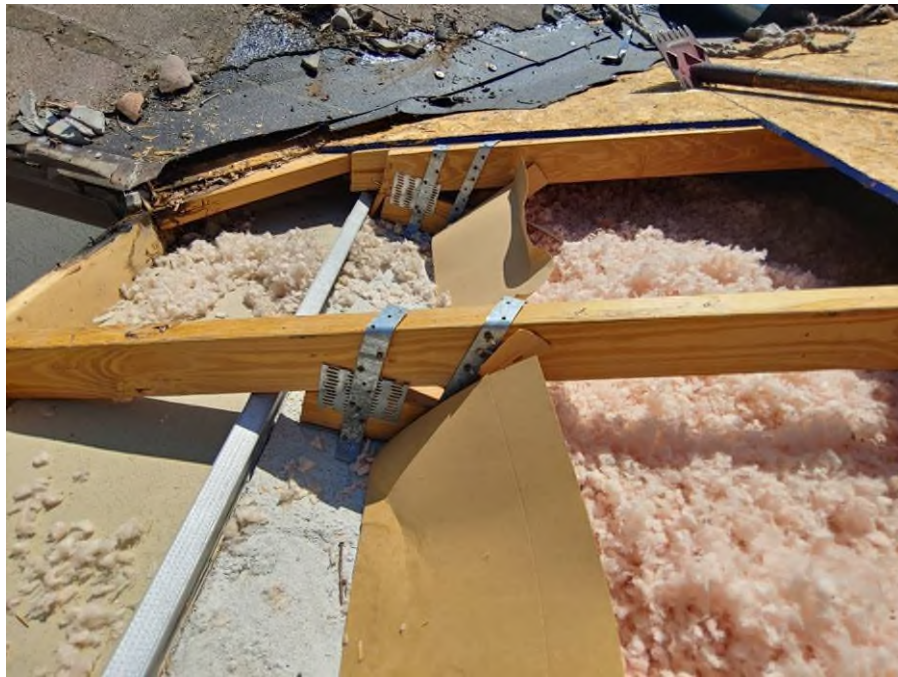
Photograph #9: Existing strap clips on the trusses have the required minimum quantity of 5 nails on building 21830.

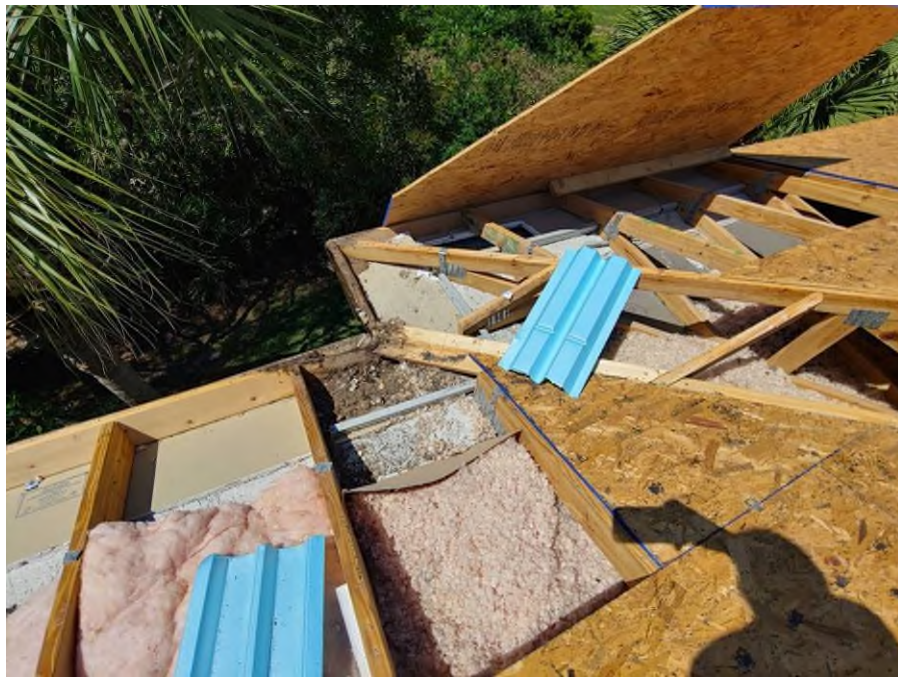
Photograph #10: Rotten fascia, truss and plywood sheathing were observed on building 21830.
