Uniform Mitigation Verification Inspection Form

Inspection Date: 6-2-2020		
Owner Information		
Owner Name: Palmetto Dunes Pelican Sound Condominium Association Inc.		Contact Person:
Address: 21821 Palmetto Dunes Drive Units 101,102,201,202		Home Phone:
City: Estero	Zip: 33928	Work Phone:
County: Lee		Cell Phone:
Insurance Company:		Policy #:
Year of Home:	# of Stories: 2	Email:

DATE	April 17, 2020	JOB NO.	20RN-0085
Palmetto Dunes CAI – Roofing Project			
LOCATION	Palmetto Dunes Drive		
CONTRACTOR	EnviroStruct, LLC	Palmetto Dunes CAI	
WEATHER	Sunny	TEMP.	84° F
		Time	12:30PM
PRESENT AT SITE	Rahmin Bahar, EnviroStruct (ES) Teresita Nazario-Acosta, Karins Engineering Group (KEG)

REPORT: FR # 27

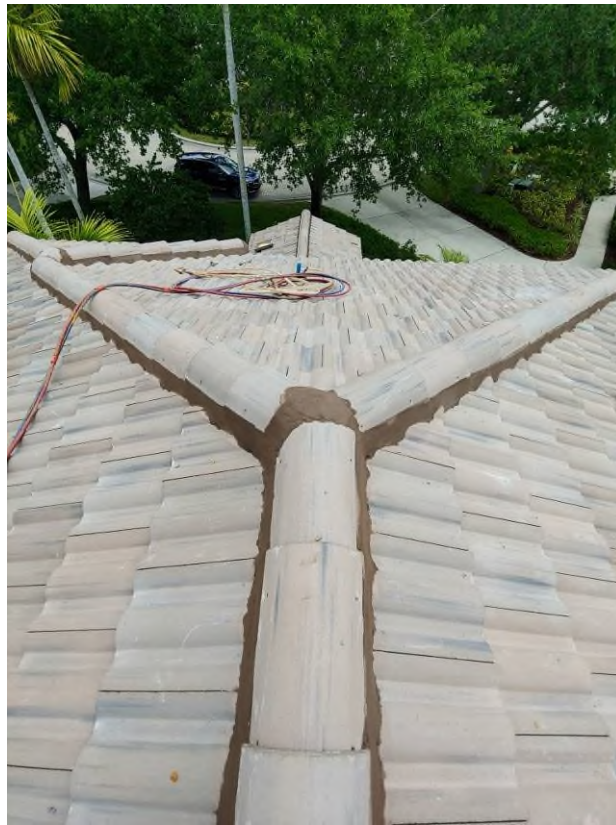
Photograph #1: Mortar adhesive application was in progress surrounding the ridge tiles and hip tiles on building 7840.

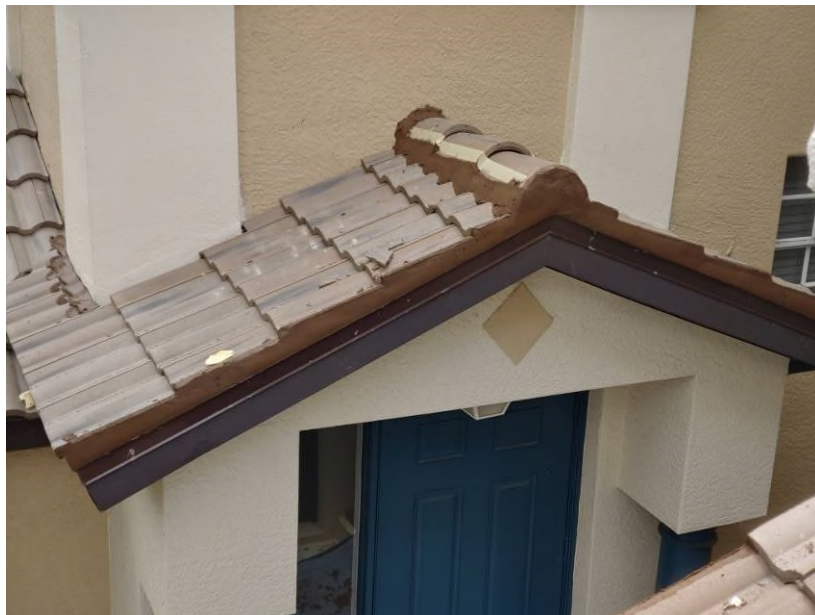
Photograph #2: Mortar adhesive application was in progress surrounding the ridge tiles and hip tiles on building 7840.

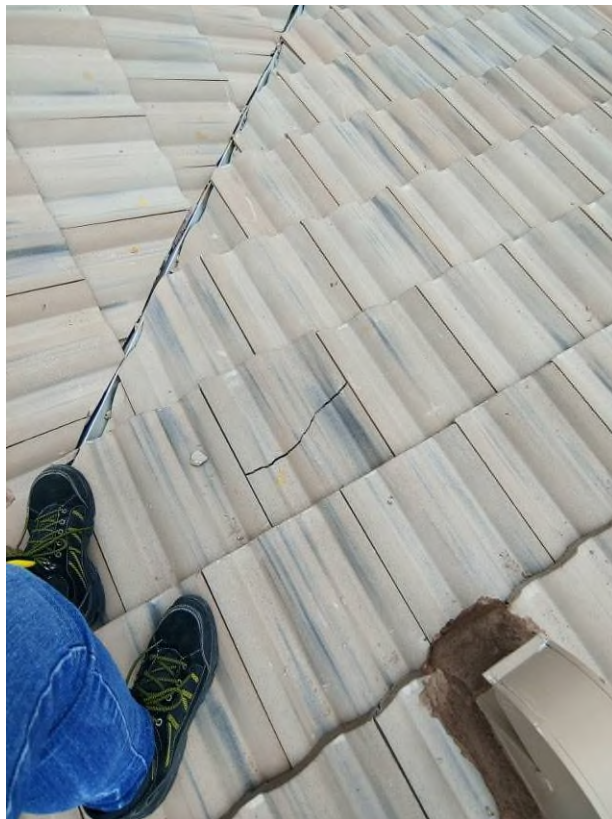
Photograph #4: Broken field tile replacement must be addressed on building 7840.

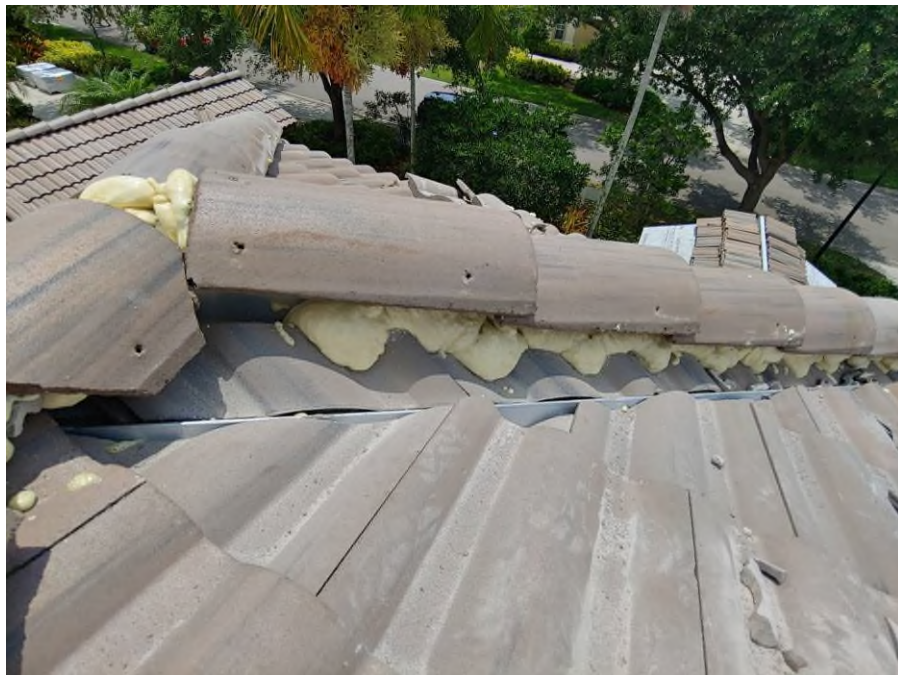
Photograph #6: Roof field, ridge and hip tile installations with polyurethane foam adhesive was in progress on building 21741.

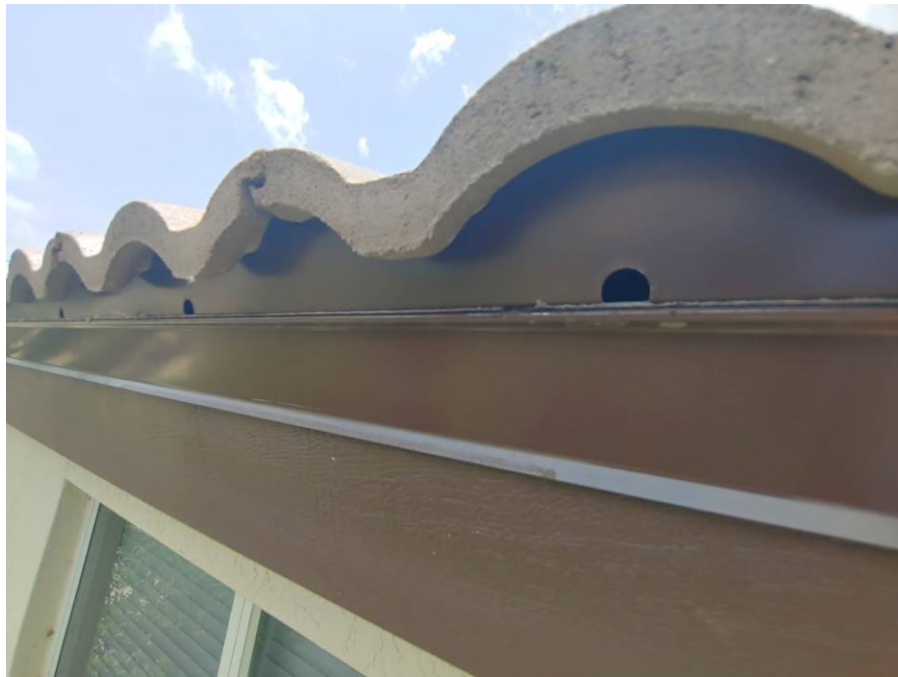
Photograph #7: Bird-stop metal flashing installation was in progress on building 21741.

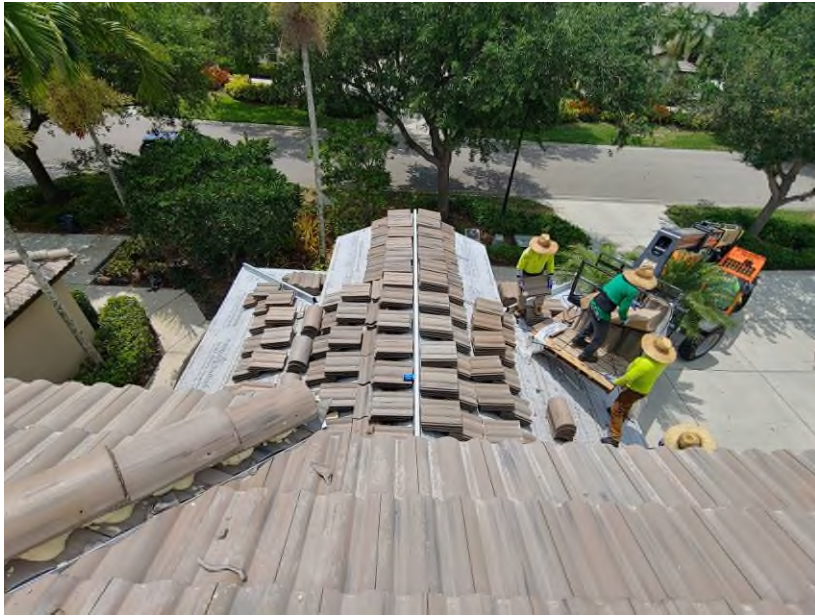
Photograph #9: Roof tiles were set in place for installation on building 21741.

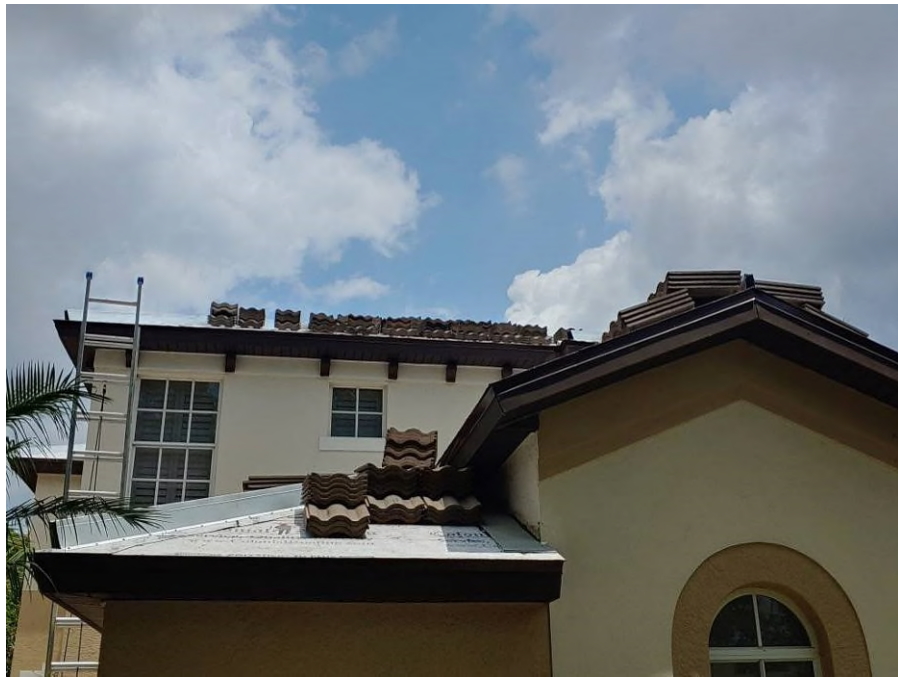
Photograph #11: Roof tiles were set in place for installation on building 21761.

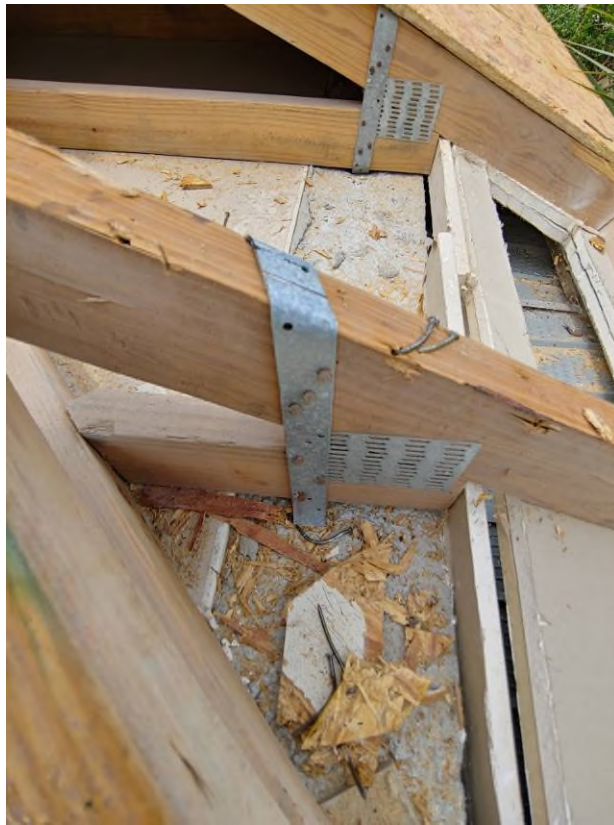
Photograph #15: Existing strap clips on the trusses have the required minimum of 5 nails on building 21821.
