# Uniform Mitigation Verification Inspection Form

| Owner Name: Palmetto Dunes Pelican Sound Condominium Association Inc. | | Contact Person: |
| Address: 7860 Classic Court Units 101,102,201,202 | | Home Phone: |

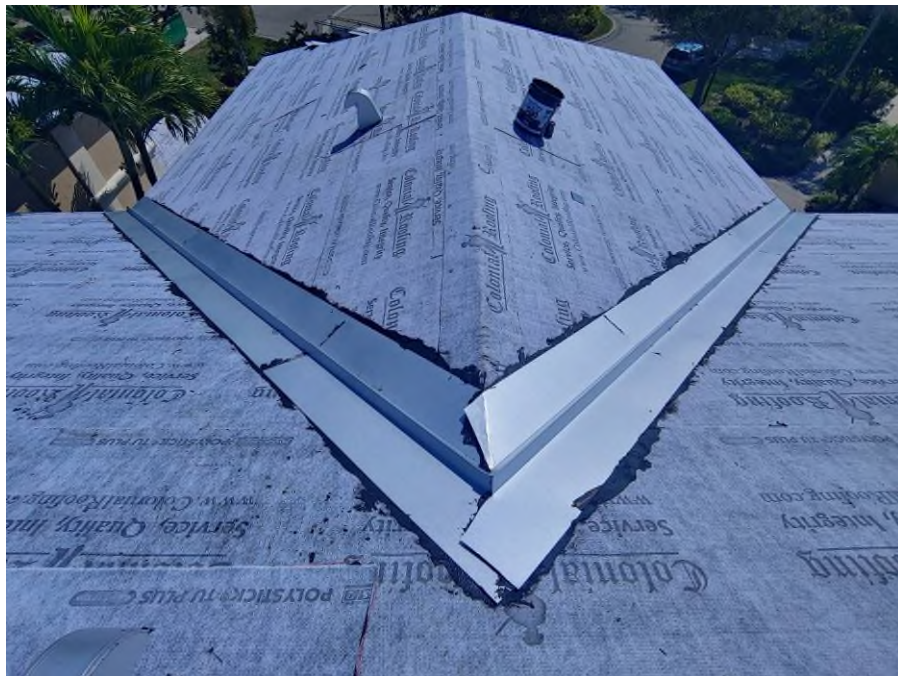
**Photograph #2: V-crimp metal valley flashing installation was in progress on building 7851.**

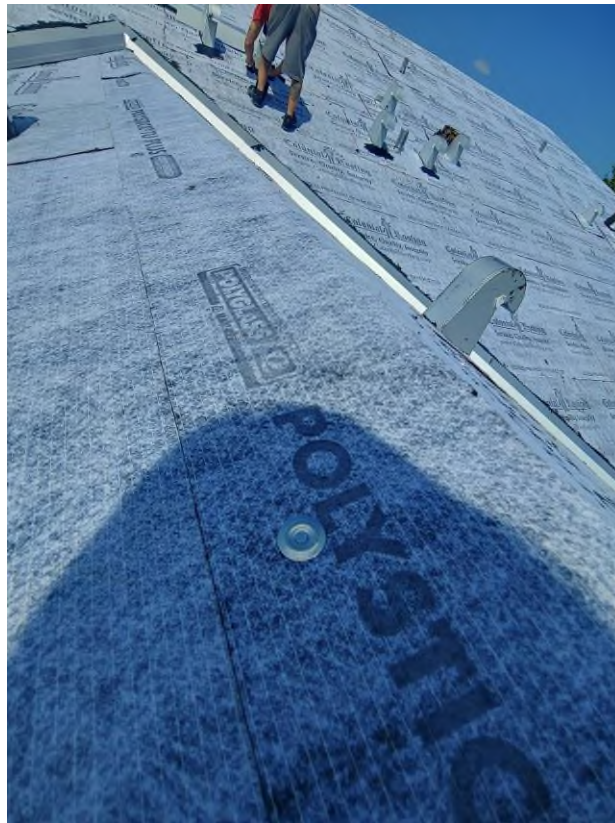
**Photograph #5: Contractor must cover all exposed nails with asphalt plastic roofing cement on building 7851.**

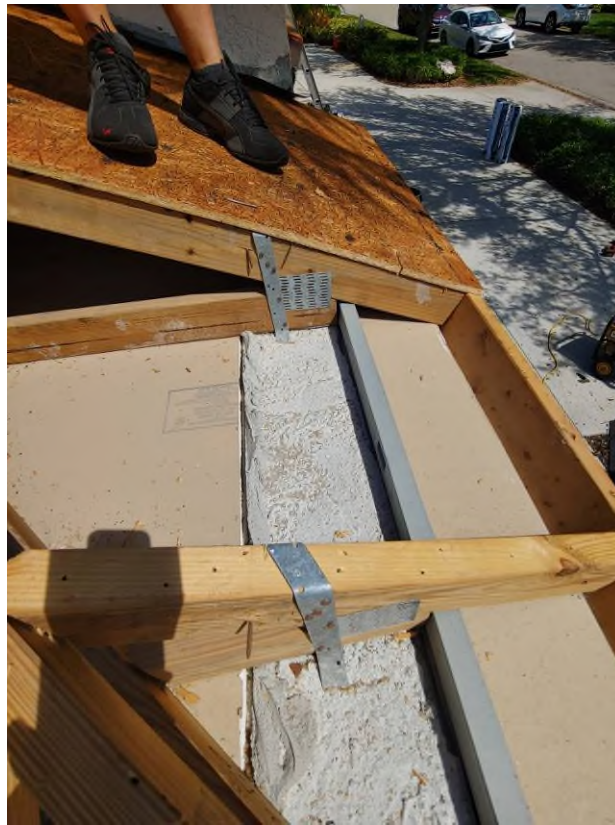
**Photograph #7: Existing strap clips on the trusses have the required minimum quantity of nails on building 7861.**

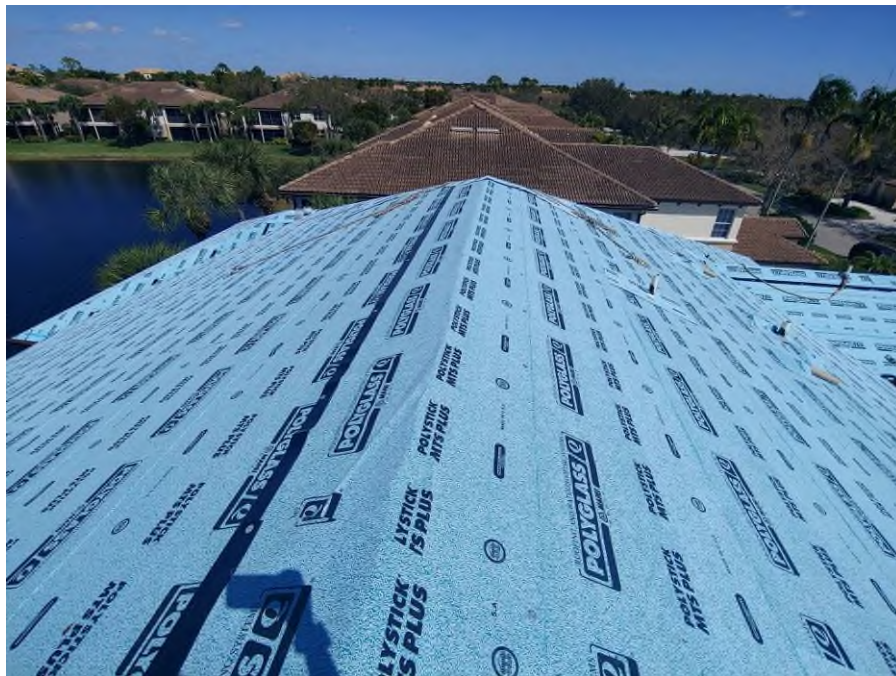
**Photograph #8: Polystick MTS Plus underlayment installation was in progress on building 7861.**

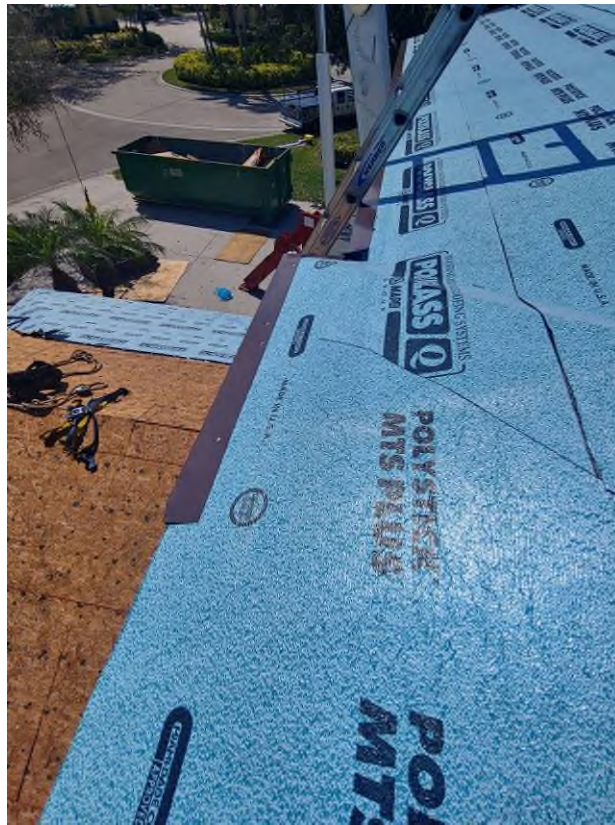
**Photograph #9: Drip edge installation was in progress on building 7861.**

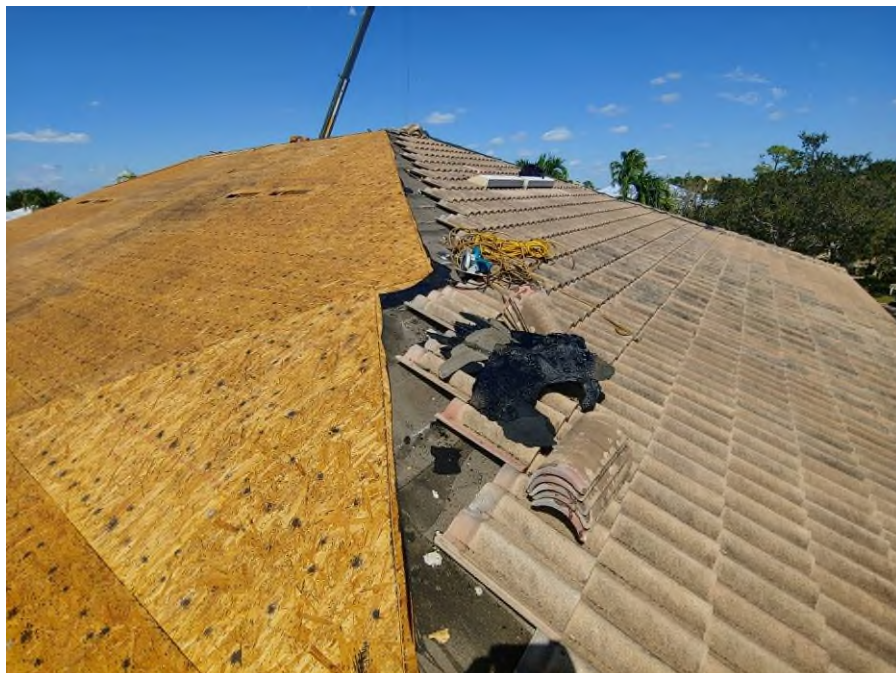
**Photograph #10: Roof tile removal was in progress on building 21740.**

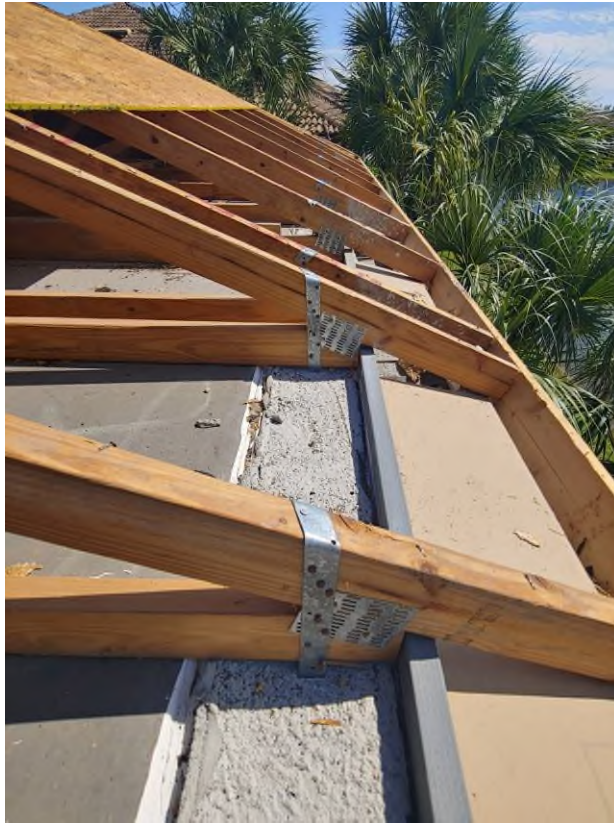
**Photograph #11: Existing strap clips on the trusses have the required minimum quantity of nails on building 21740.**

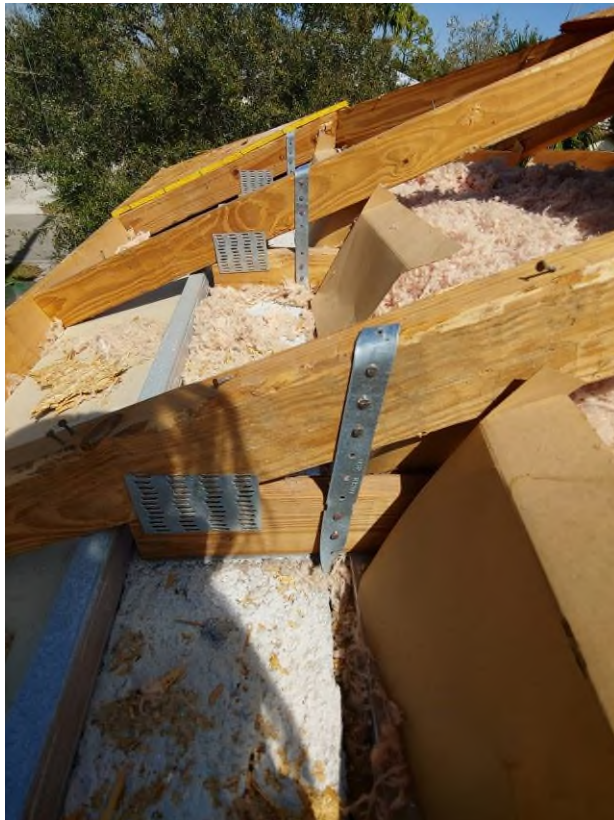
**Photograph #12: Existing strap clips on the trusses have the required minimum quantity of nails on building 21740.**

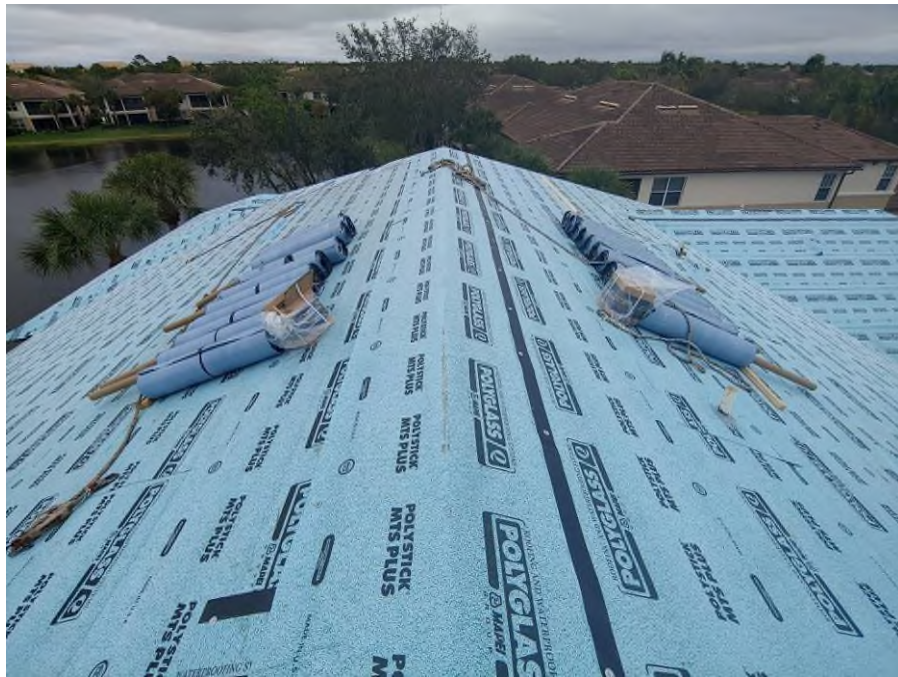
**Photograph #1: Polystick MTS Plus underlayment installation was in progress on building 7851.**

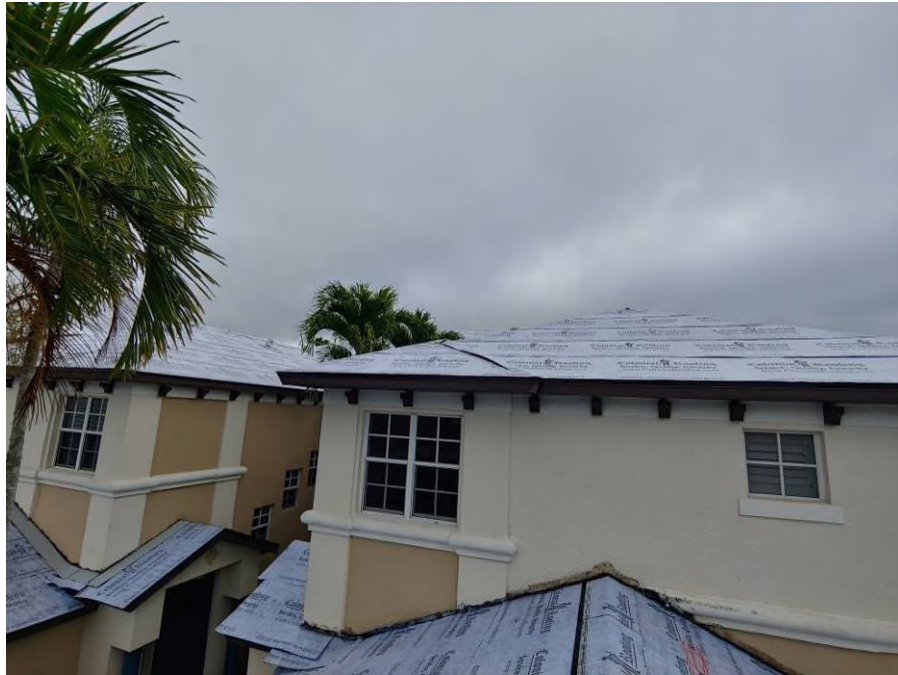
**Photograph #5: Second layer of underlayment installation was in progress on building 7860.**

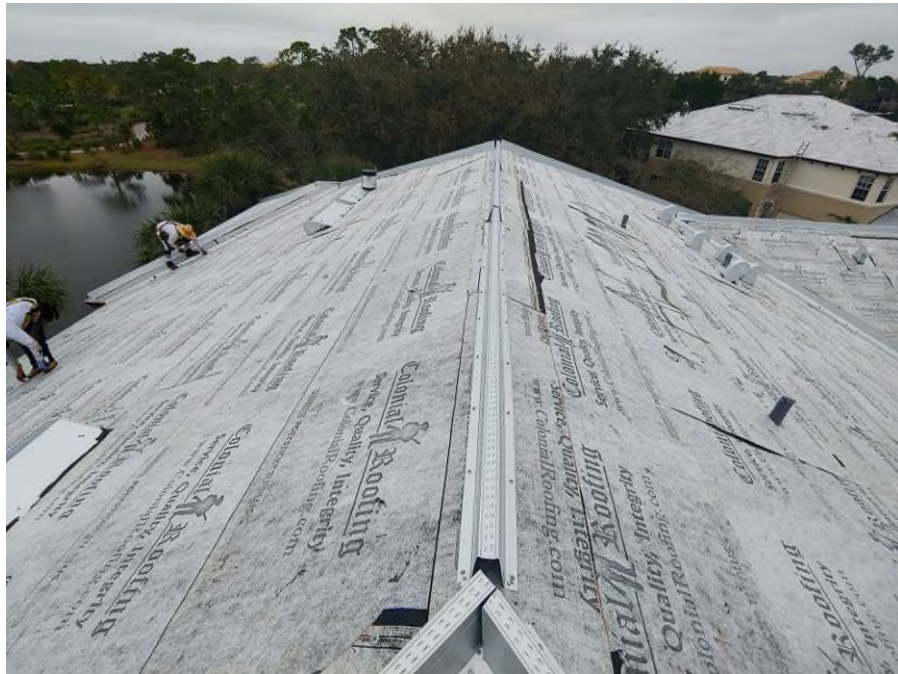
**Photograph #6: V-crimp metal valley flashing, and hip/ridge metal channel installations were in progress on building 21700.**

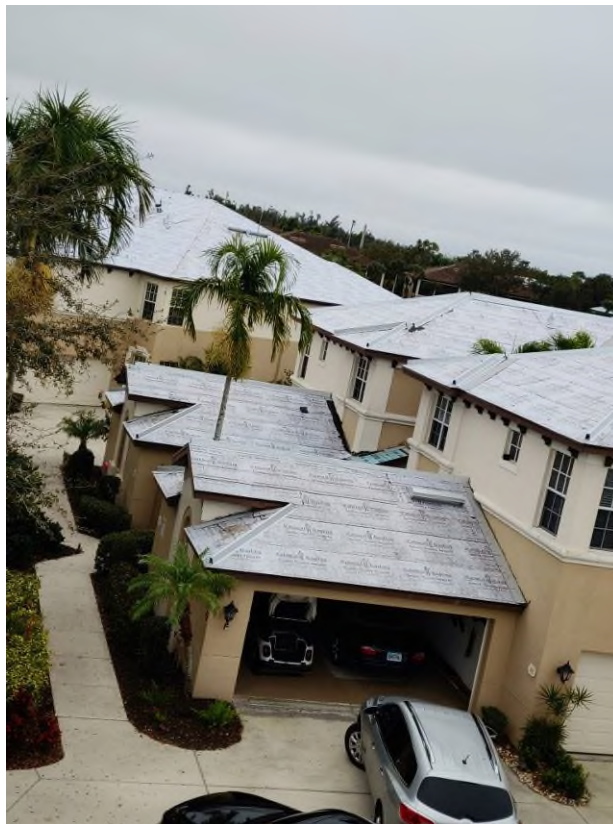
**Photograph #10: Second layer of underlayment installation was in progress on building 21710.**

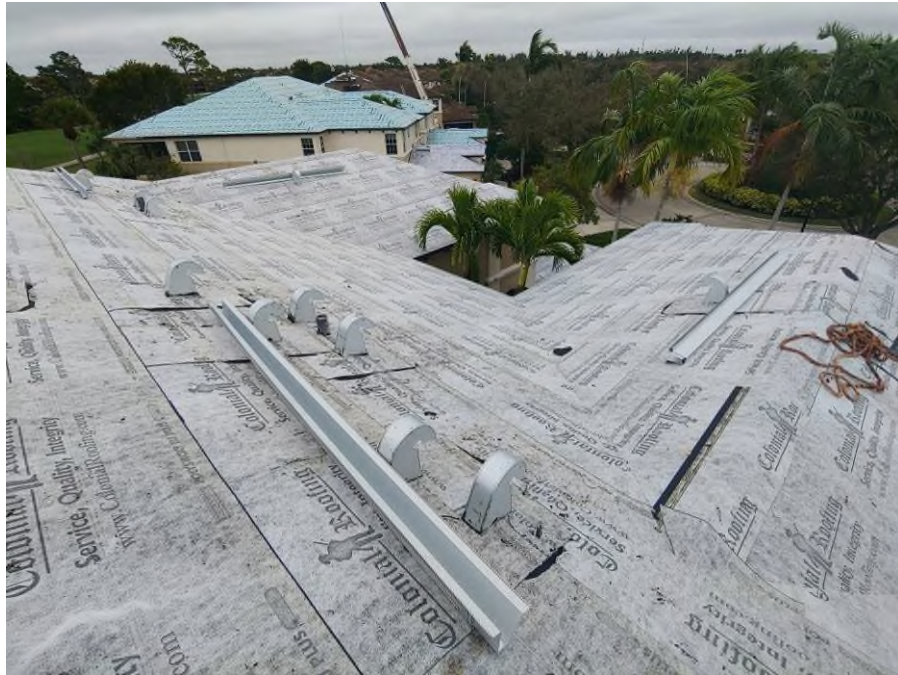
**Photograph #13: V-crimp metal valley flashing, and hip/ridge metal channel installations were in progress on building 21711.**

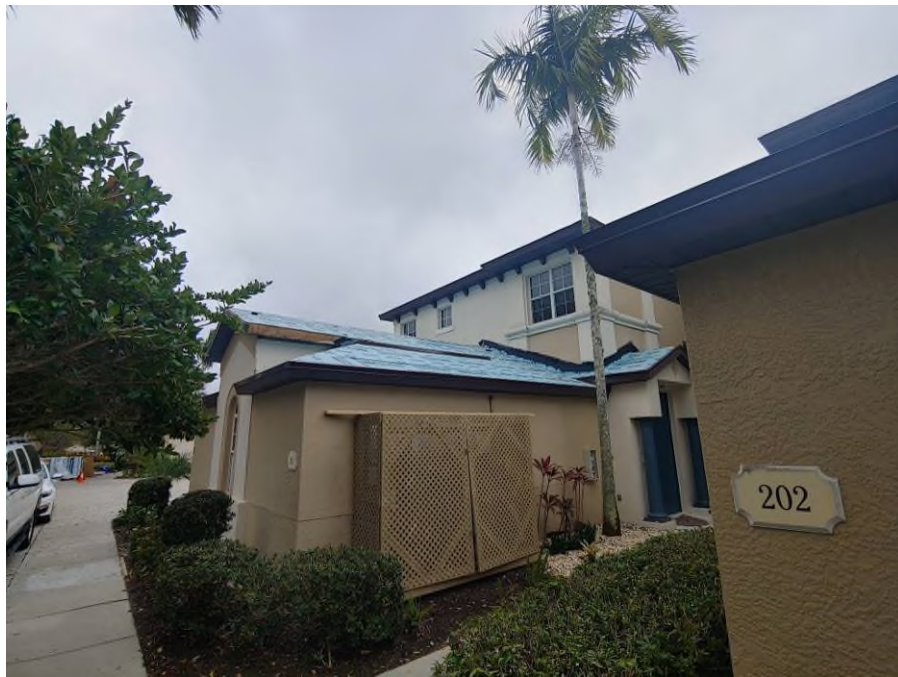
**Photograph #14: Second layer of underlayment installation was in progress on building 21720.**

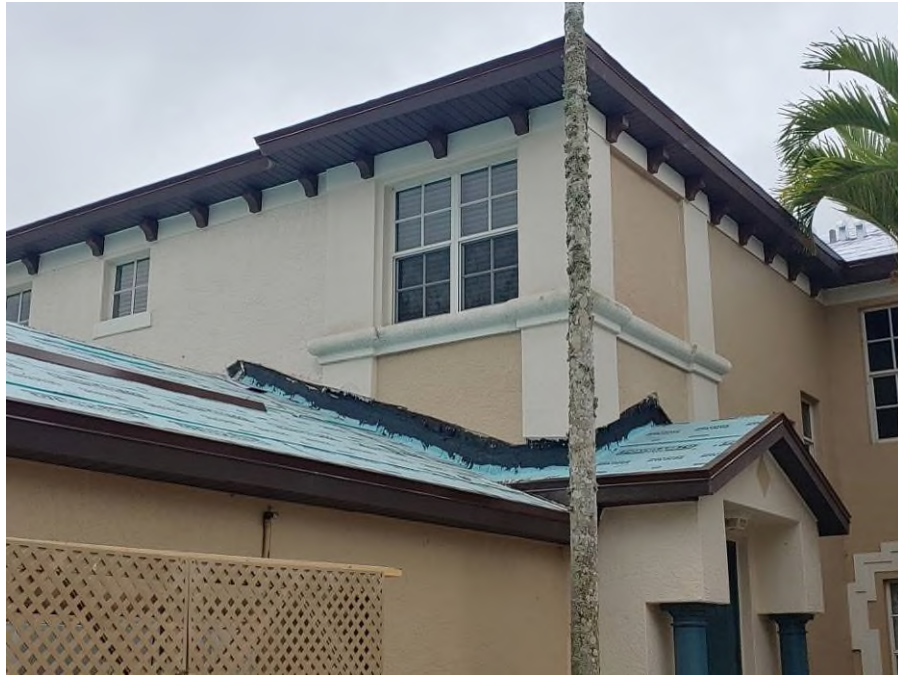
**Photograph #15: Drip-edge flashing installation was in progress on building 21720.**

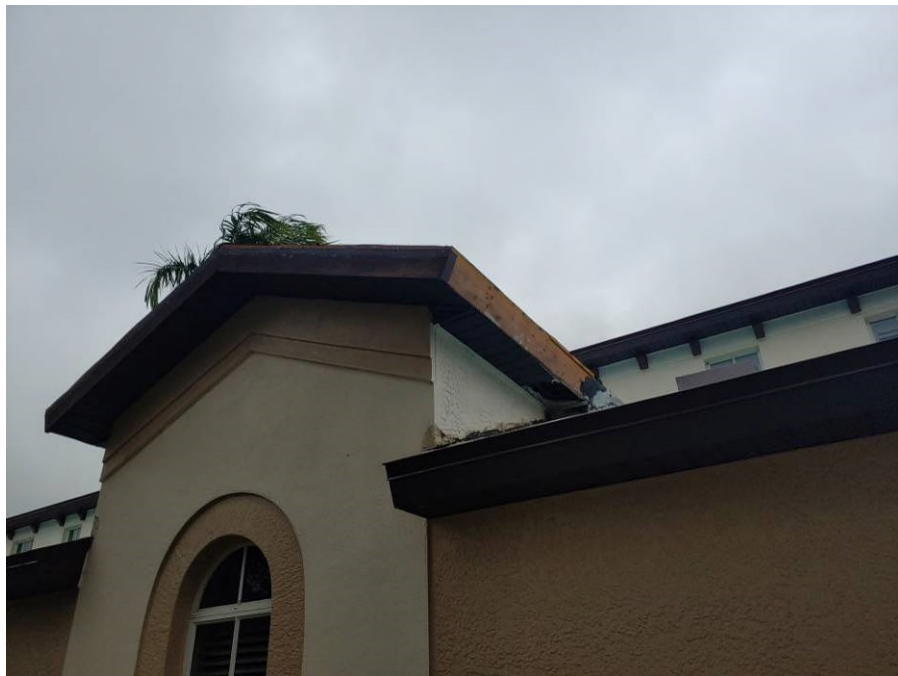
**Photograph #16: Fascia repair was in progress on building 21720.**

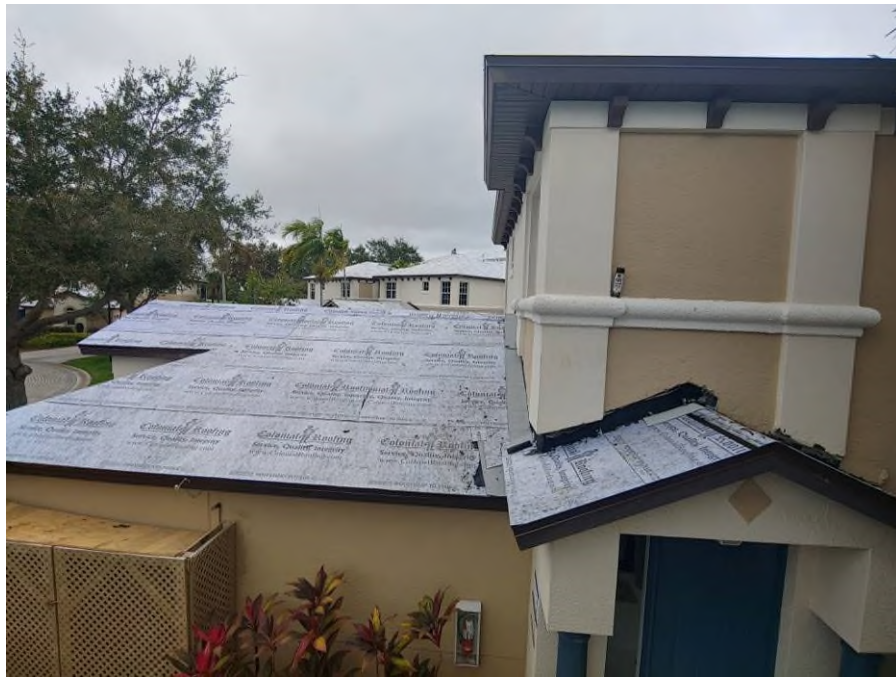
**Photograph #17: Second layer of underlayment installation was in progress on building 21721.**

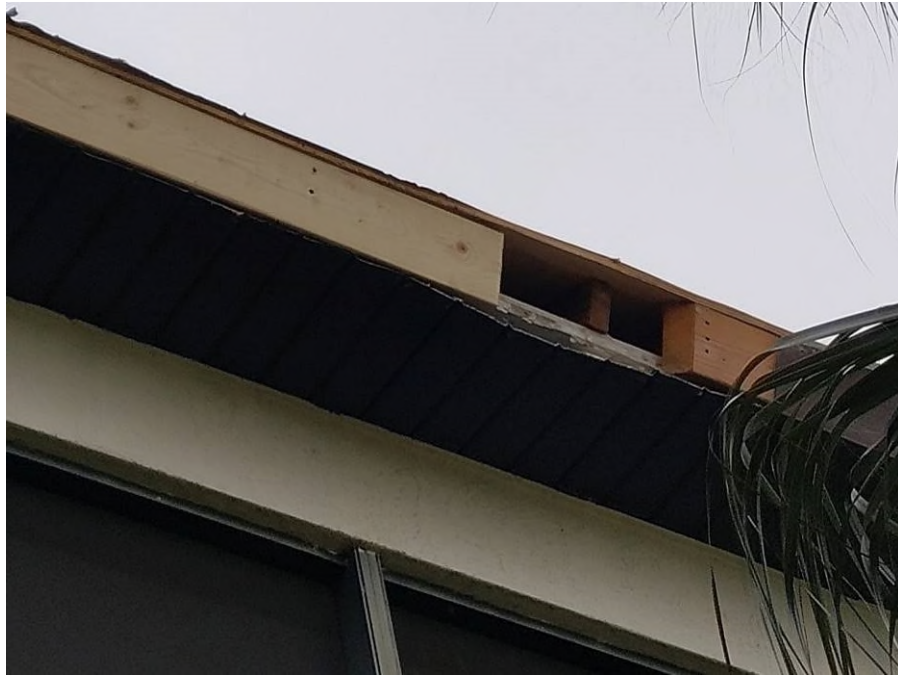
**Photograph #19: Fascia repair was in progress on building 21721.**

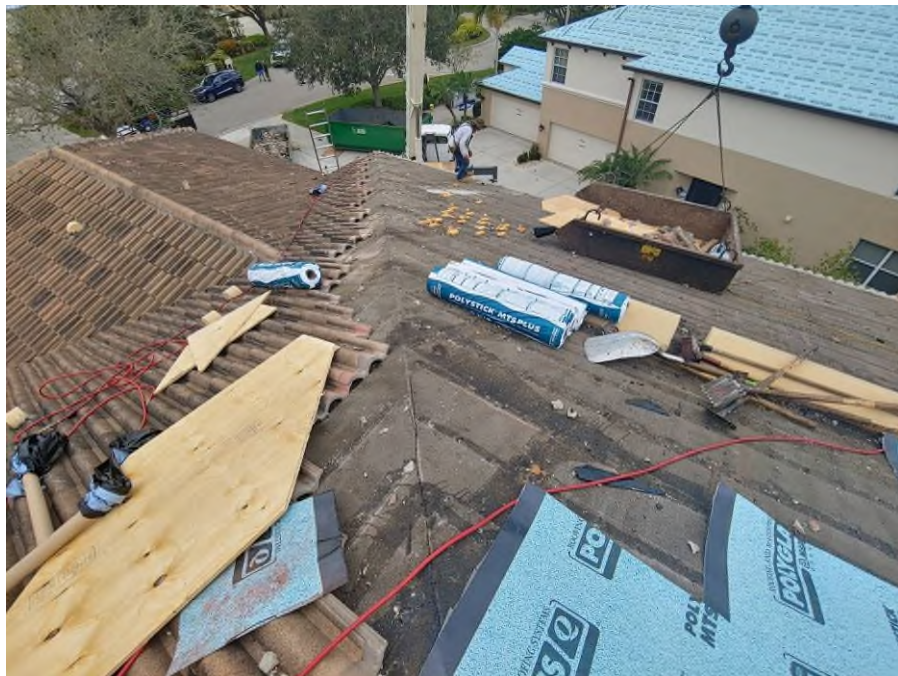
**Photograph #20: Roof tile removal was in progress on building 21731.**

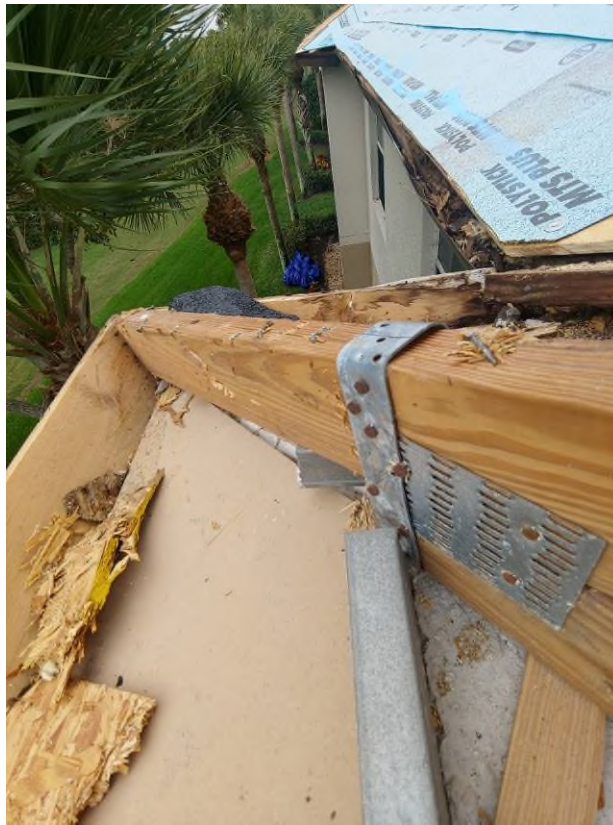
**Photograph #21: Existing strap clips on trusses have the required minimum quantity of nails on building 21731. Installation of new hurricane truss anchor straps (HGAM10) is not required.**

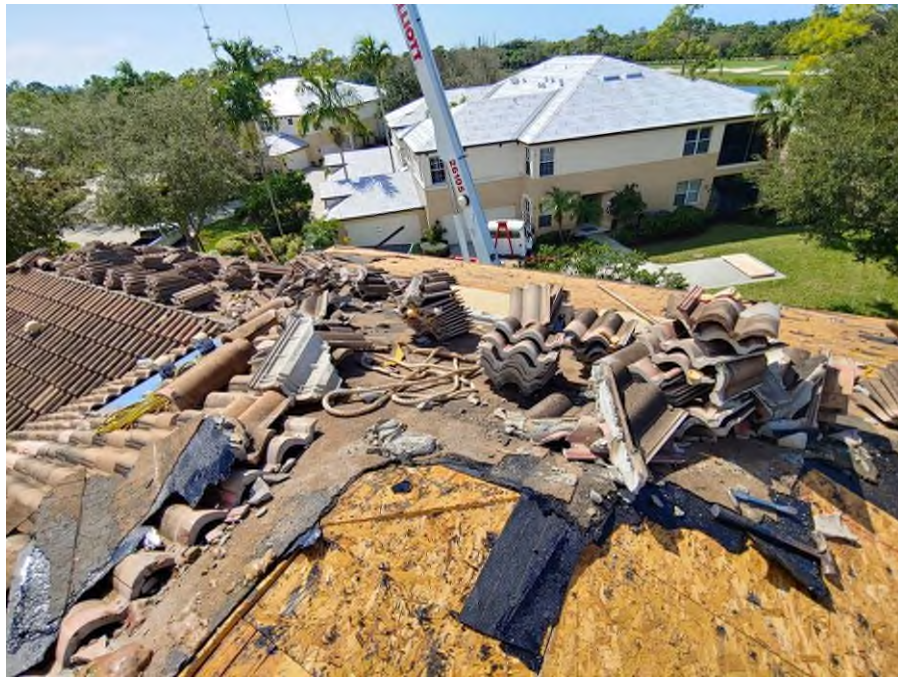
**Photograph #1: Roof tile removal was in progress on building 7851.**

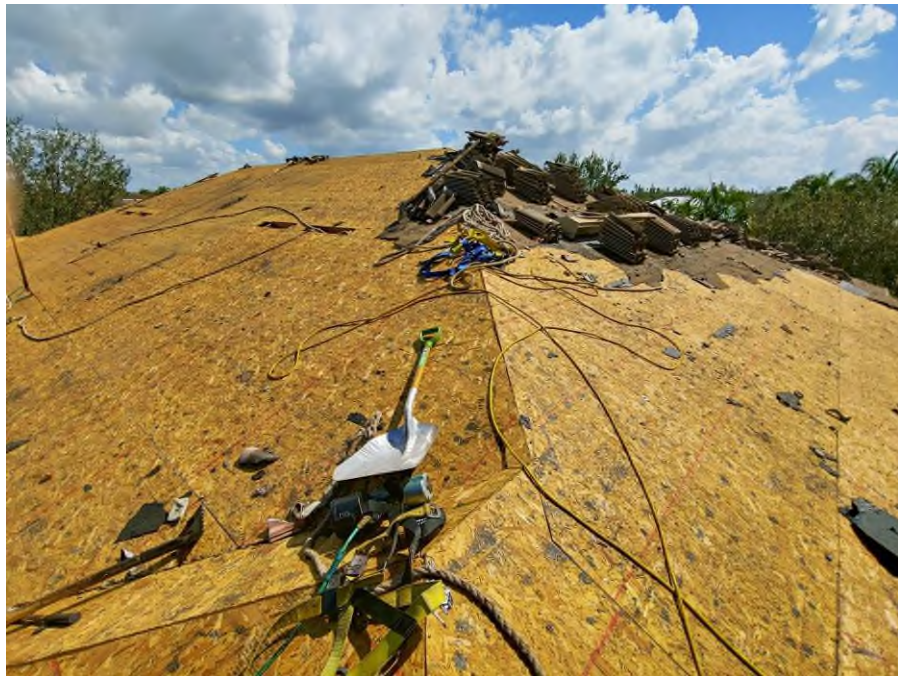
**Photograph #2: Roof tile removal was in progress on building 7851.**

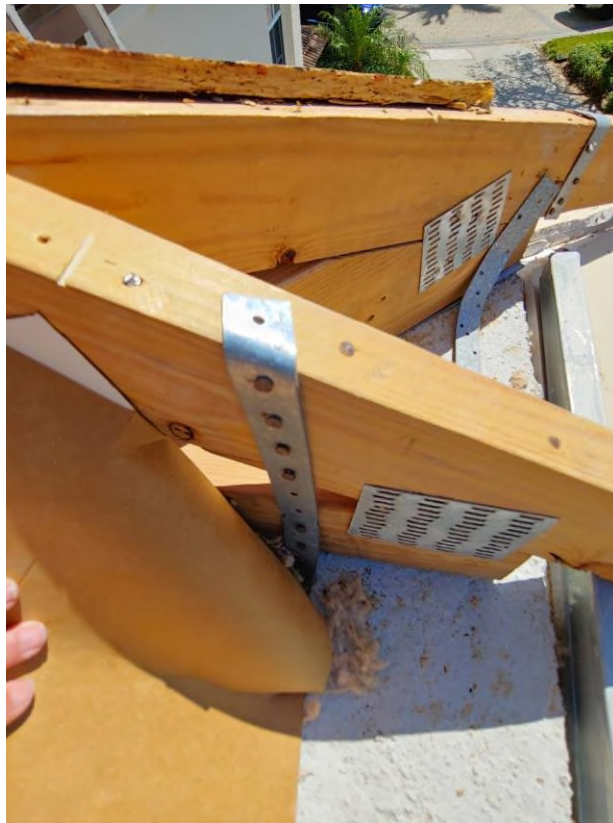
**Photograph #3: Existing strap clips on trusses have the required minimum quantity of nails on building 7851.**

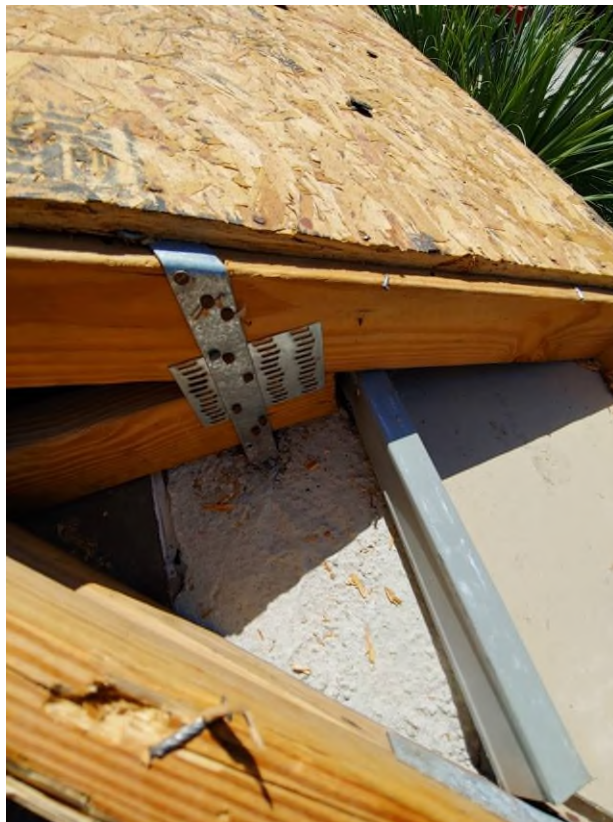
**Photograph #4: Existing strap clips on trusses have the required minimum quantity of nails on building 7851.**

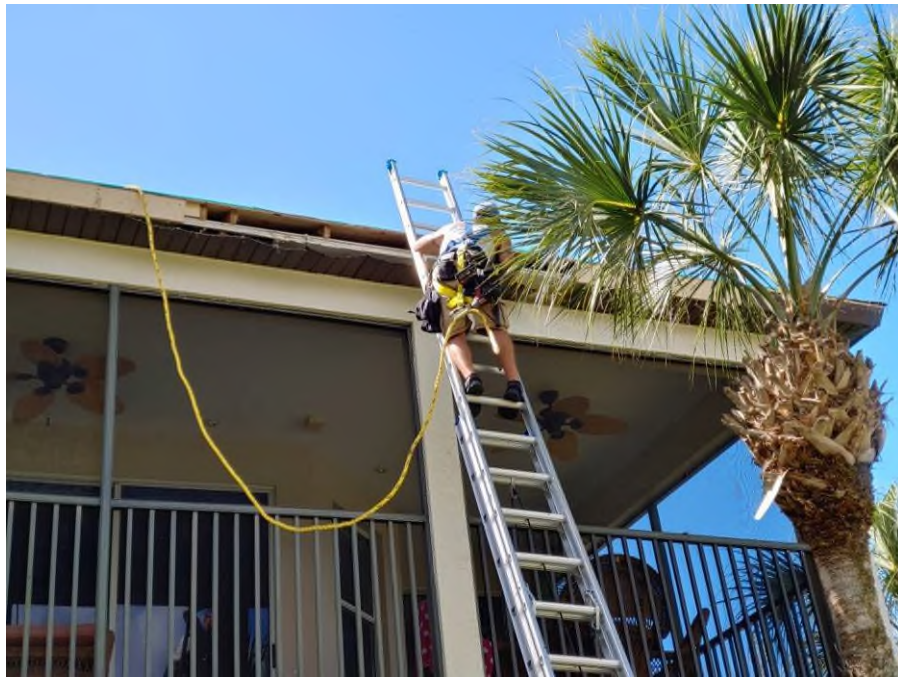
**Photograph #5: Fascia repair was in progress on building 21721.**

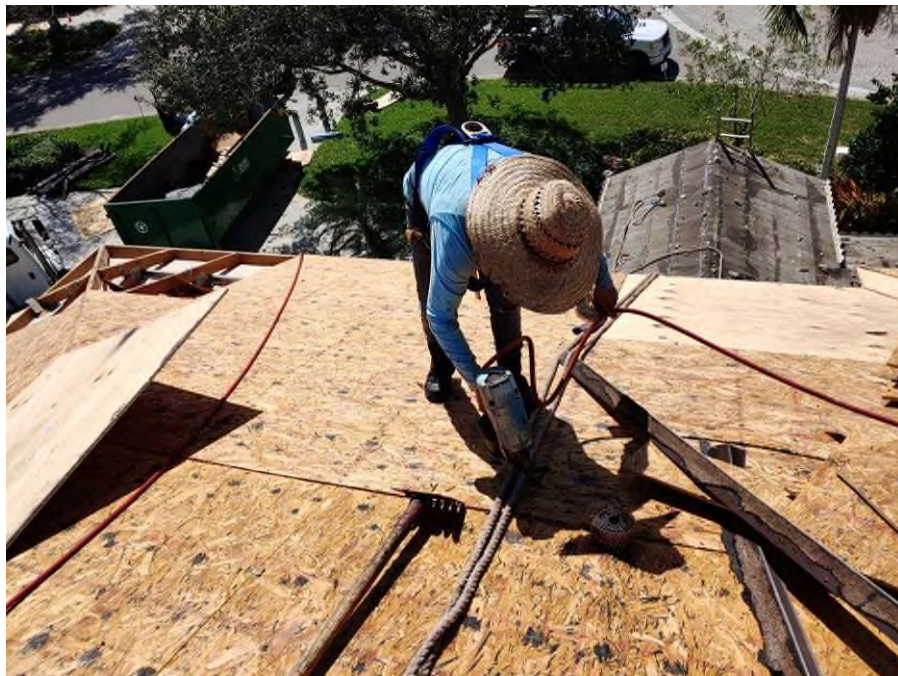
**Photograph #6: Re-nail pattern at plywood sheathing was in progress on building 21721.**

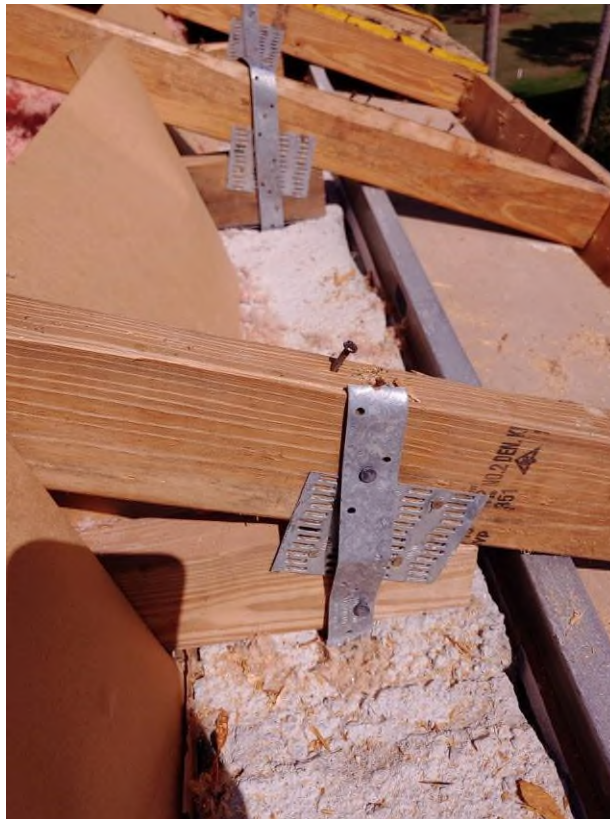
**Photograph #7: KEG observed a lack of nails on a few existing straps on building 21721. N8d nails were installed during the site visit to comply with the Florida Building Code.**

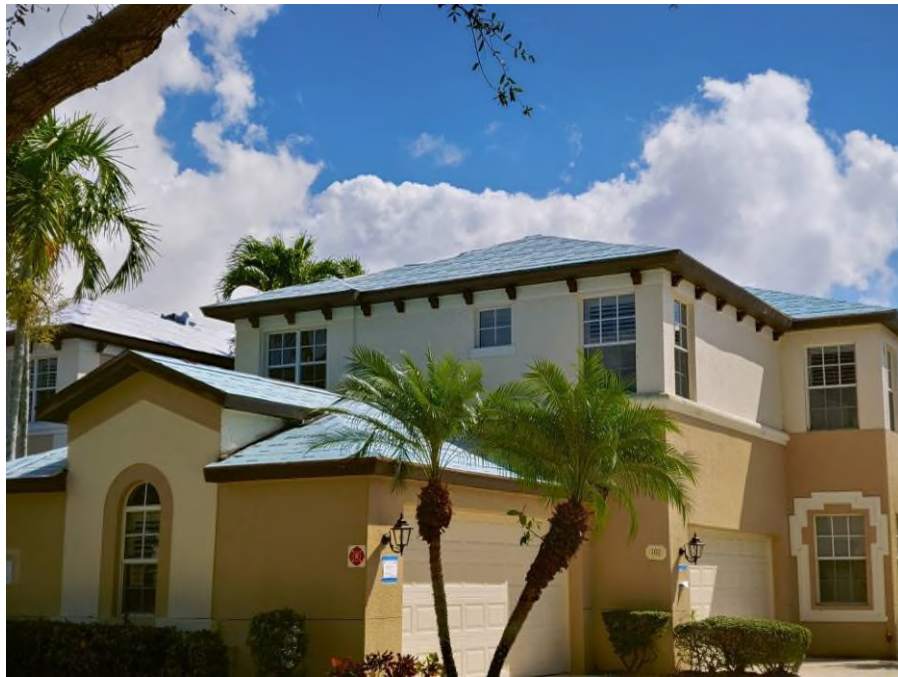
**Photograph #9: Second layer of underlayment installation was in progress on building 7860.**

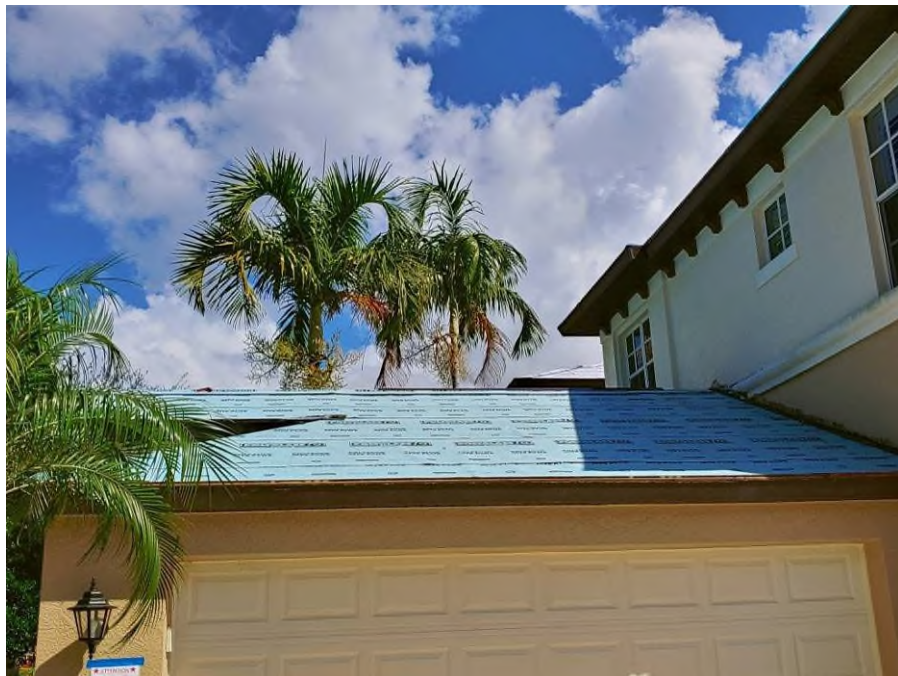
**Photograph #10: Polystick MTS Plus underlayment installation was completed on building 7860.**

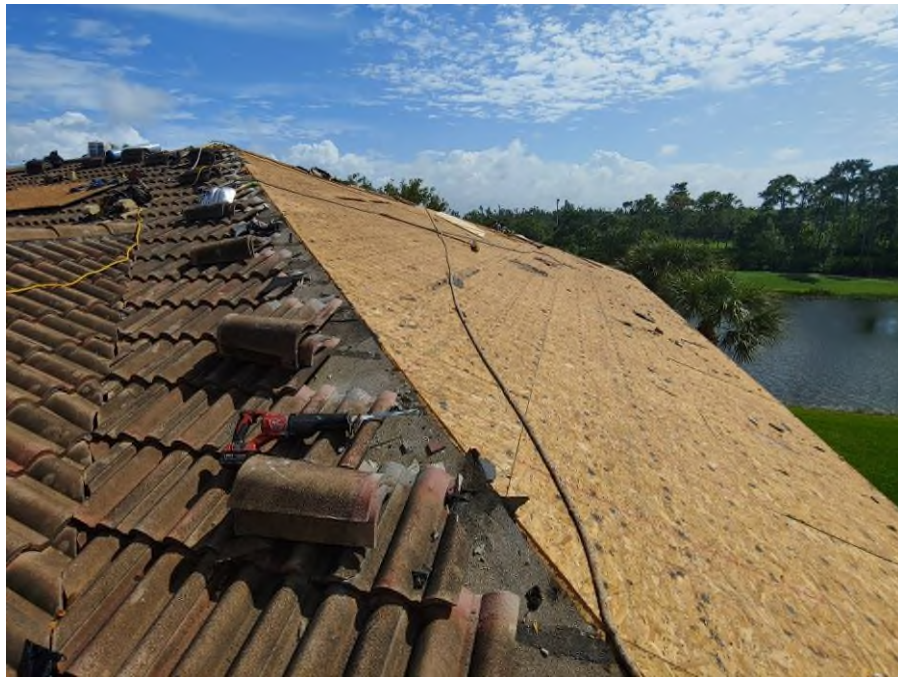
**Photograph #1: Roof tile removal was in progress on building 7860.**

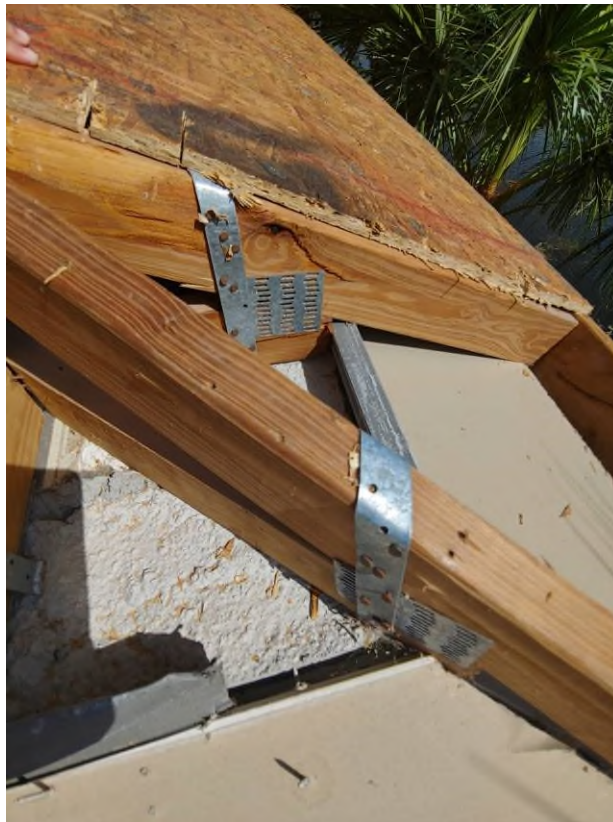
**Photograph #2: Existing strap clips on trusses have the required minimum quantity of nails on building 7860.**

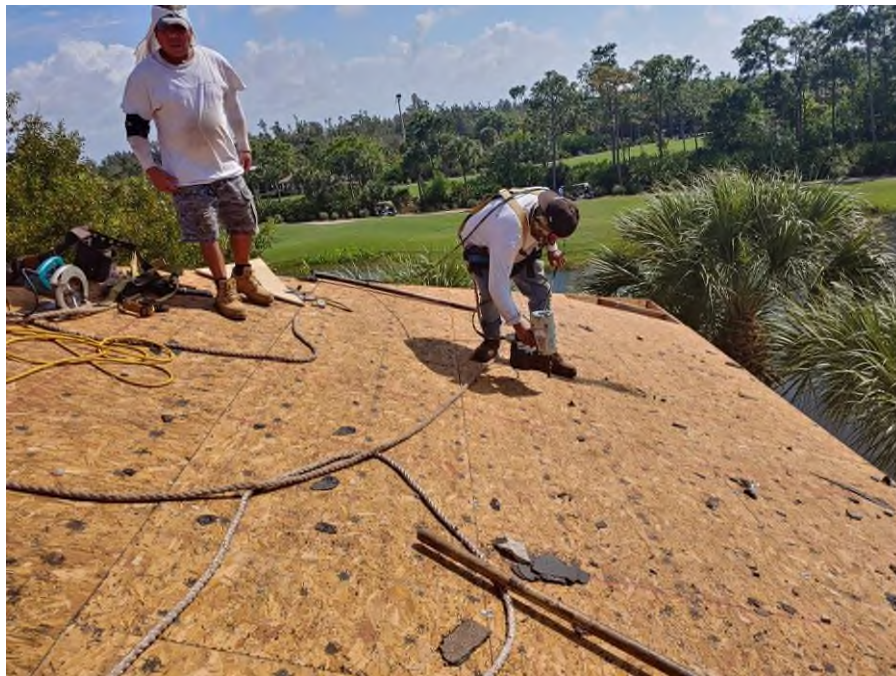
**Photograph #4: Re-nail pattern at plywood sheathing was in progress on building 7860.**

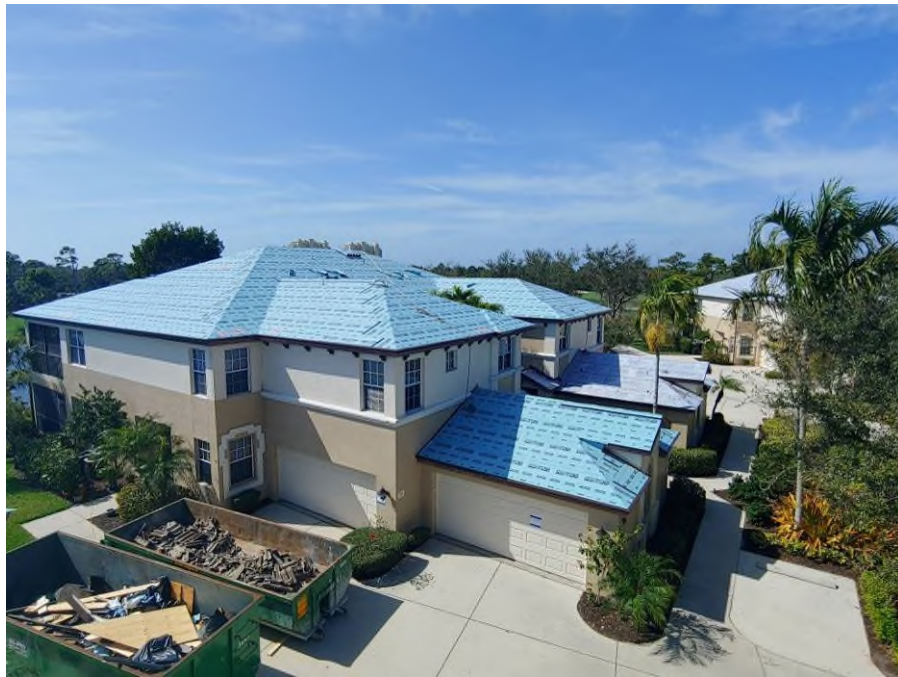
**Photograph #5: Polystick MTS Plus underlayment installation was completed on building 21710.**

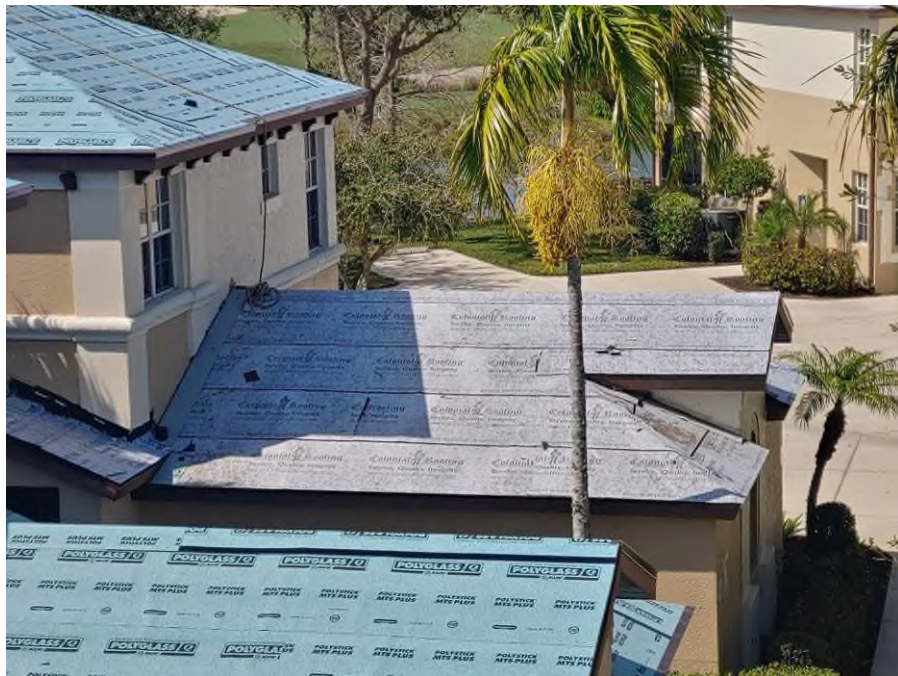
**Photograph #6: Second layer of underlayment installation was in progress on building 21710.**

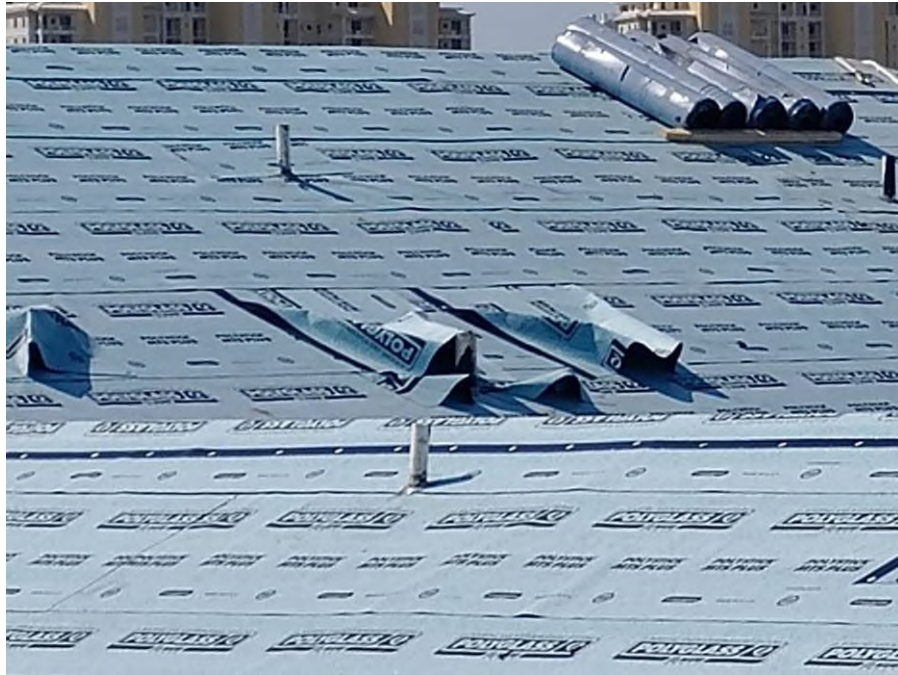
**Photograph #7: Polystick MTS Plus underlayment installation was completed on building 21710.**

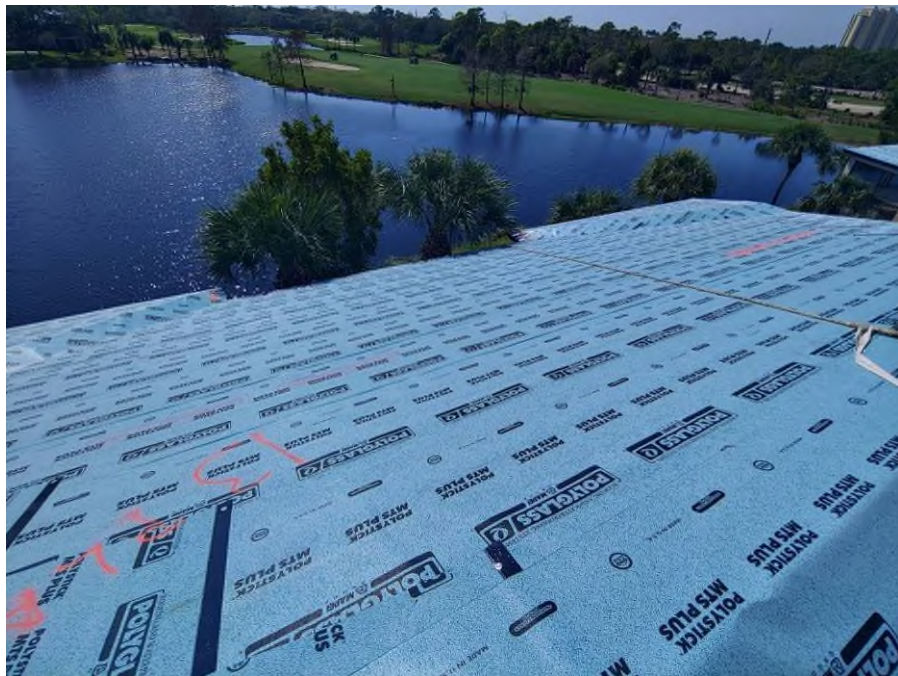
**Photograph #8: Polystick MTS Plus underlayment installation was completed on building 21720.**

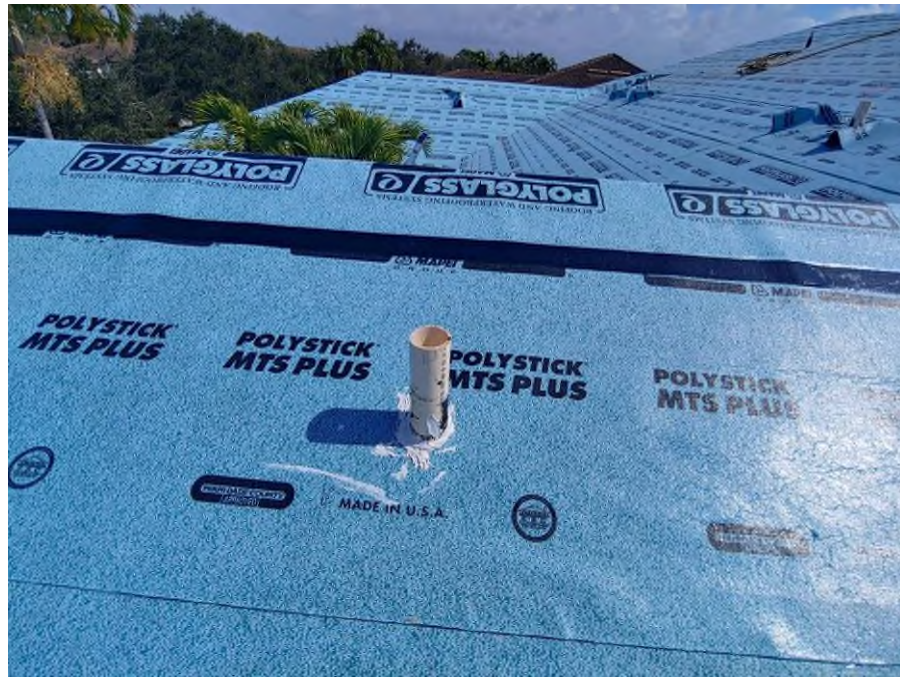
**Photograph #9: Sealant application on Vent-pipe was in progress on building 21720.**

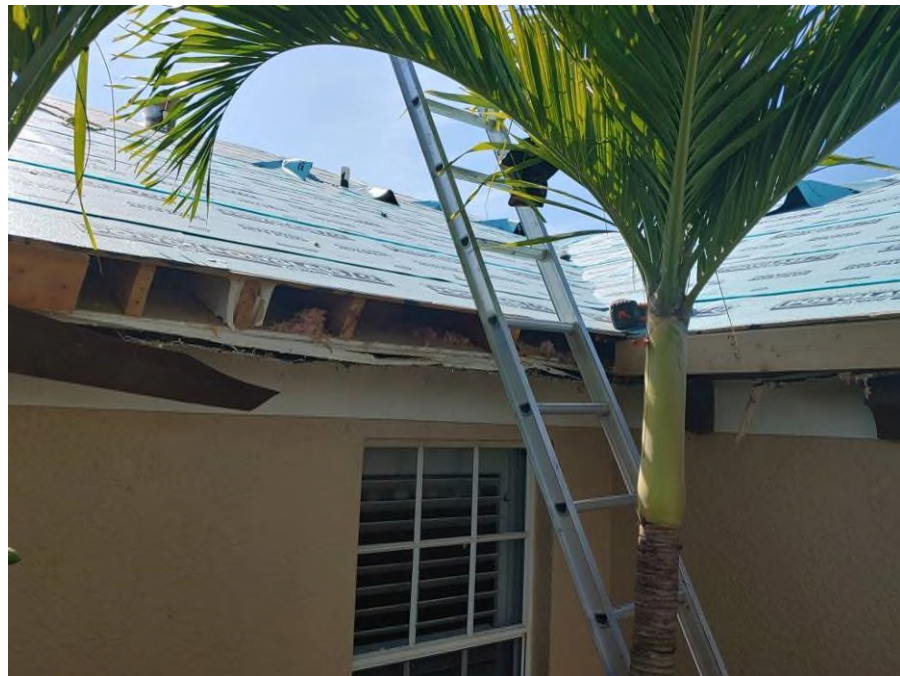
**Photograph #10: Fascia repair was in progress on building 21720.**
