# Uniform Mitigation Verification Inspection Form

**RE: Palmetto Dunes Condominium**  
**21770 Palmetto Dunes Drive**  
**Estero, FL 33928**  
**Roofing Restoration**  
KEG File #20RN-0085  
**Wind Mitigation**  
**Permit # 1721918-0**

| Palmetto Dunes CAI – Roofing Project | | | |

REPORT: FR # 15

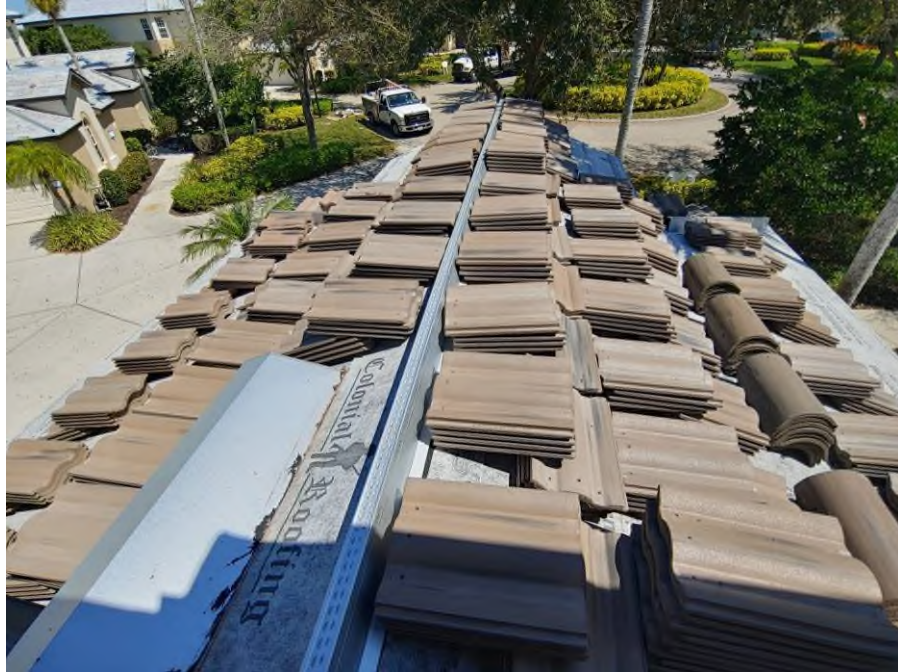
**Photograph #1: Tiles were set in place for installation at building 7840.**

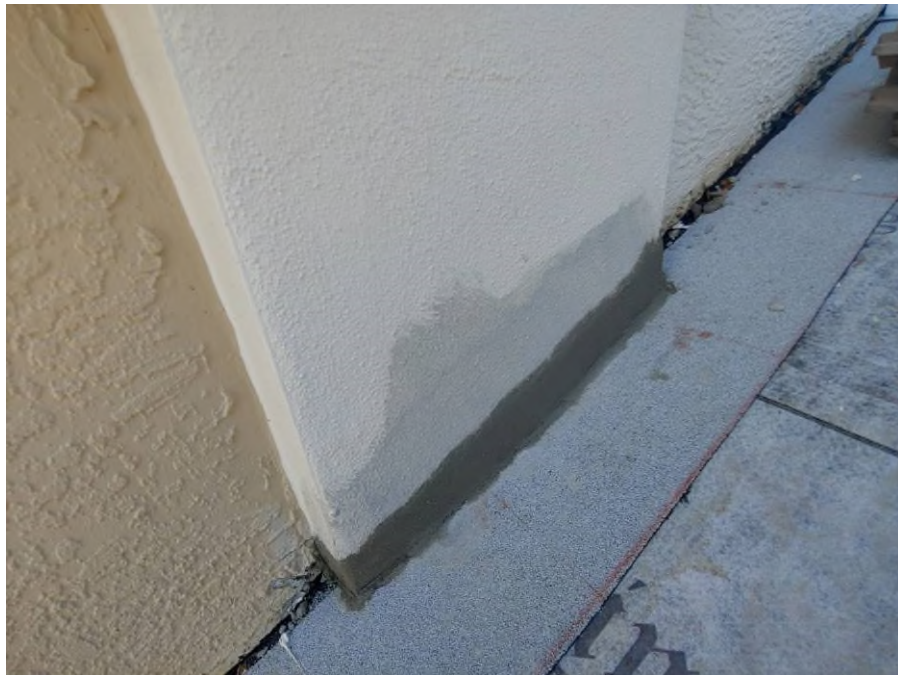
**Photograph #2: Stucco application was completed on the columns at building 7840.**

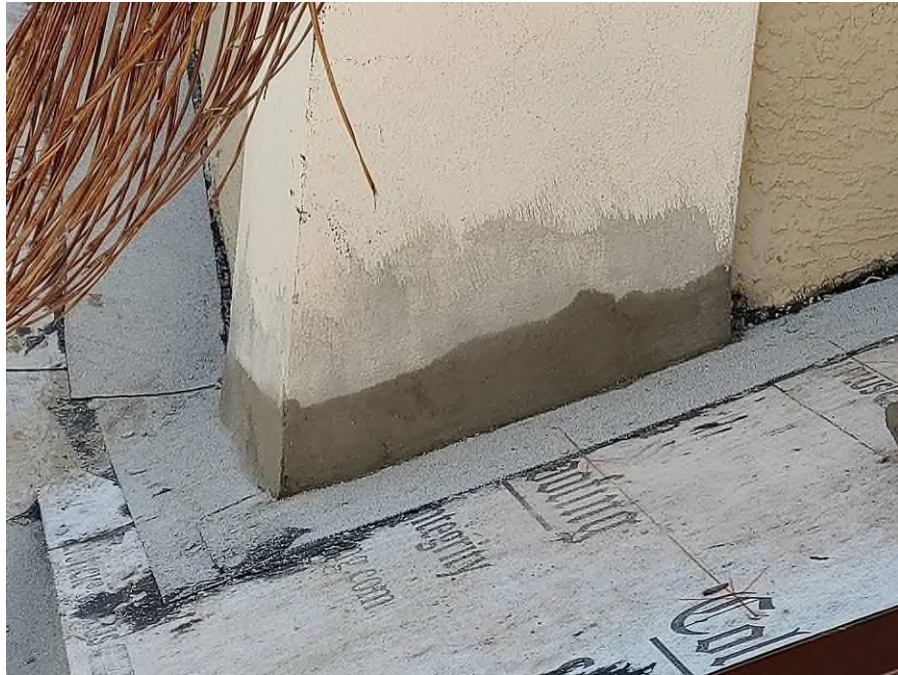
**Photograph #3: Stucco application was completed on the columns at building 7840.**

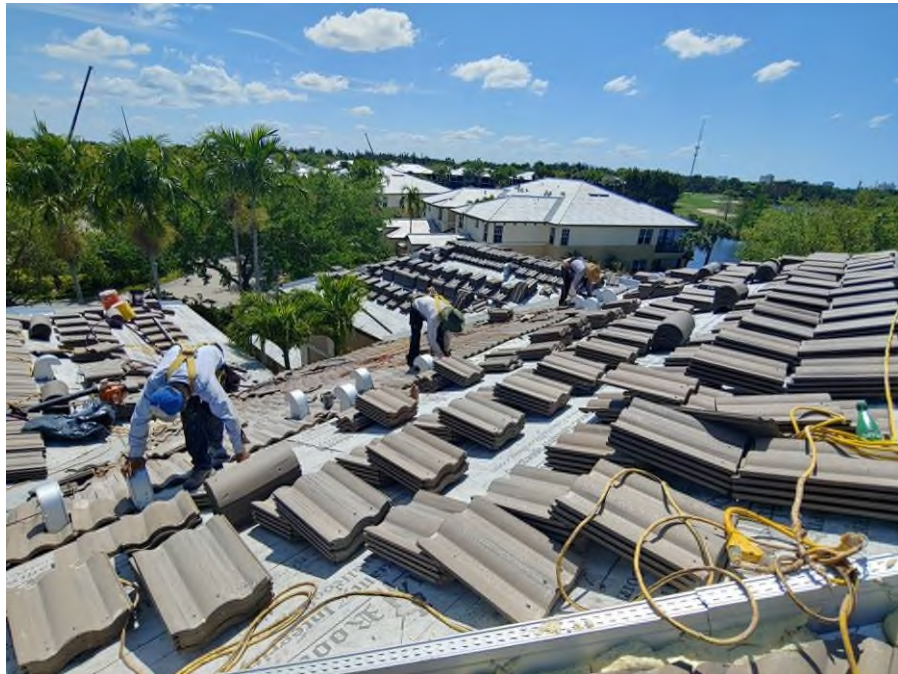
**Photograph #4: Roof field tile installations with polyurethane foam adhesive was in progress on building 21700.**

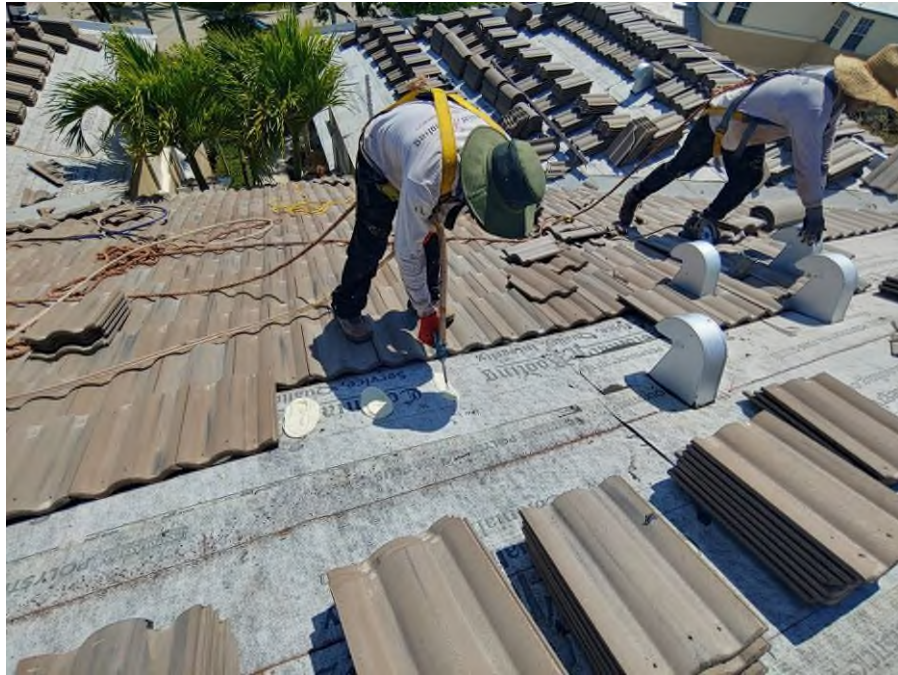
**Photograph #5: Roof field tile installations with polyurethane foam adhesive was in progress on building 21700.**

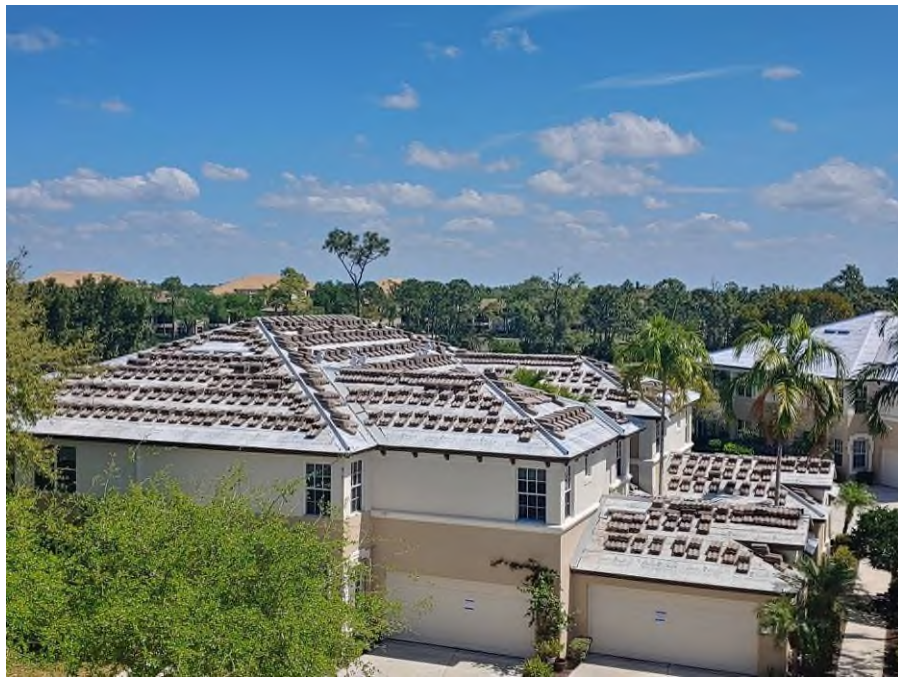
**Photograph #6: Tiles were set in place for installation at building 21711.**

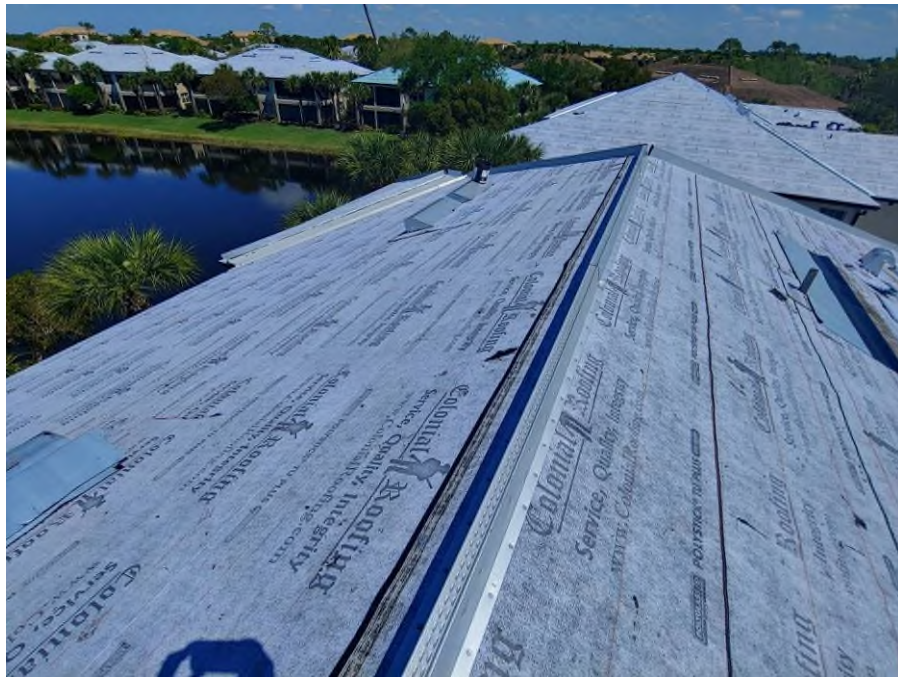
**Photograph #7: Second layer of underlayment installation was completed on building 7881.**

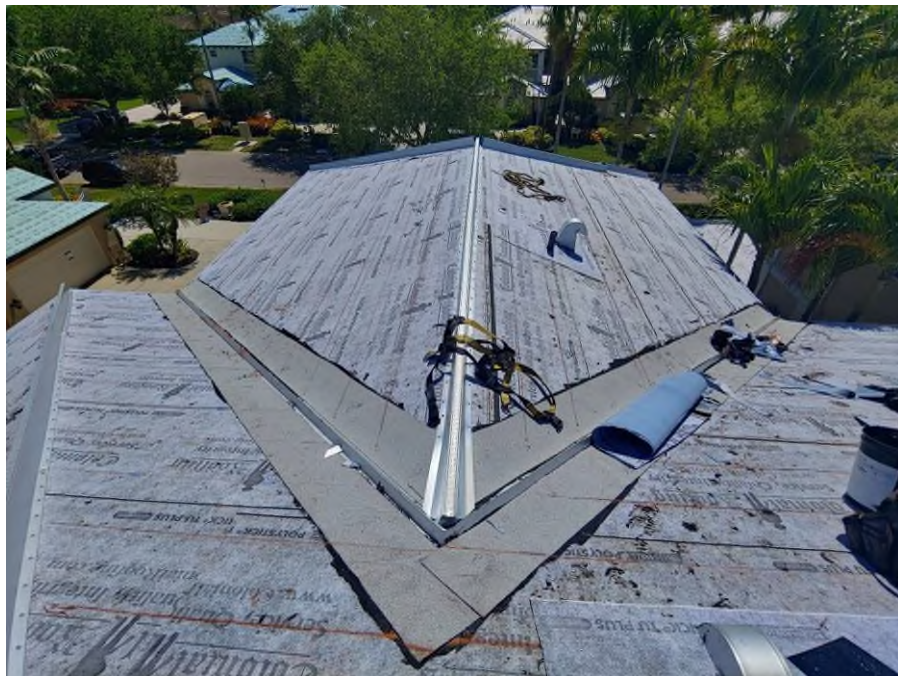
**Photograph #8: V-crimp metal valley flashing installations were in progress on building 7881.**

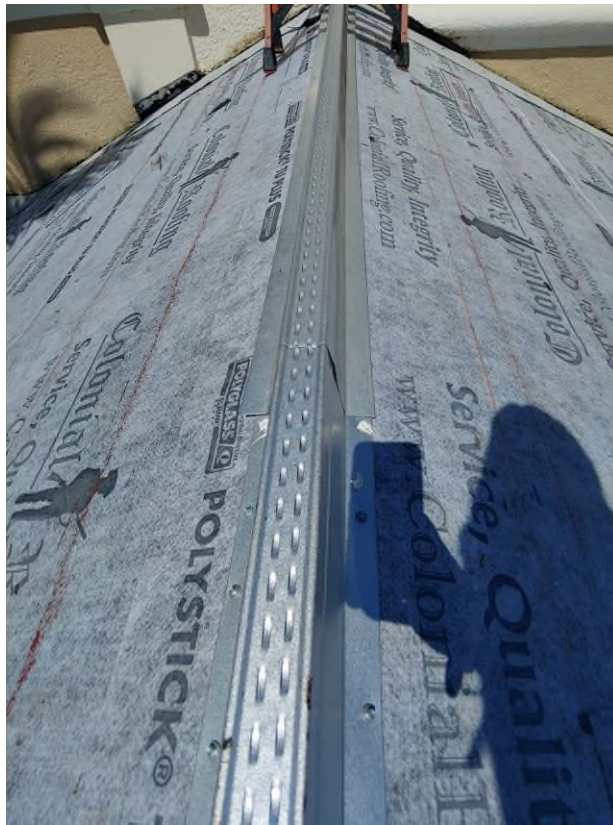
**Photograph #9: Hip/ridge metal channel installations were in progress on building 7881.**

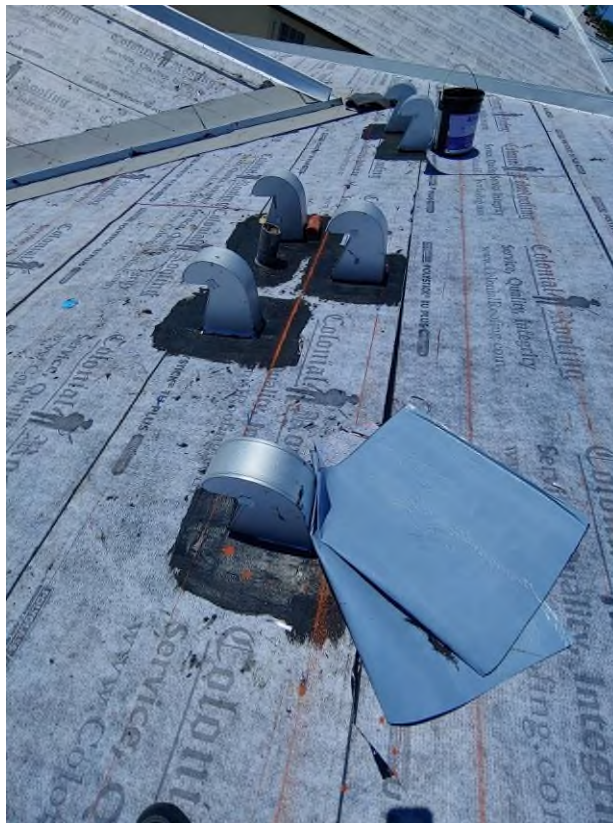
**Photograph #10: Pipe and exhaust vent installations were in progress on building 7881.**

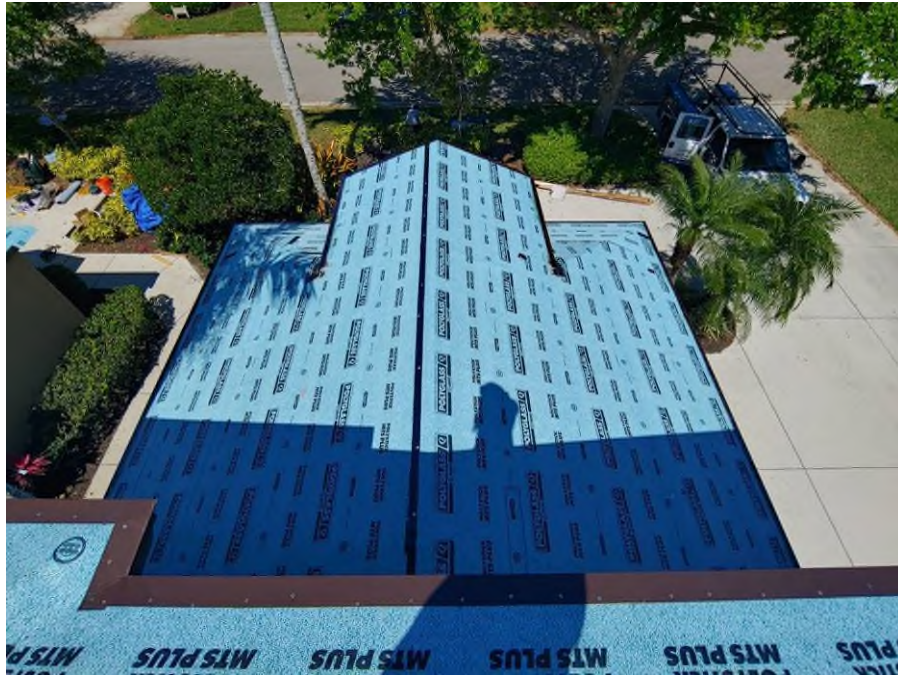
**Photograph #11: Polystick MTS Plus underlayment installation was completed on building 7890.**

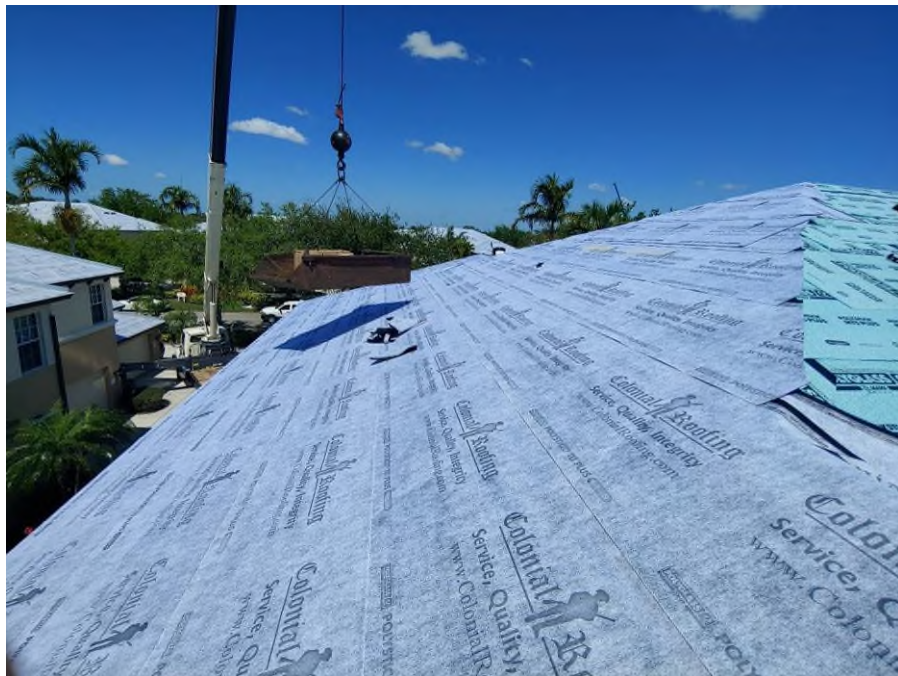
**Photograph #12: Second layer of underlayment installation was in progress on building 7890.**

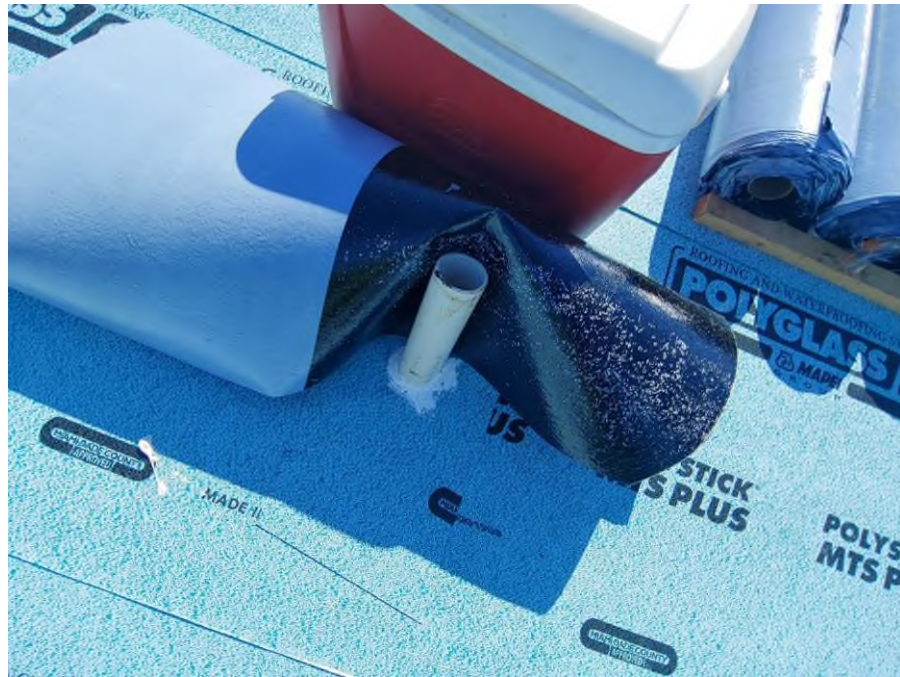
Photograph #13: Pipe installations were in progress on building 7890.

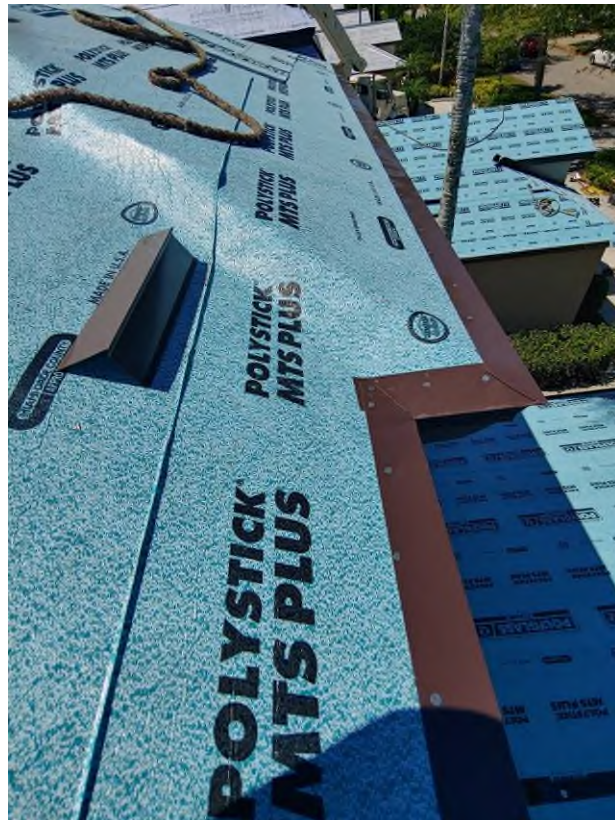
Photograph #14: Drip edge installation was in progress on building 7890.

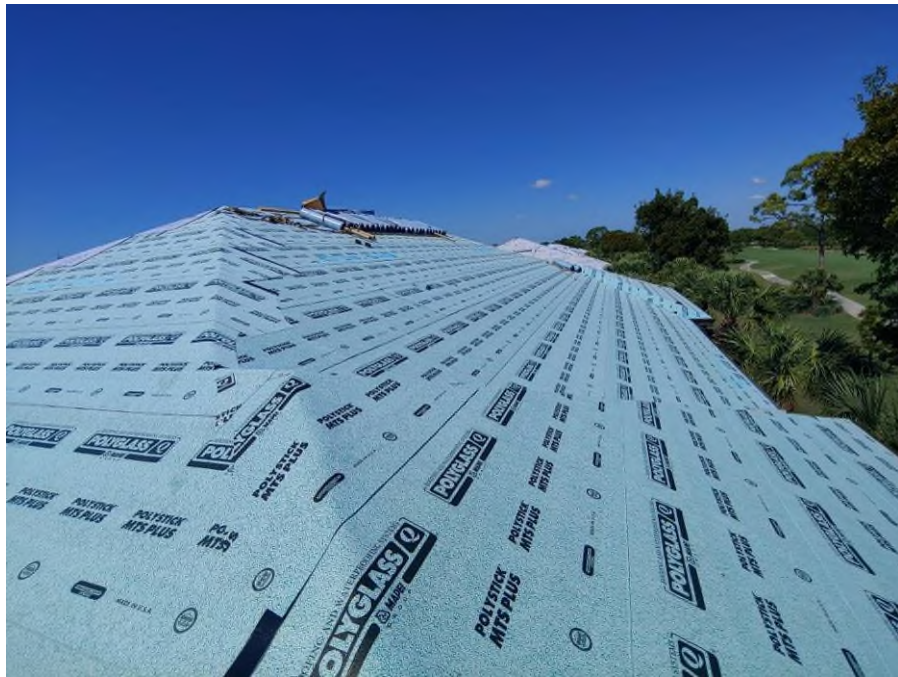
**Photograph #15: Polystick MTS Plus underlayment installation was completed on building 21751.**

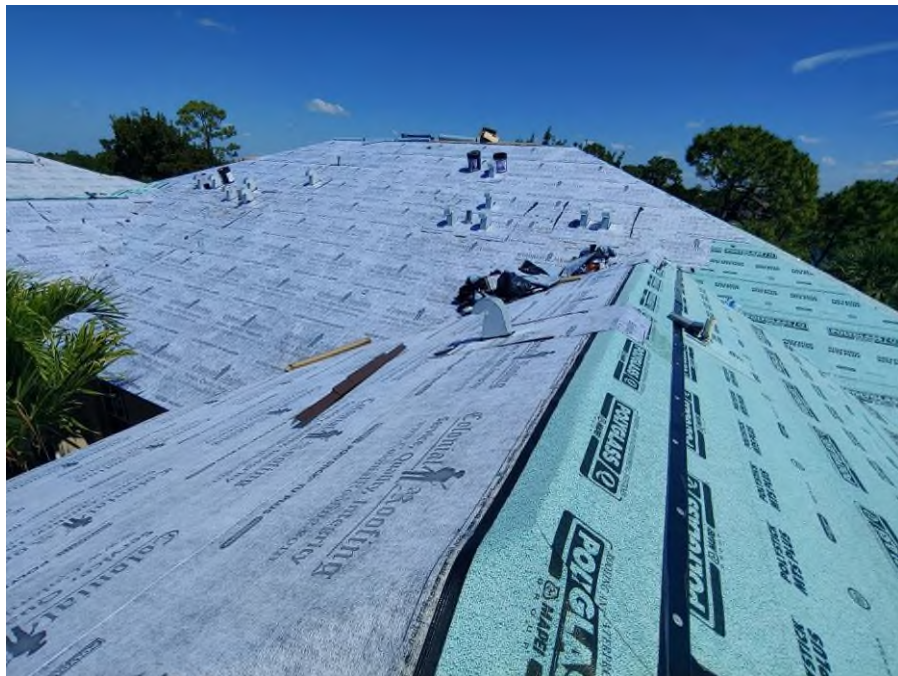
**Photograph #16: Second layer of underlayment installation was in progress on building 21751.**

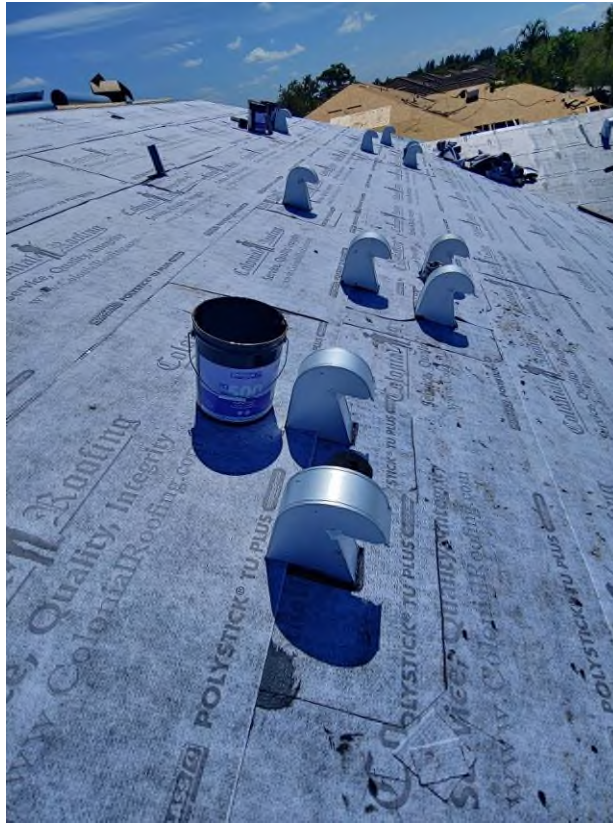
Photograph #17: Pipe and exhaust vent installations were in progress on building 21751.

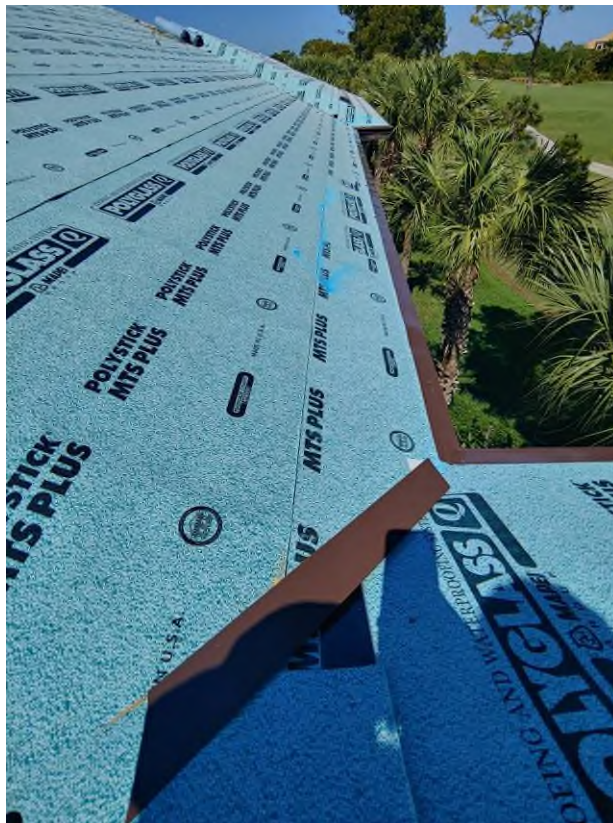
Photograph #18: Drip edge installation was in progress on building 21751.

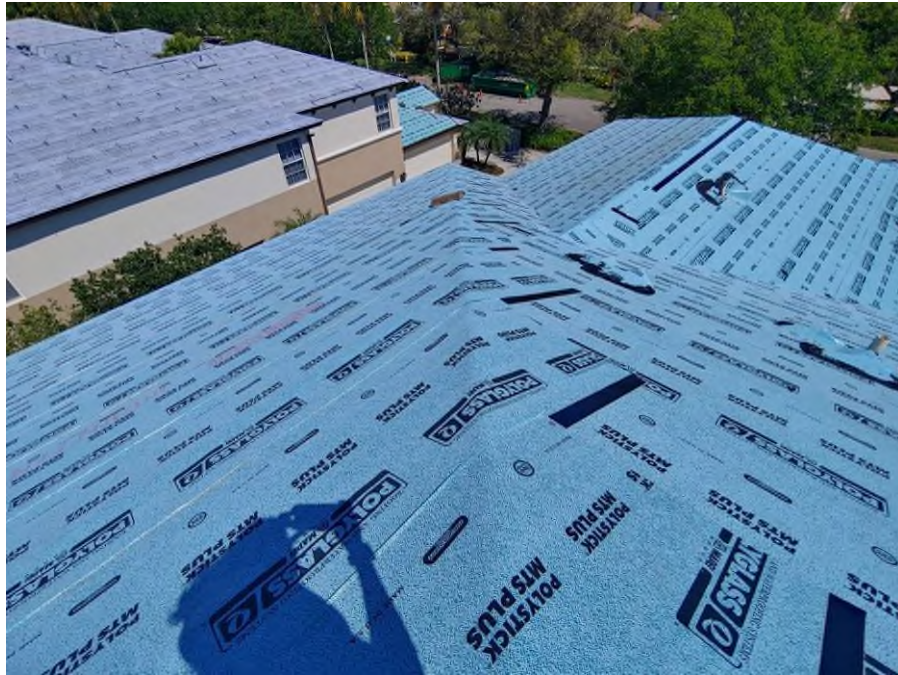
**Photograph #19: Polystick MTS Plus underlayment installation was completed on building 21770.**

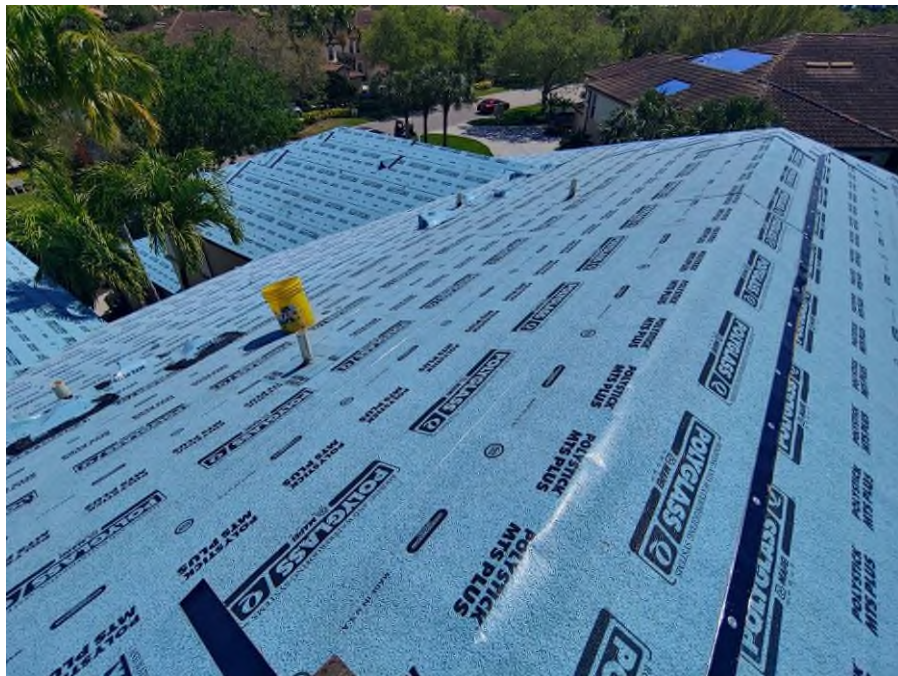
**Photograph #20: Pipe installations were in progress on building 21770.**

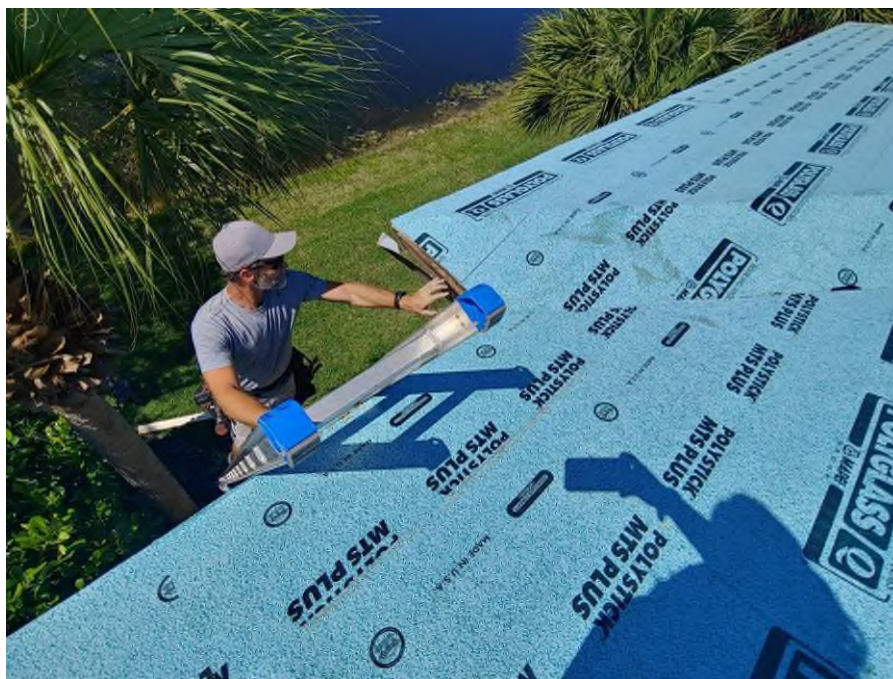
**Photograph #21: Fascia repair was observed on building 21770.**

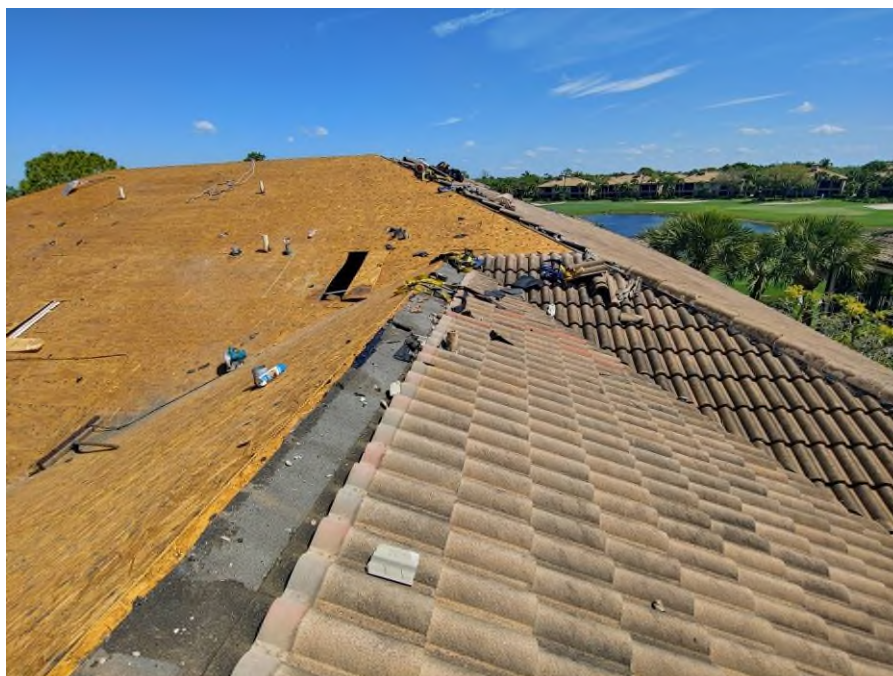
**Photograph #22: Roof tile removal was in progress on building 21761.**

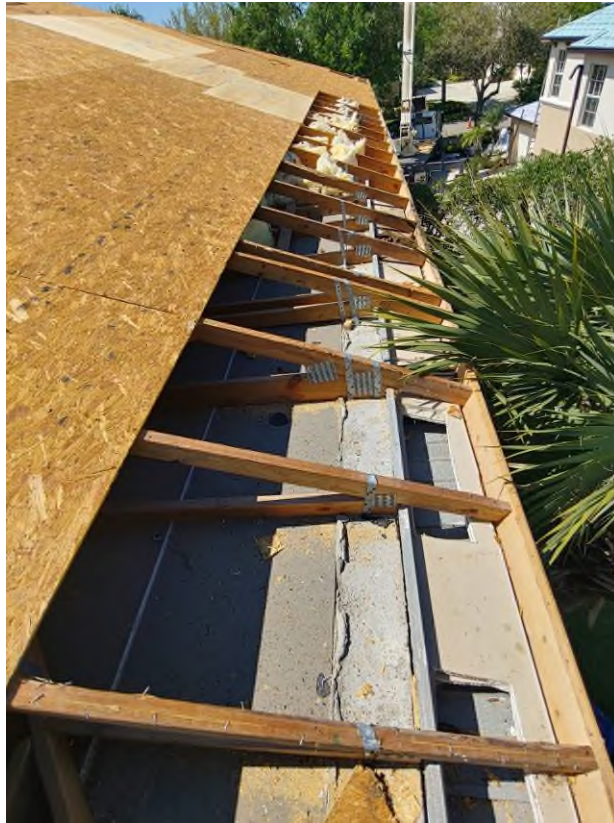
**Photograph #23: Existing strap clips on the trusses have the required minimum of nails on building 21761.**

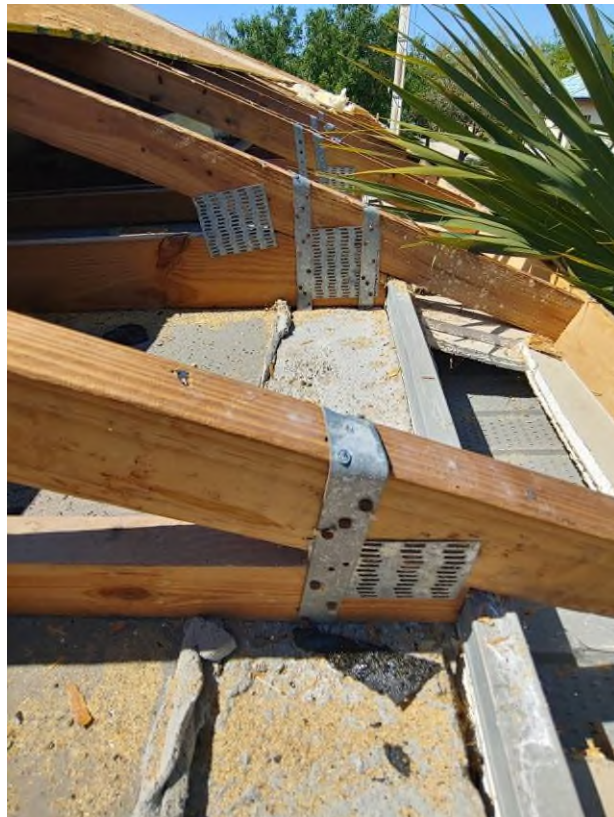
**Photograph #24: Existing strap clips on the trusses have the required minimum of nails on building 21761.**

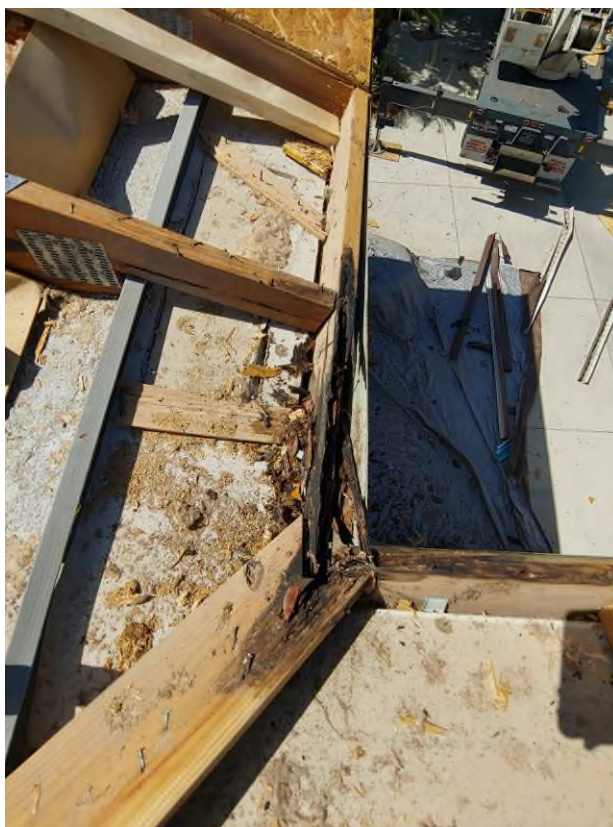
**Photograph #25: Rotten fascia and trusses were observed on building 21761.**

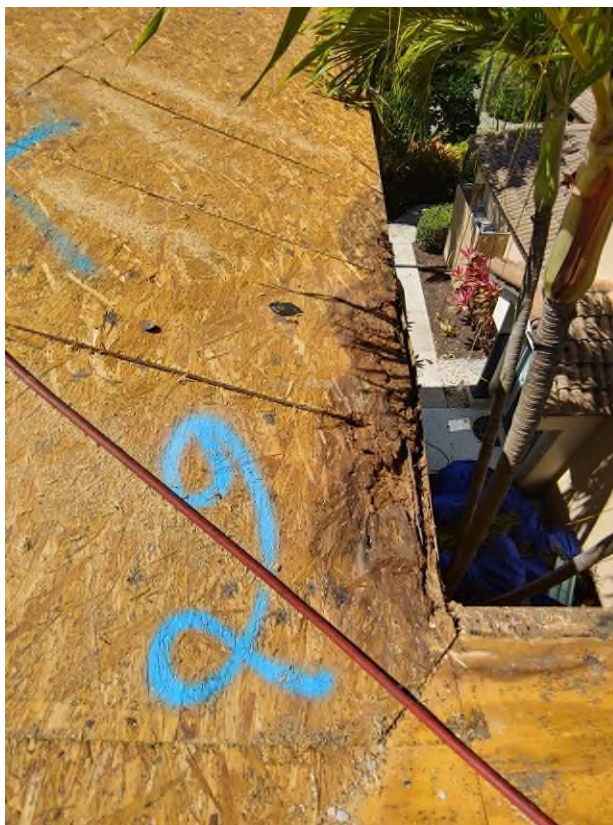
**Photograph #26: Rotten fascia and plywood sheathing were observed on building 21761.**

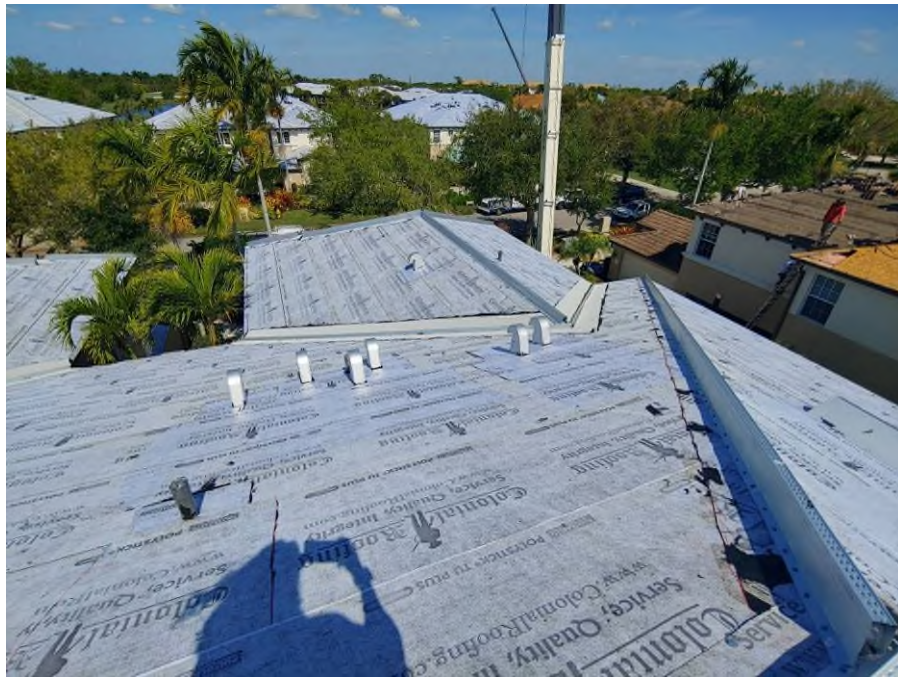
**Photograph #1: Second layer of underlayment installation was completed on building 7880.**

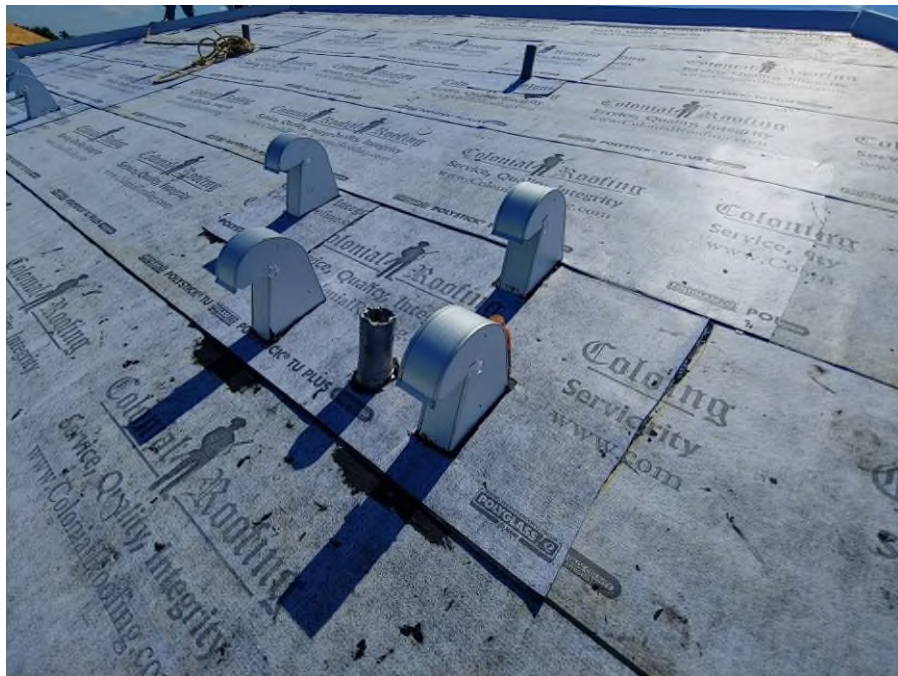
**Photograph #2: Pipe and exhaust vent installations were completed on building 7880.**

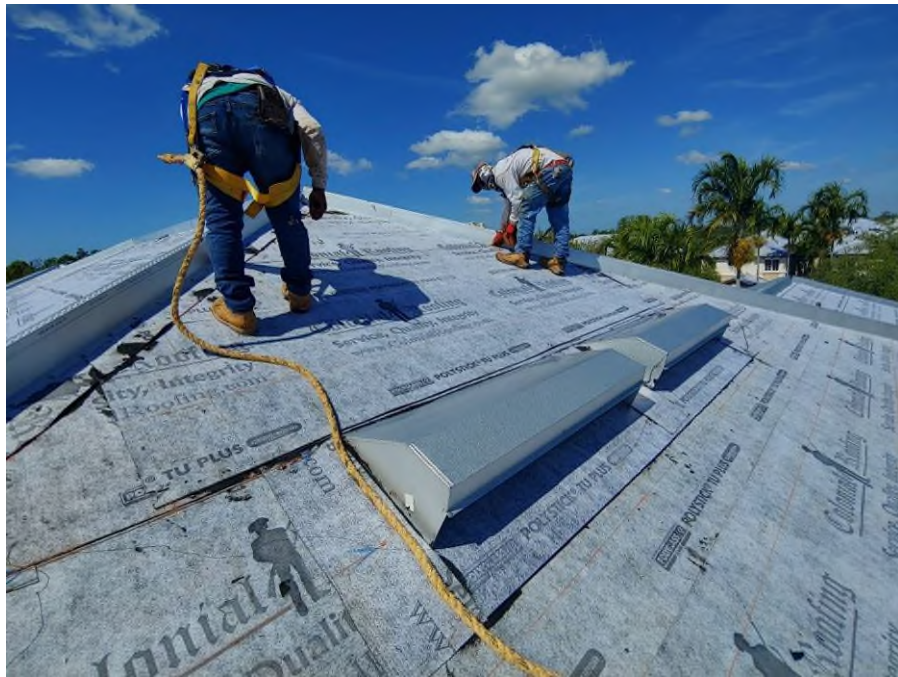
**Photograph #3: Exhaust vent installations were completed on building 7880.**

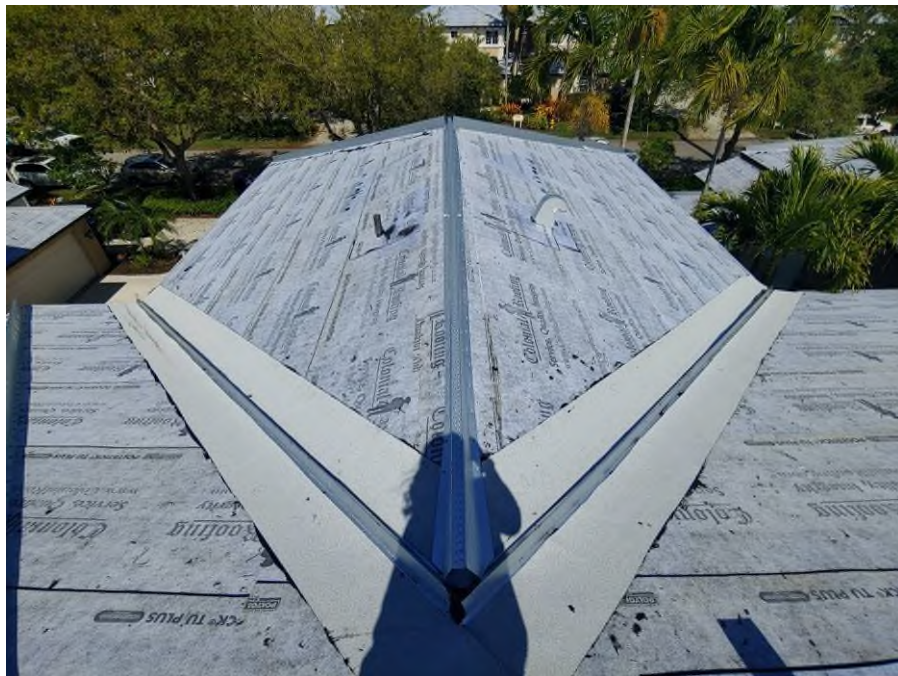
**Photograph #4: V-crimp metal valley flashing installations were completed on building 7880.**

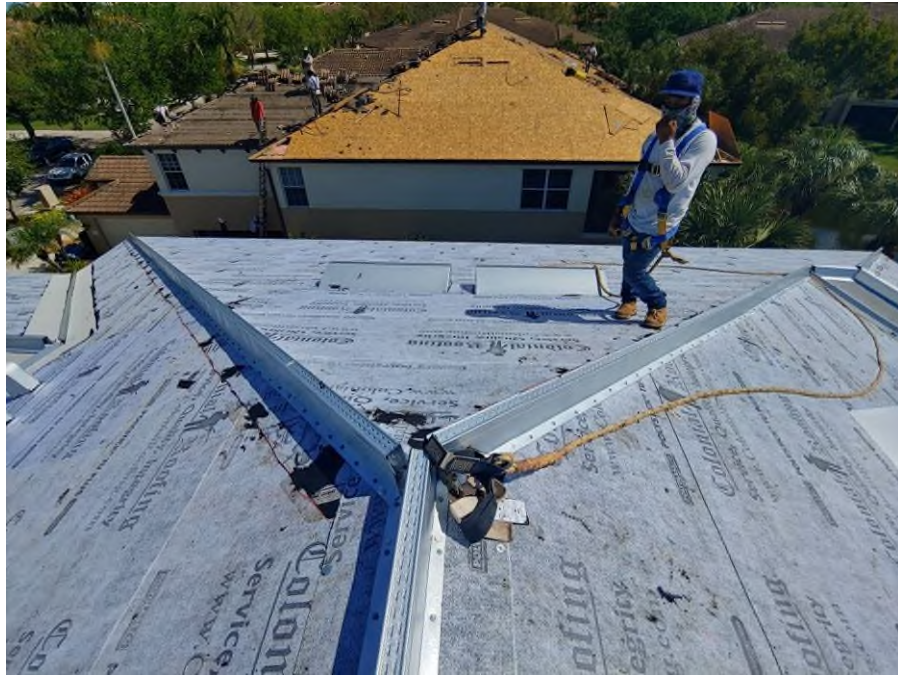
**Photograph #5: Hip/ridge metal channel installation was in progress on building 7880.**

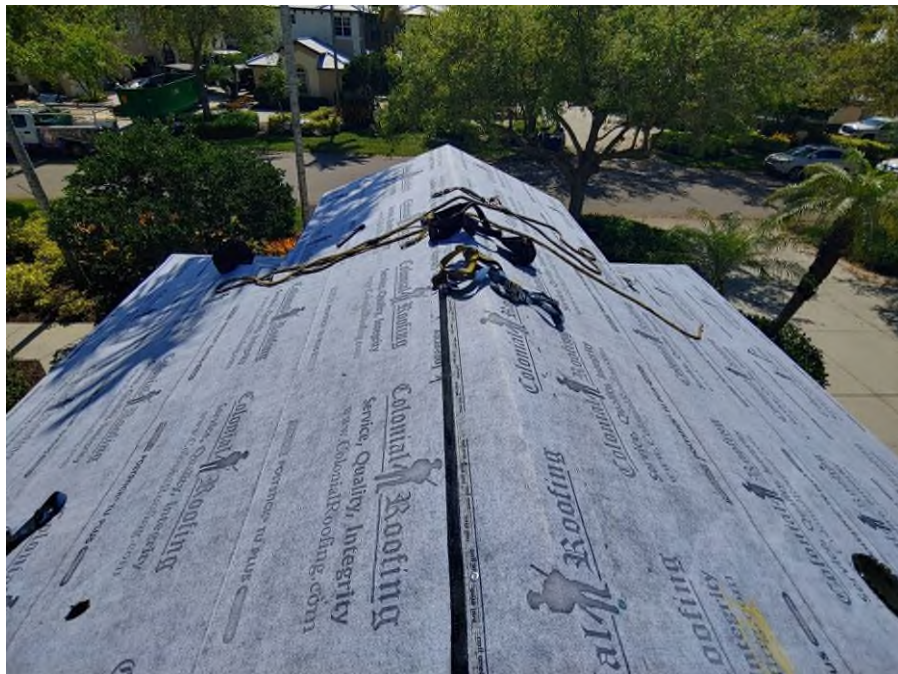
**Photograph #6: Second layer of underlayment installation was completed on building 7881.**

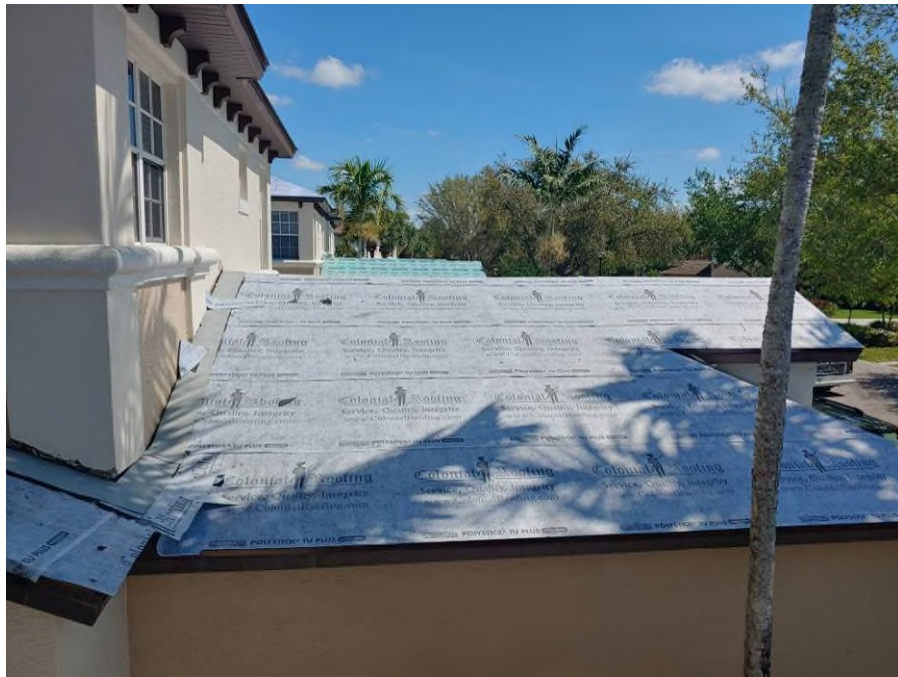
**Photograph #7: Second layer of underlayment installation was completed on building 7881.**

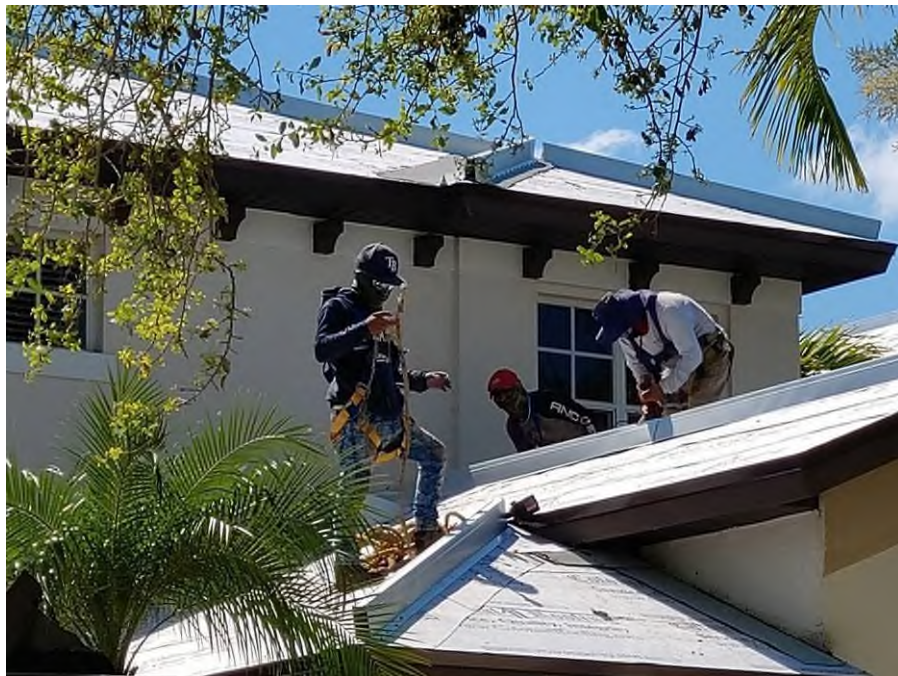
**Photograph #8: Hip/ridge metal channel installation was in progress on building 7881.**

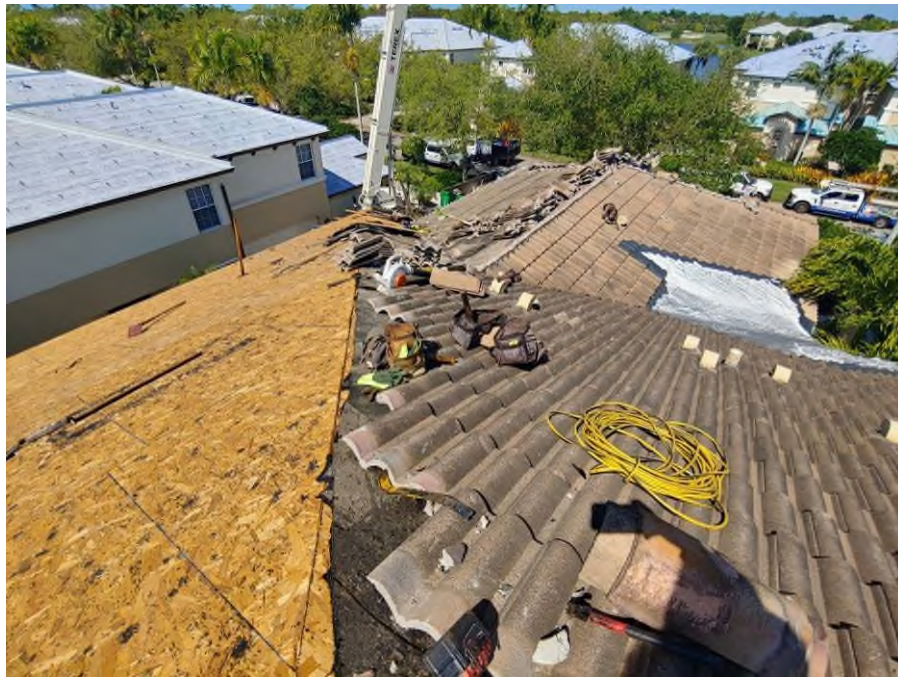
**Photograph #9: Roof tile removal was in progress on building 7890.**

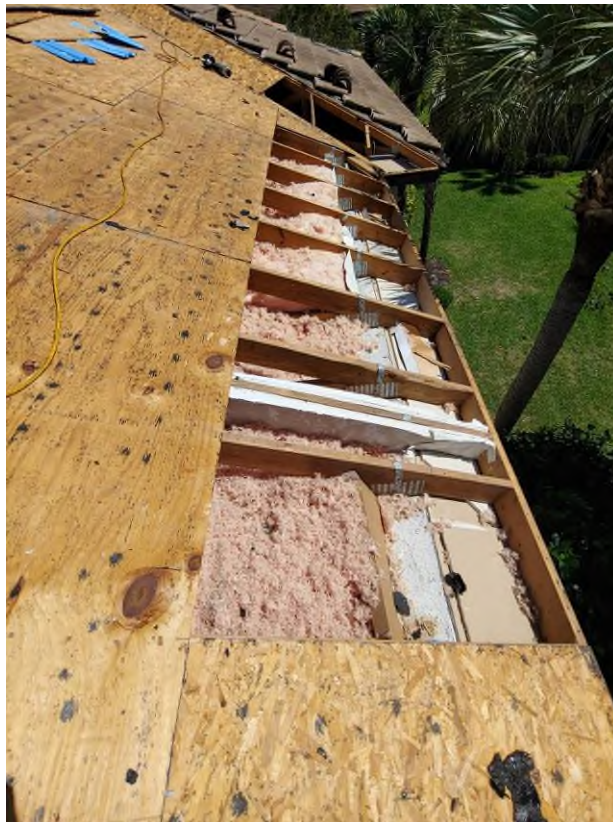
**Photograph #10: Existing strap clips on the trusses have the required minimum quantity of nails on building 7890.**

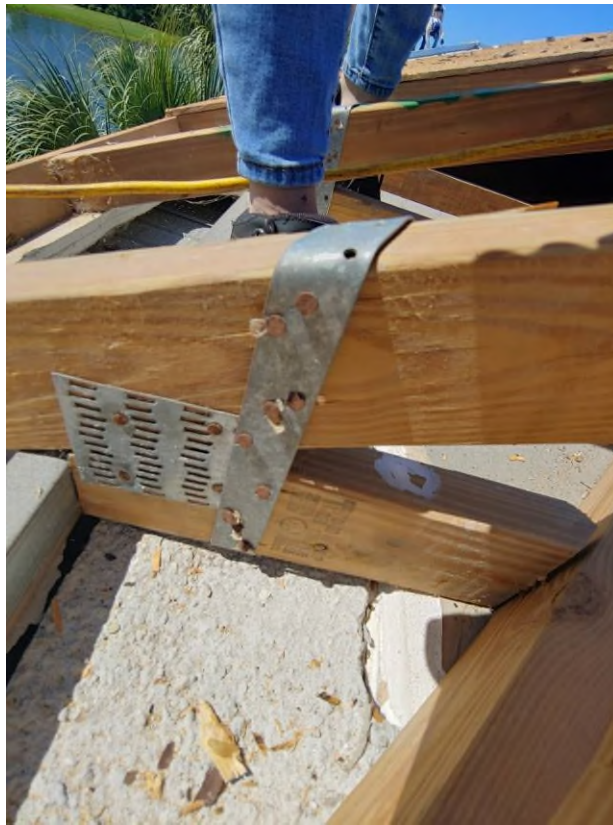
**Photograph #11: Existing strap clips on the trusses have the required minimum quantity of nails on building 7890.**

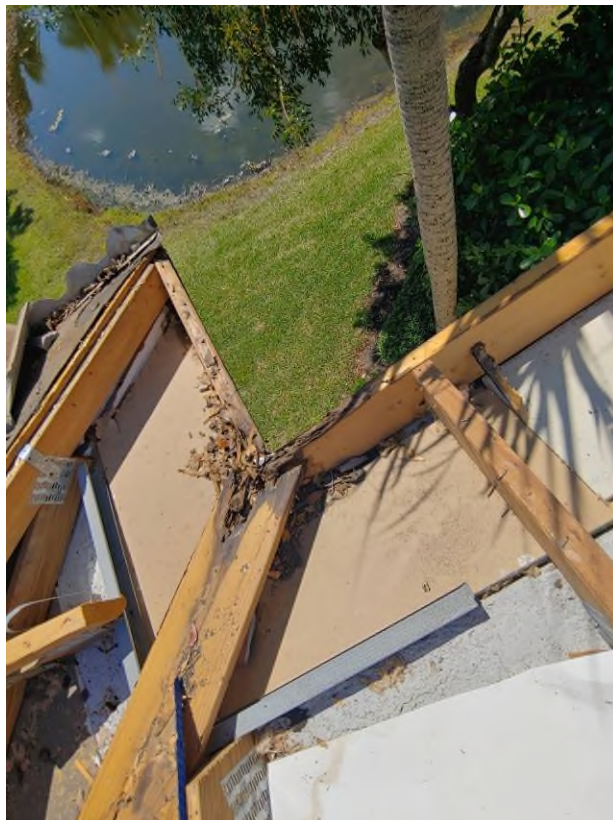
**Photograph #12: Rotten fascia and trusses were observed on building 7890.**
