# Uniform Mitigation Verification Inspection Form

**RE: Palmetto Dunes Condominium**  
**21770 Palmetto Dunes Drive**  
**Estero, FL 33928**  
**Roofing Restoration**  
KEG File #20RN-0085  
**Wind Mitigation**  
**Permit # 1721918-0**

| Palmetto Dunes CAI – Roofing Project | | | |

REPORT: FR # 15

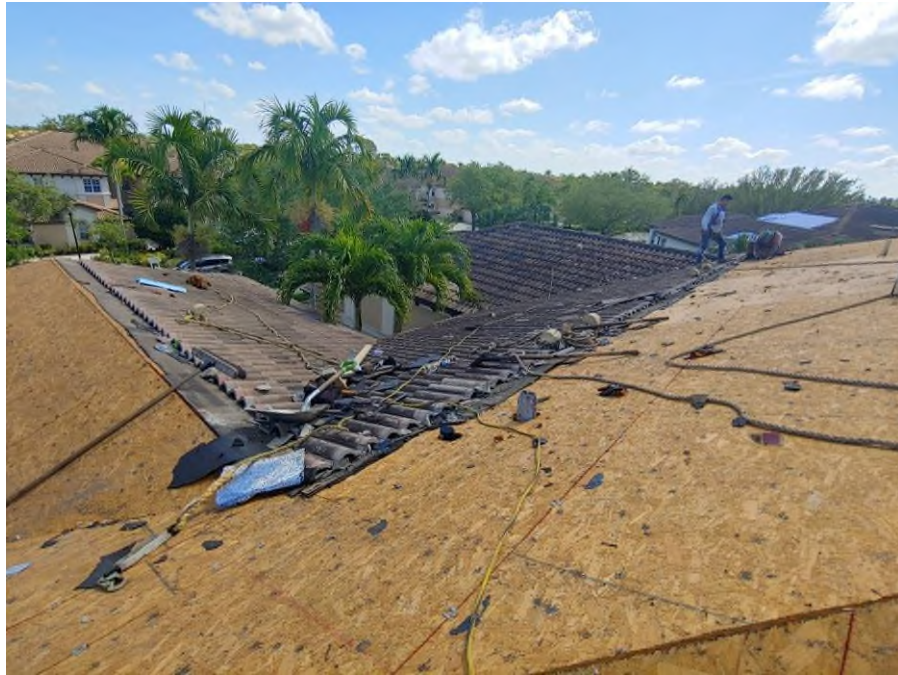
**Photograph #13: Roof tile removal was in progress on building 21770.**

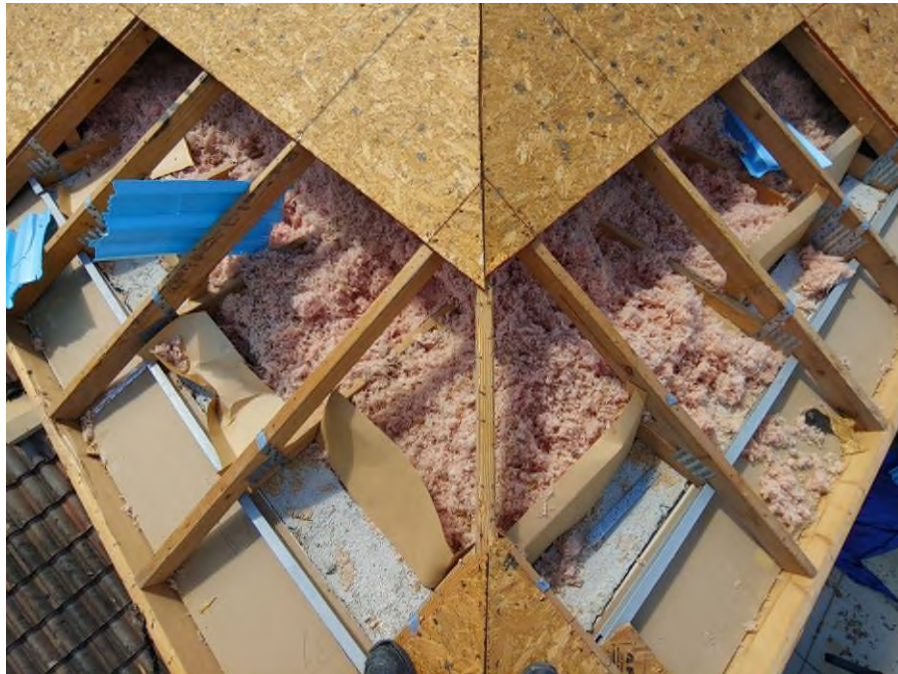
**Photograph #14: Existing strap clips on the trusses have the required minimum quantity of nails on building 21770.**

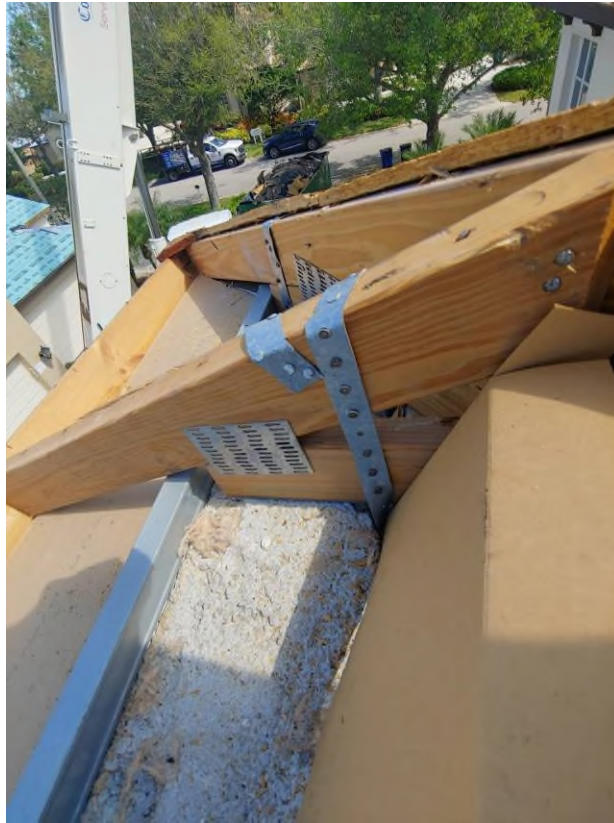
**Photograph #15: Existing strap clips on the trusses have the required minimum quantity of nails on building 21770.**

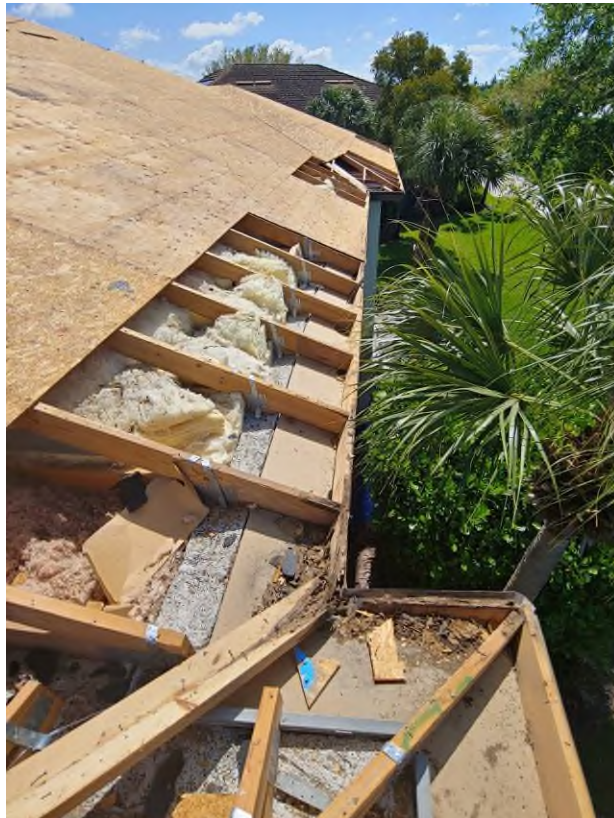
**Photograph #16: Rotten fascia and trusses were observed on building 21770.**
