Uniform Mitigation Verification Inspection Form

Inspection Date: 06-25-2020		
Owner Information		
Owner Name: Palmetto Dunes Pelican Sound Condominium Association Inc.		Contact Person:
Address: 21711 Palmetto Dunes Drive Units 101,102,201,202		Home Phone:
City: Estero	Zip: 33928	Work Phone:
County: Lee		Cell Phone:
Insurance Company:		Policy #:
Year of Home: 2001	# of Stories: 2	Email:

DATE	March 30, 2020	JOB NO.	20RN-0085
Palmetto Dunes CAI – Roofing Project			
LOCATION	Palmetto Dunes Drive		
CONTRACTOR	EnviroStruct, LLC	Palmetto Dunes CAI	
WEATHER	Sunny	TEMP. 88° F	Time 2:30PM
PRESENT AT SITE	Rahmin Bahar, EnviroStruct (ES) Teresita Nazario-Acosta, Karins Engineering Group (KEG)

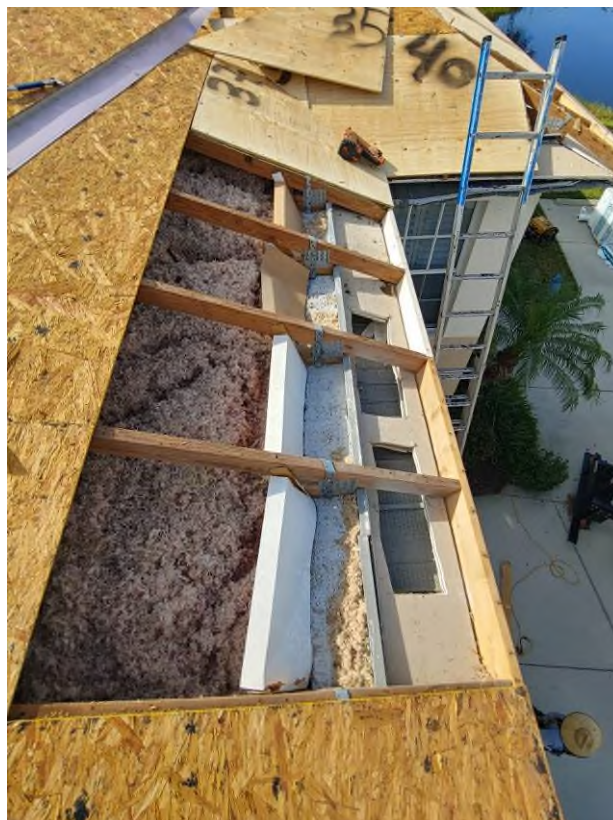
Photograph #5: Existing strap clips on trusses have the required minimum quantity of nails on building 7841.
