Uniform Mitigation Verification Inspection Form

Inspection Date: 06-25-2020		
Owner Information		
Owner Name: Palmetto Dunes Pelican Sound Condominium Association Inc.		Contact Person:
Address: 21711 Palmetto Dunes Drive Units 101,102,201,202		Home Phone:
City: Estero	Zip: 33928	Work Phone:
County: Lee		Cell Phone:
Insurance Company:		Policy #:
Year of Home: 2001	# of Stories: 2	Email:

DATE	March 30, 2020	JOB NO.	20RN-0085
Palmetto Dunes CAI – Roofing Project			
LOCATION	Palmetto Dunes Drive		
CONTRACTOR	EnviroStruct, LLC	Palmetto Dunes CAI	
WEATHER	Sunny	TEMP. 88° F	Time 2:30PM
PRESENT AT SITE	Rahmin Bahar, EnviroStruct (ES) Teresita Nazario-Acosta, Karins Engineering Group (KEG)

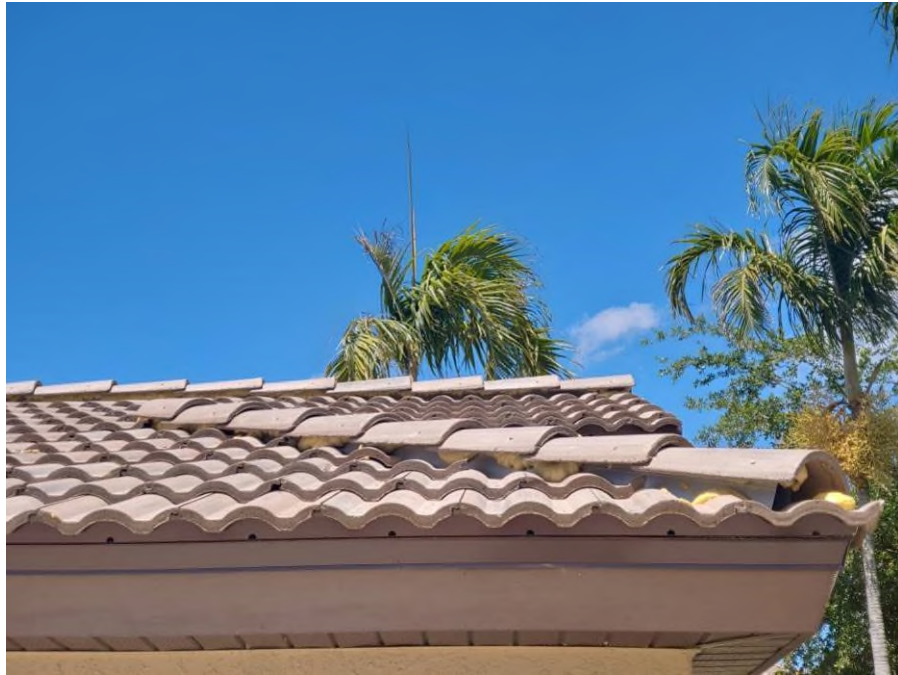
Photograph #1: Roof field, ridge and hip tile installations with polyurethane foam adhesive were in progress on building 21710.

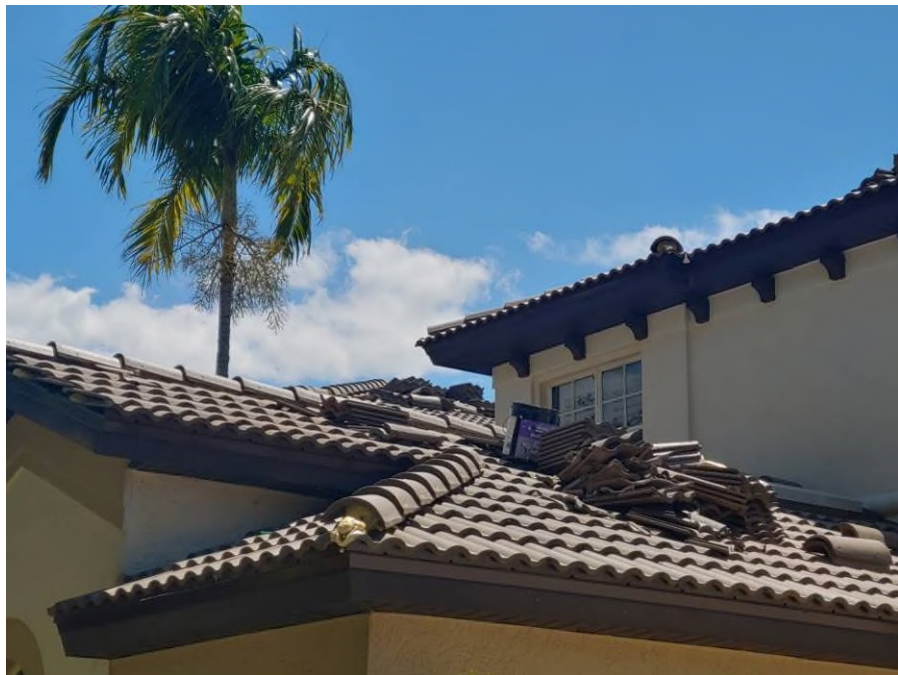
Photograph #2: Roof field, ridge and hip tile installations with polyurethane foam adhesive were in progress on building 21710.

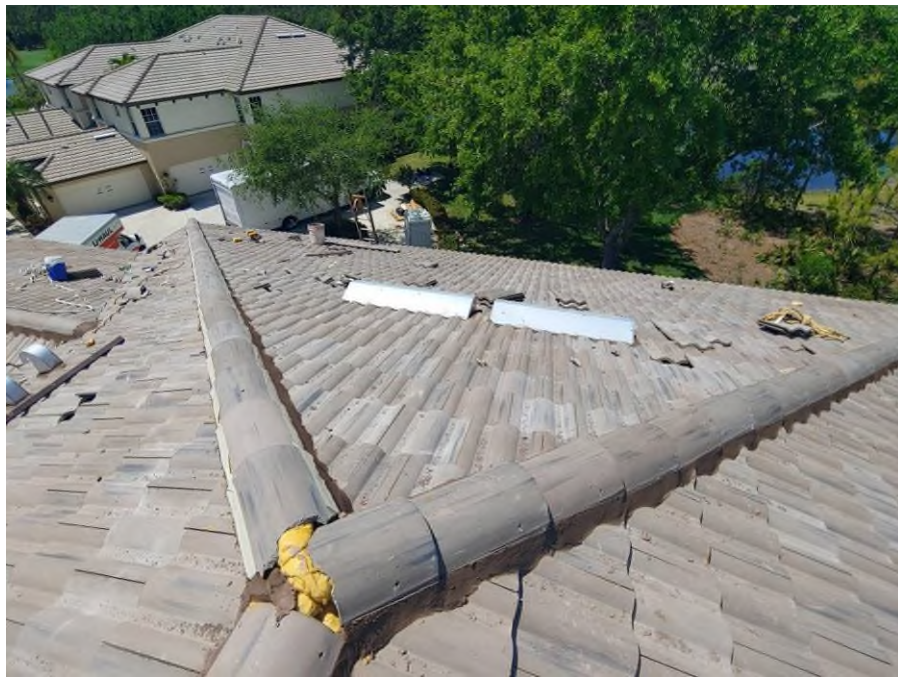
Photograph #6: Roof field, ridge and hip tile installations with polyurethane foam adhesive were in progress on building 21711.

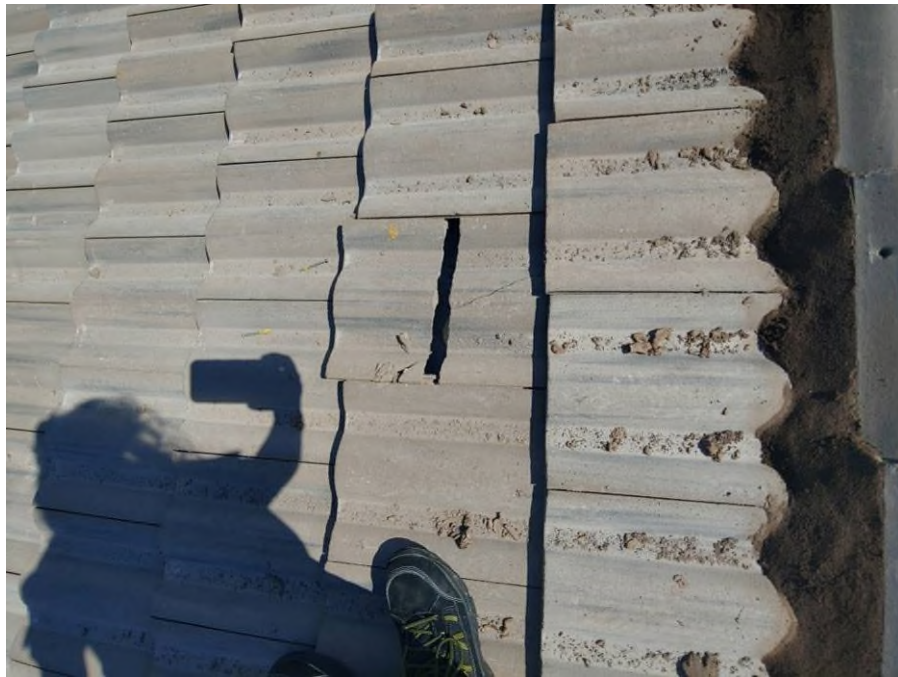
Photograph #7: Broken field tile replacement must be addressed on building 21711.

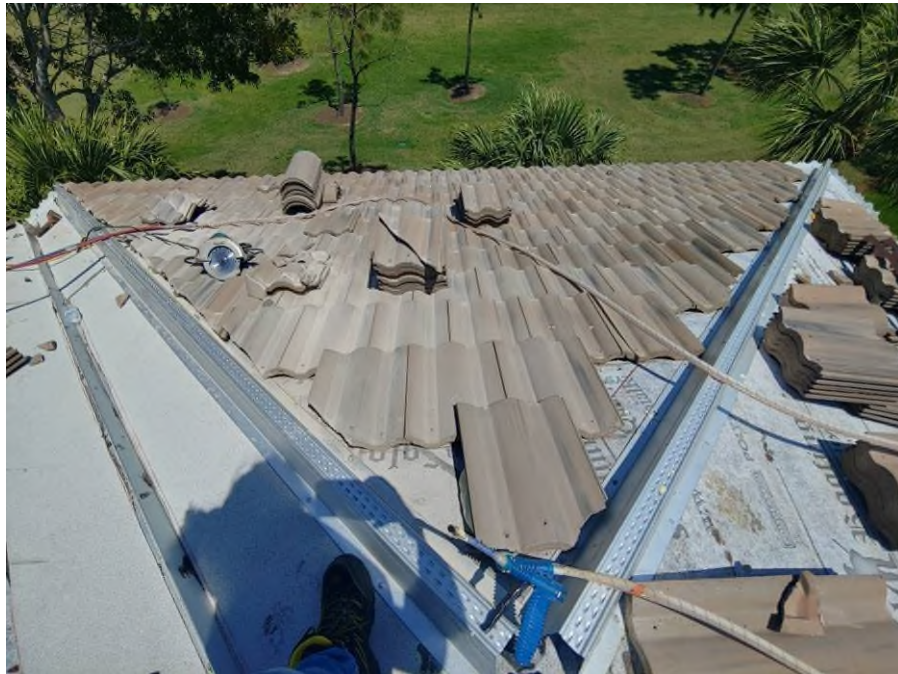
Photograph #10: Roof field, ridge and hip tile installations with polyurethane foam adhesive were in progress on building 21721.

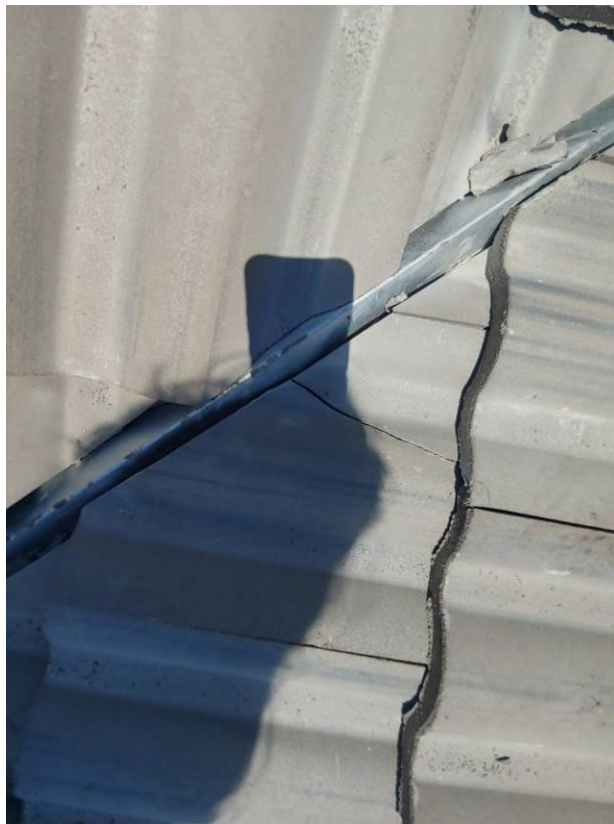
Photograph #12: Broken field tile replacement must be addressed on building 21721.

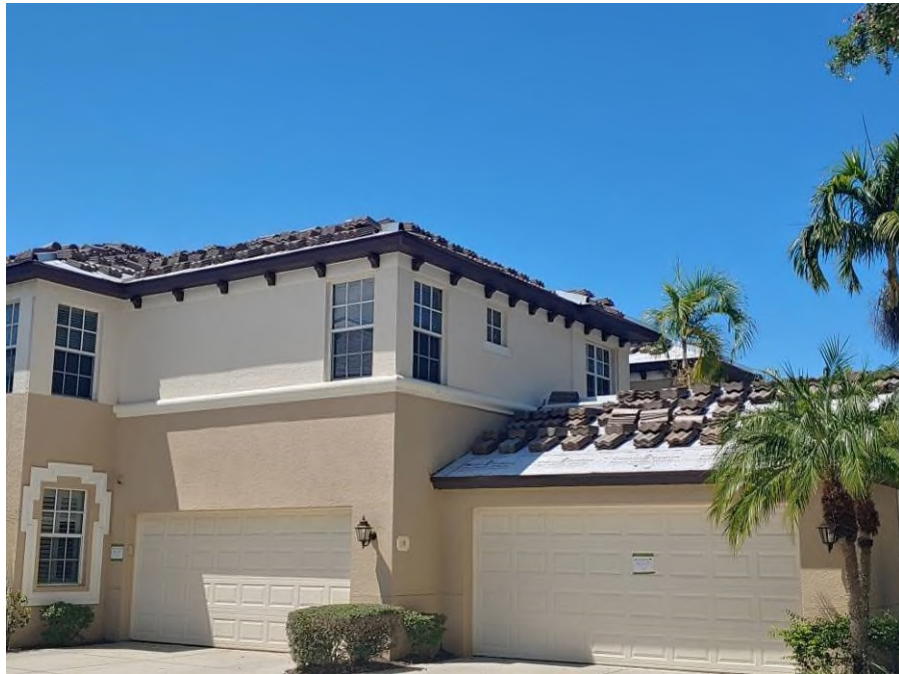
Photograph #14: Roof tiles were set into place for installation on building 21740.

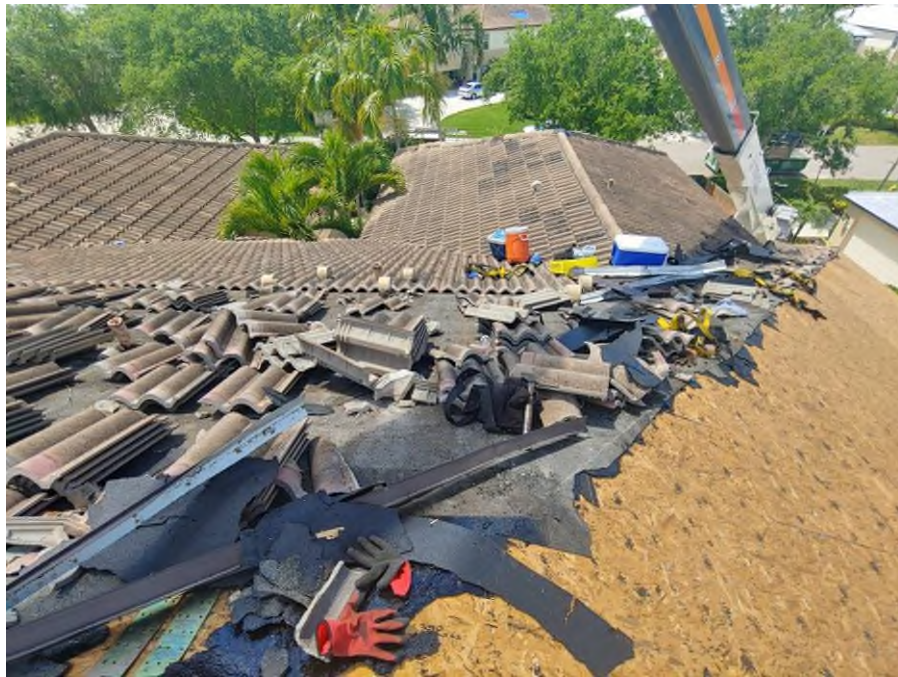
Photograph #15: Roof tile removal was in progress on building 21781.

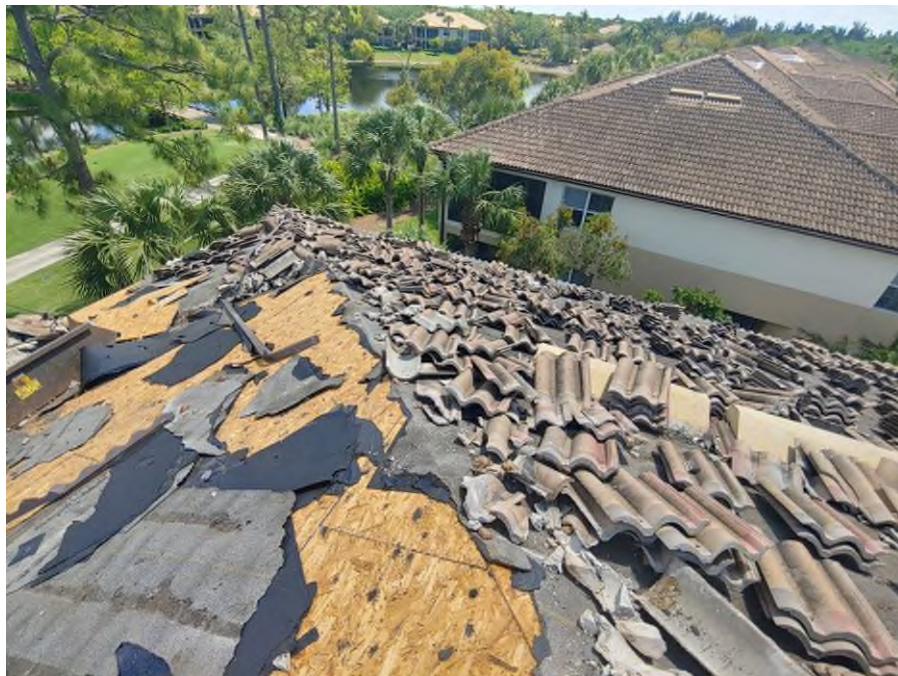
Photograph #16: Roof tile removal was in progress on building 21781.

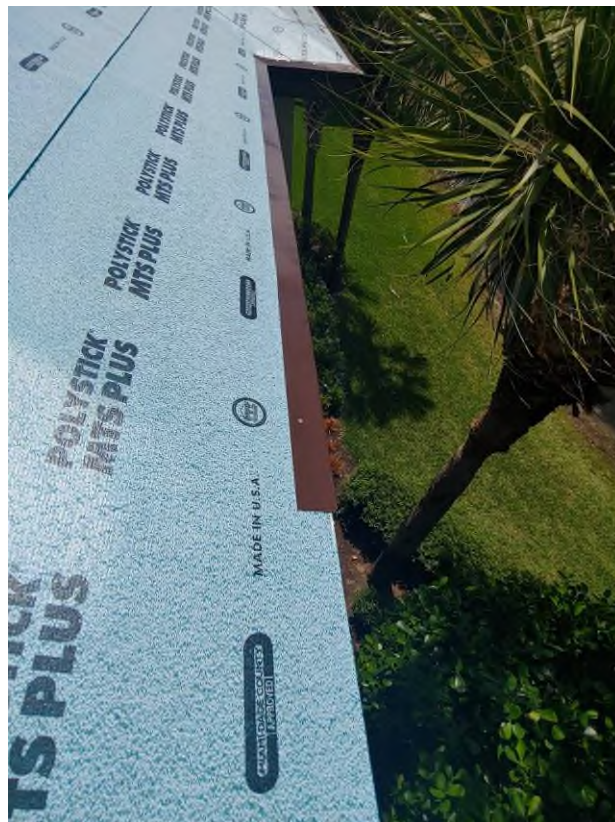
Photograph #22: Drip-edge installation was in progress on building 21810.

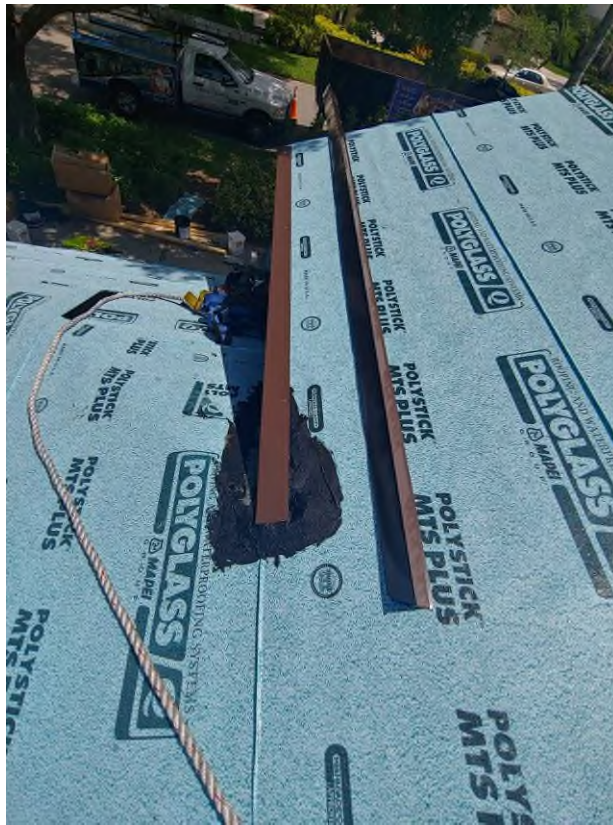
Photograph #23: Drip-edge installation was in progress on building 21810.

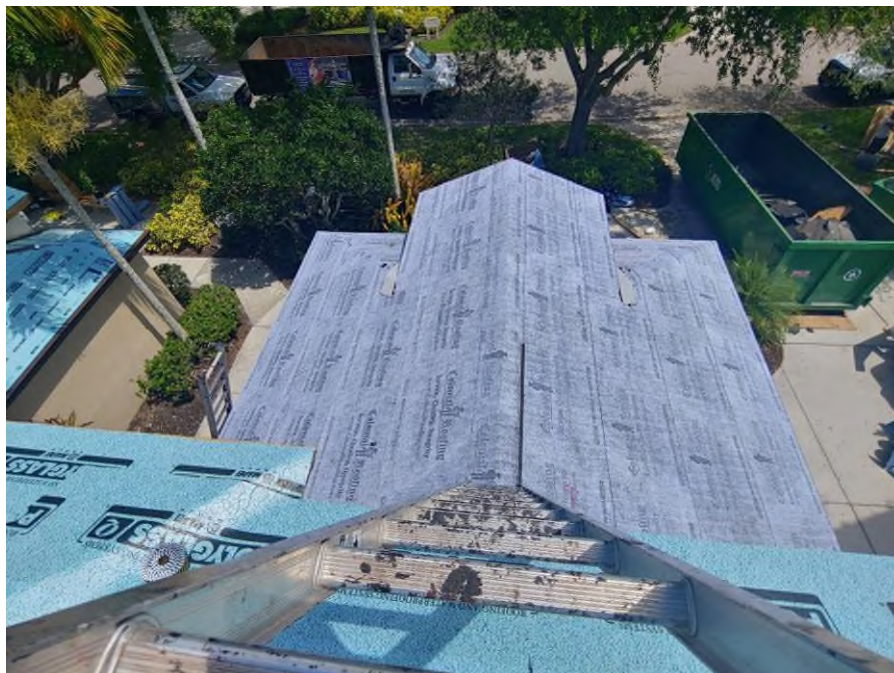
Photograph #24: Second layer of underlayment began on building 21810.

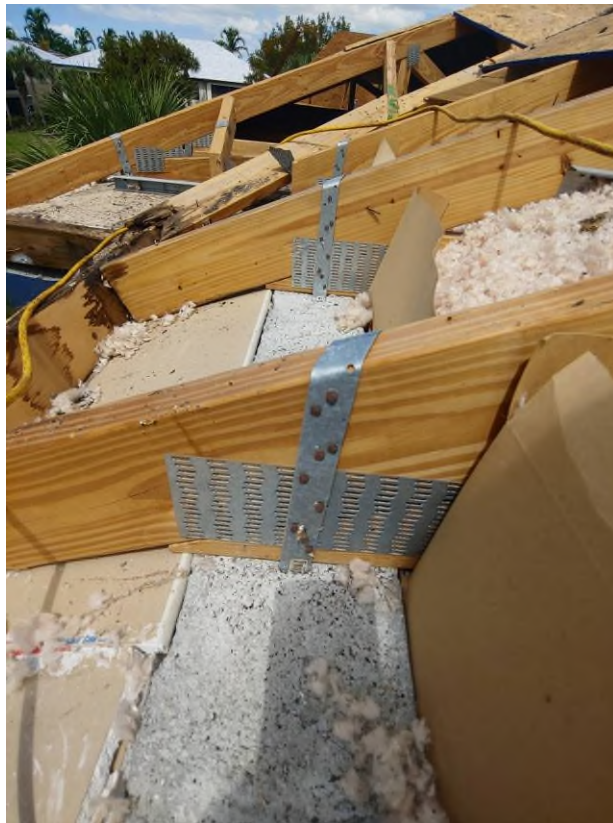
Photograph #27: Existing strap clips on the trusses have the required minimum of nails on building 21820.

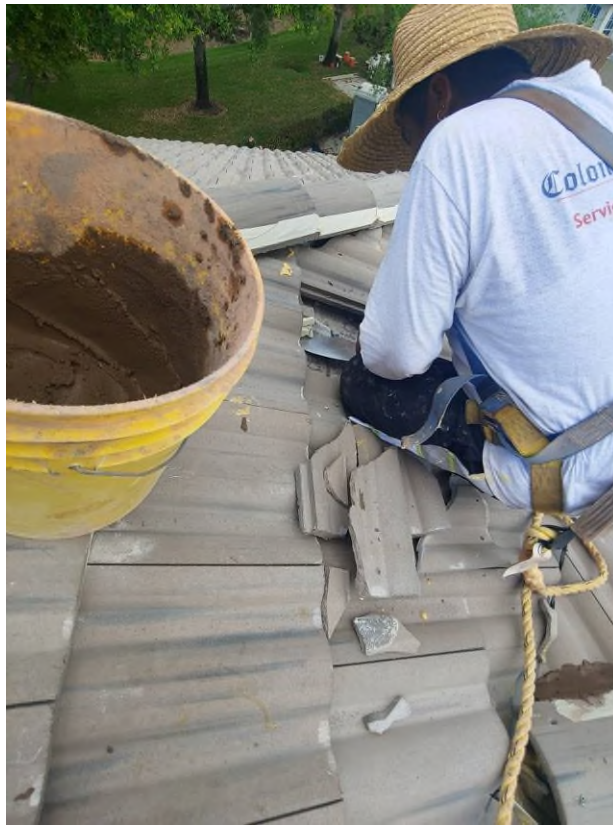
Photograph #7: Broken field tile replacement was in progress on building 21700.

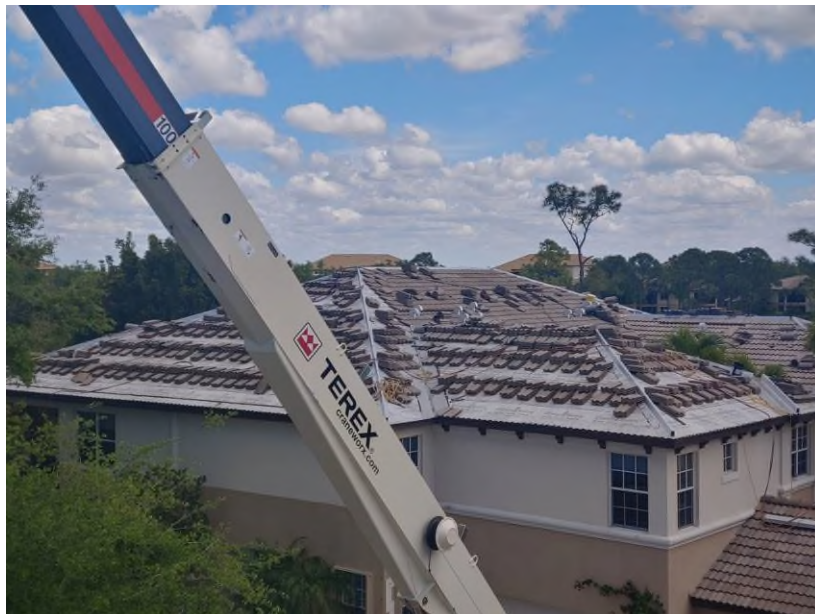
Photograph #8: Roof tiles installation were in progress on building 21711.

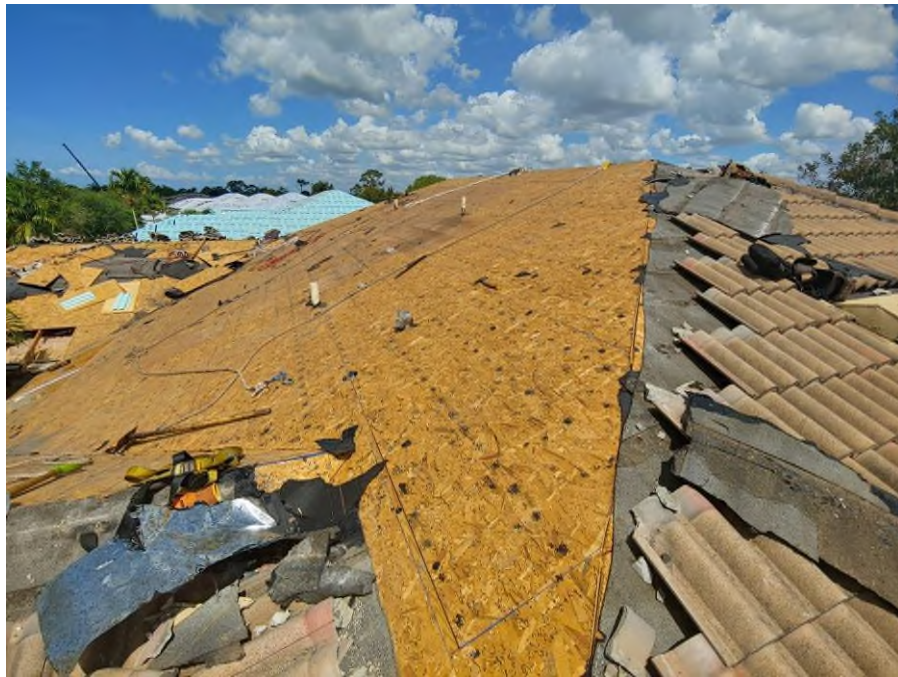
Photograph #9: Roof tile removal was in progress on building 21771.

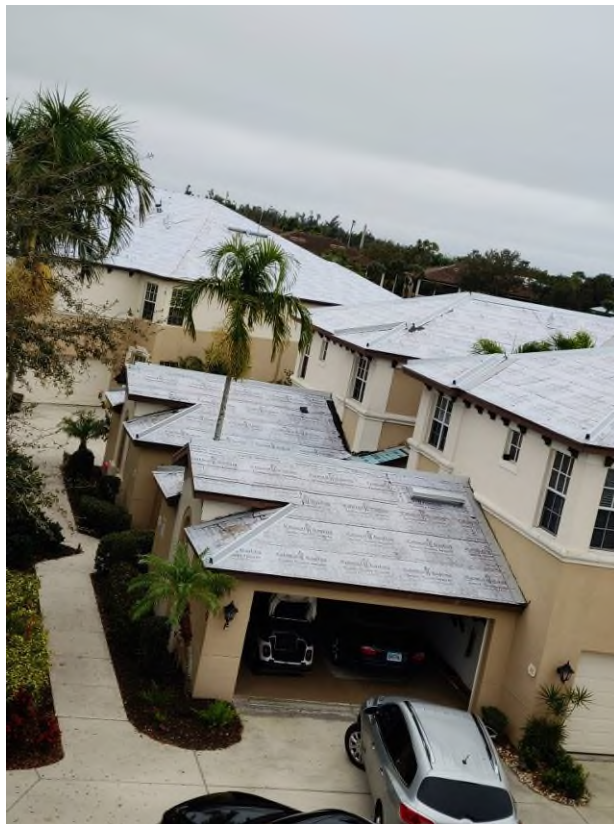
Photograph #10: Second layer of underlayment installation was in progress on building 21710.

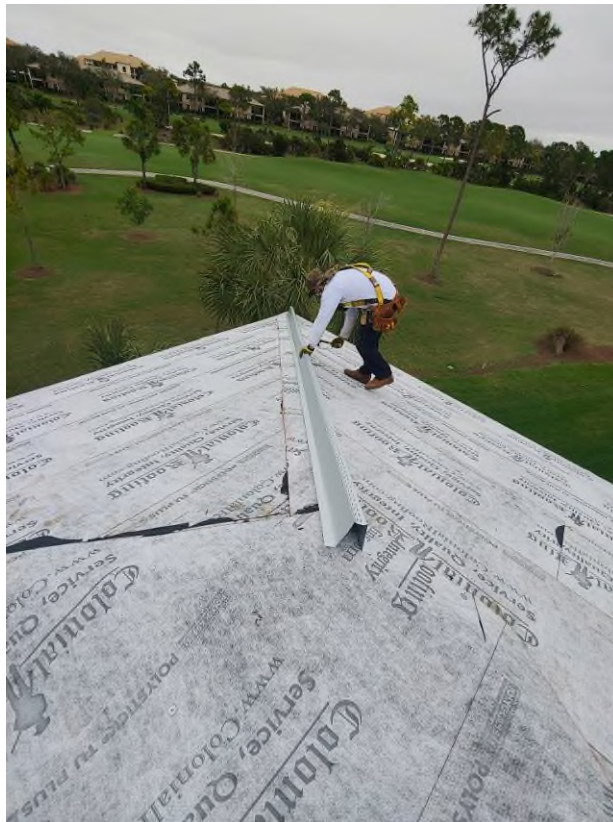
Photograph #12: V-crimp metal valley flashing, and hip/ridge metal channel installations were in progress on building 21711.

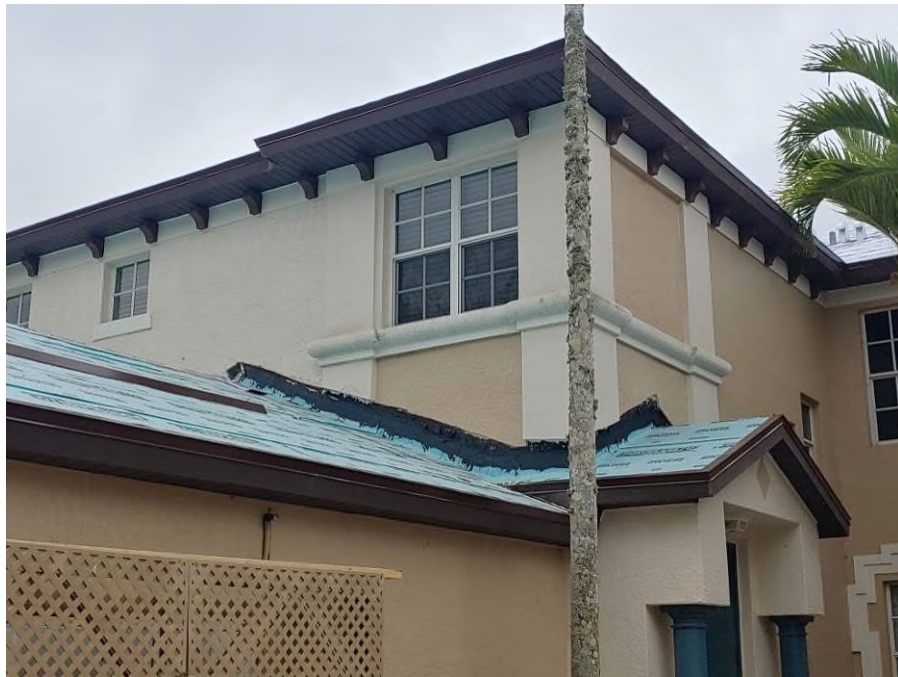
Photograph #15: Drip-edge flashing installation was in progress on building 21720.

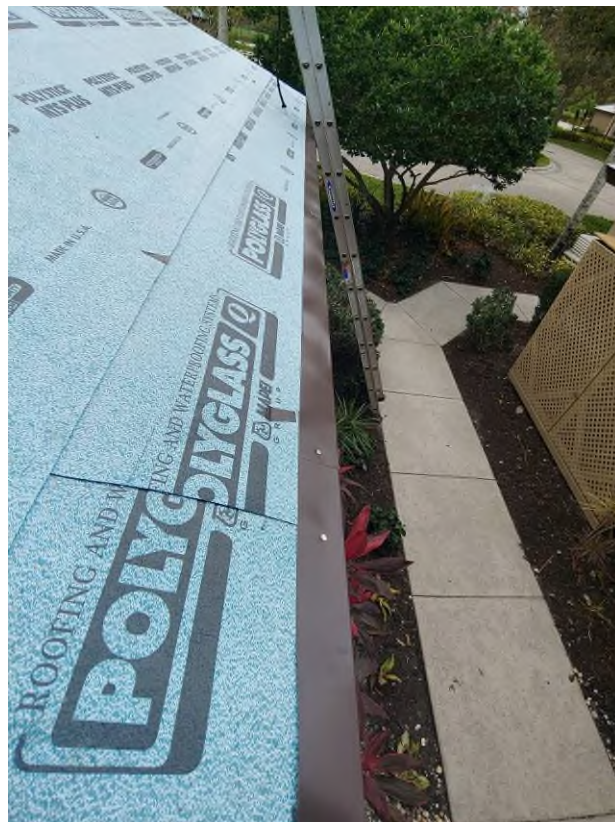
Photograph #18: Drip-edge flashing installation was in progress on building 21721.

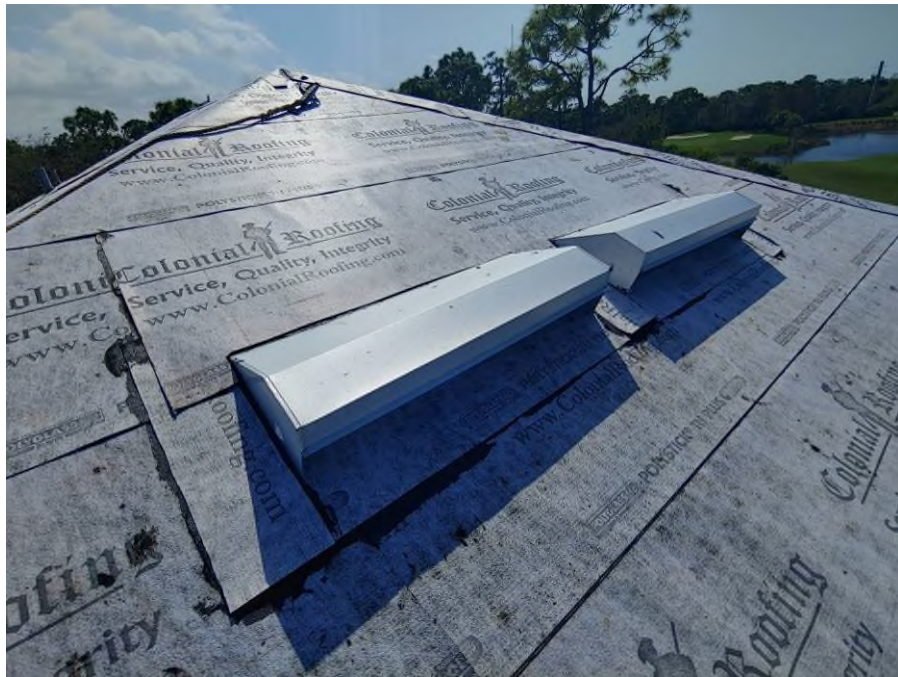
Photograph #3: Exhaust vent installations were in progress on building 7840.

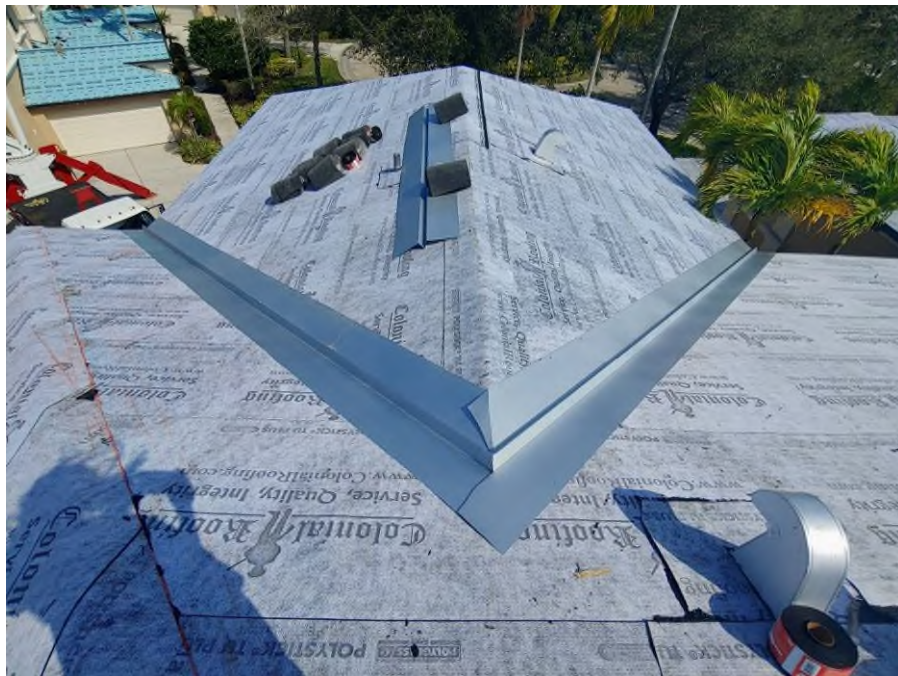
Photograph 4: V-crimp metal Valley flashing installation was in progress on building 7840.

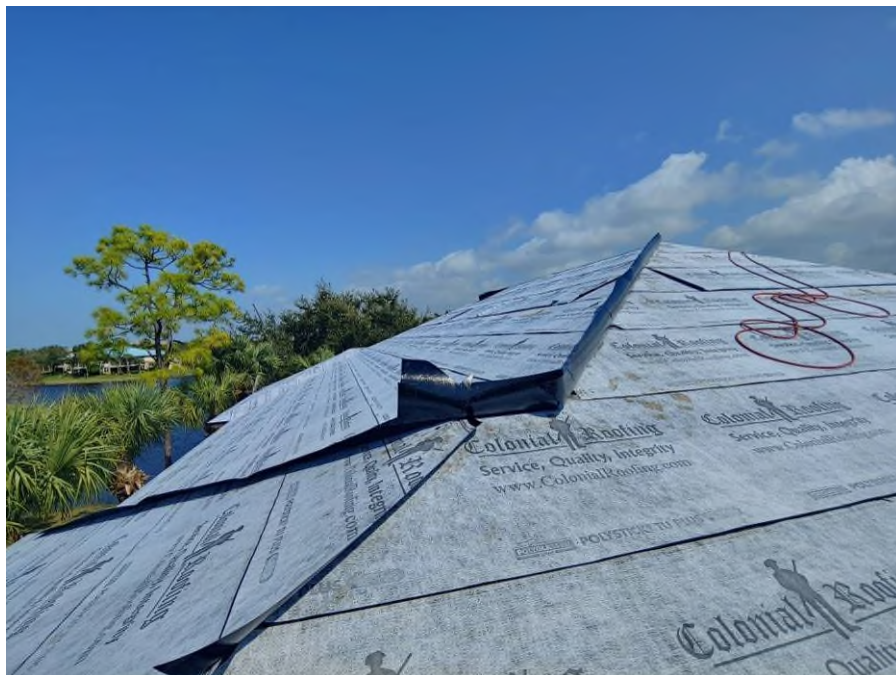
Photograph #6: Second layer of underlayment installation was in progress on building 7841.

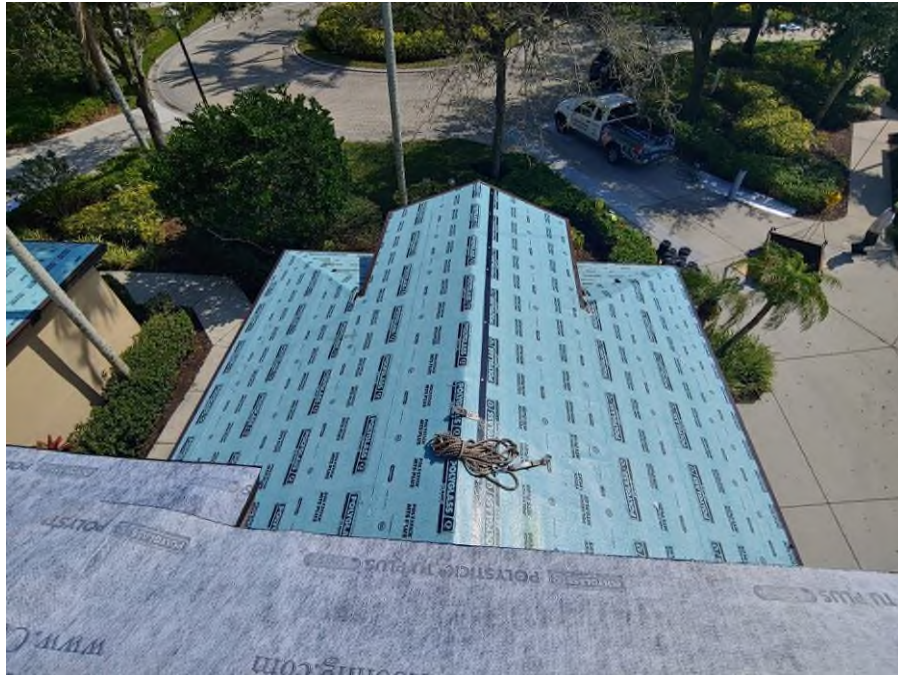
Photograph #7: Polystick MTS Plus underlayment installation was completed on building 7841.

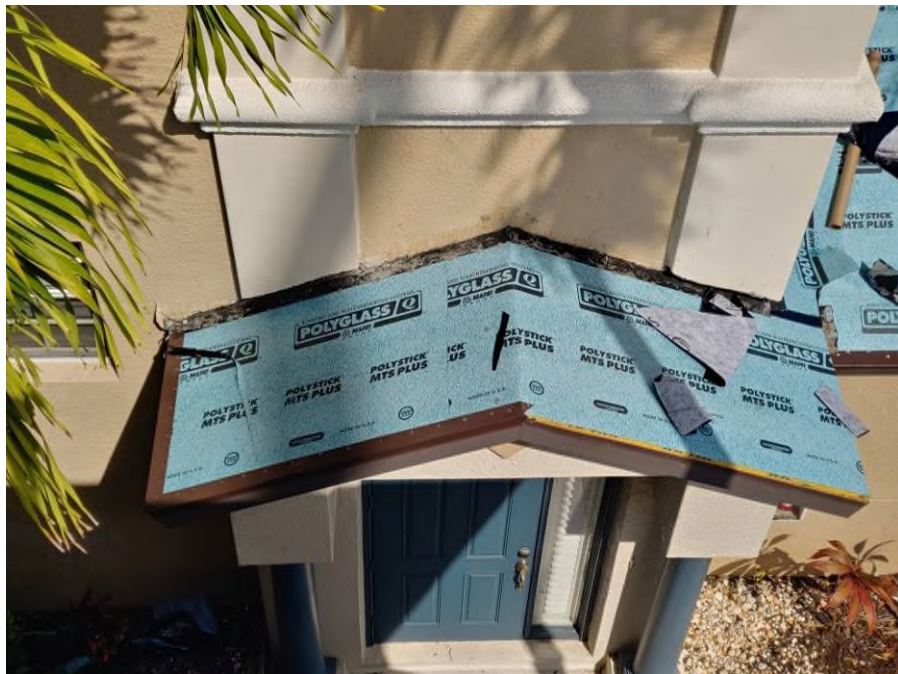
Photograph #8: Drip-edge flashing installation was in progress on building 7841.

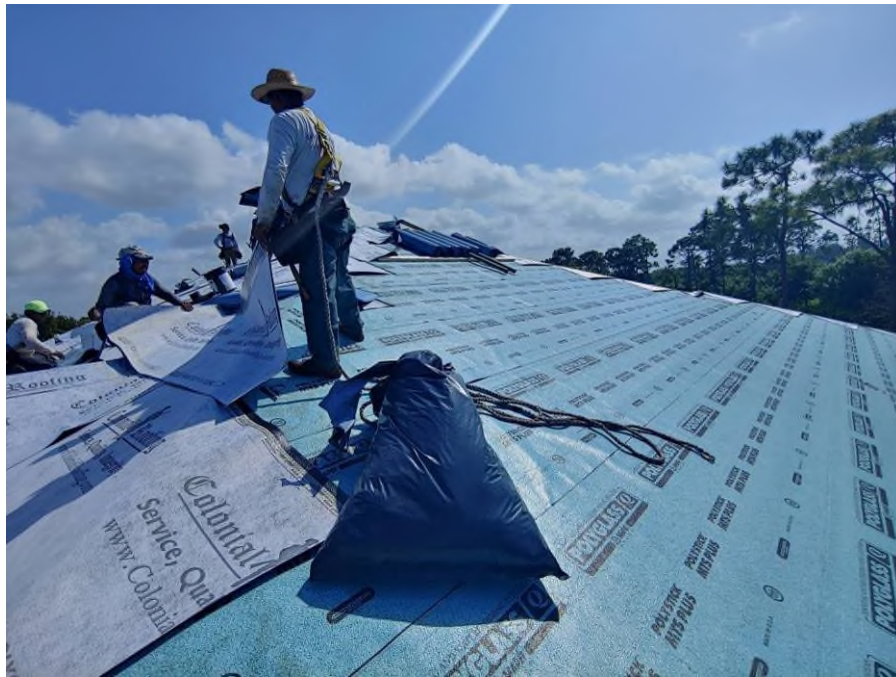
Photograph #11: Polystick MTS Plus underlayment installation was completed on building 7850.

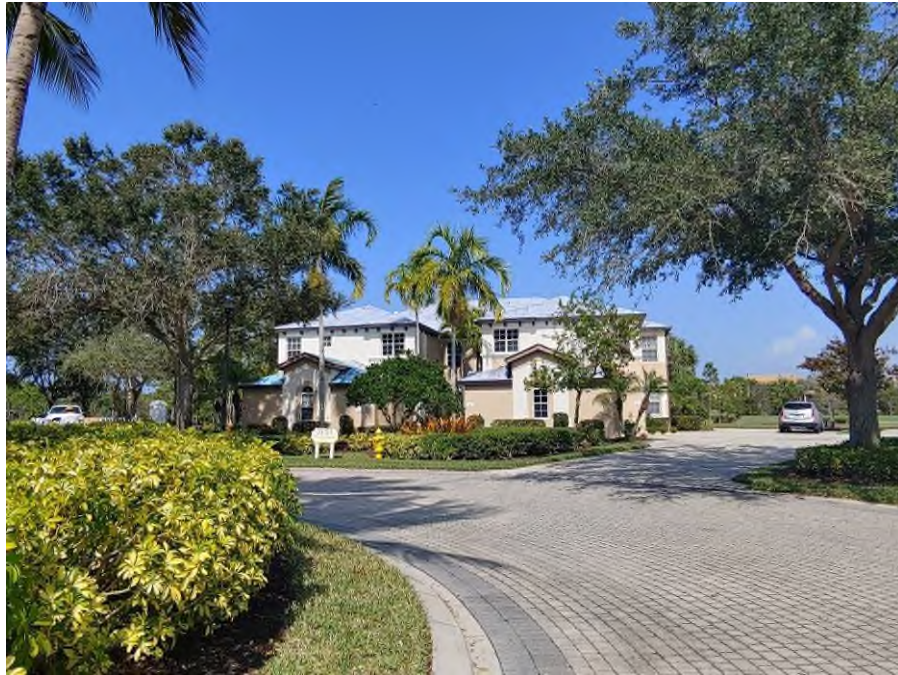
Photograph #15: Second layer of underlayment installation was in progress on building 21711.

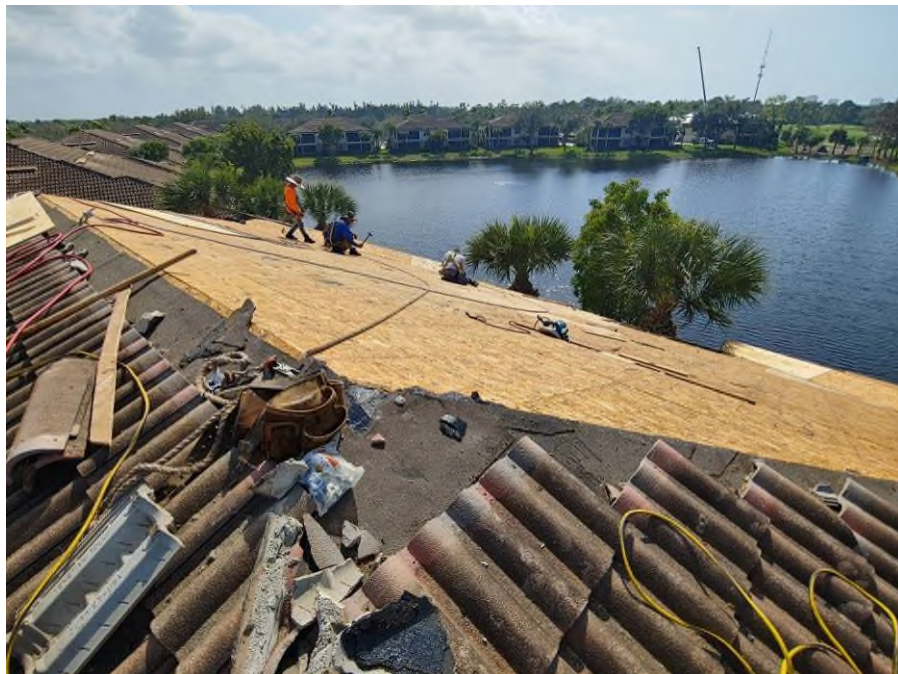
Photograph #16: Roof tile removal was in progress on building 21720.

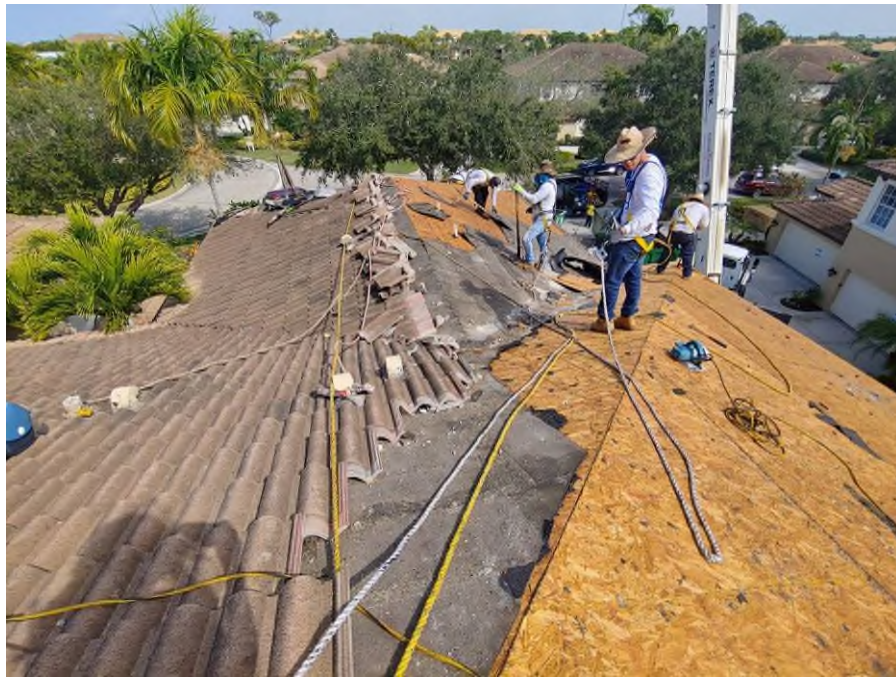
Photograph #17: Roof tile removal was in progress on building 21720.

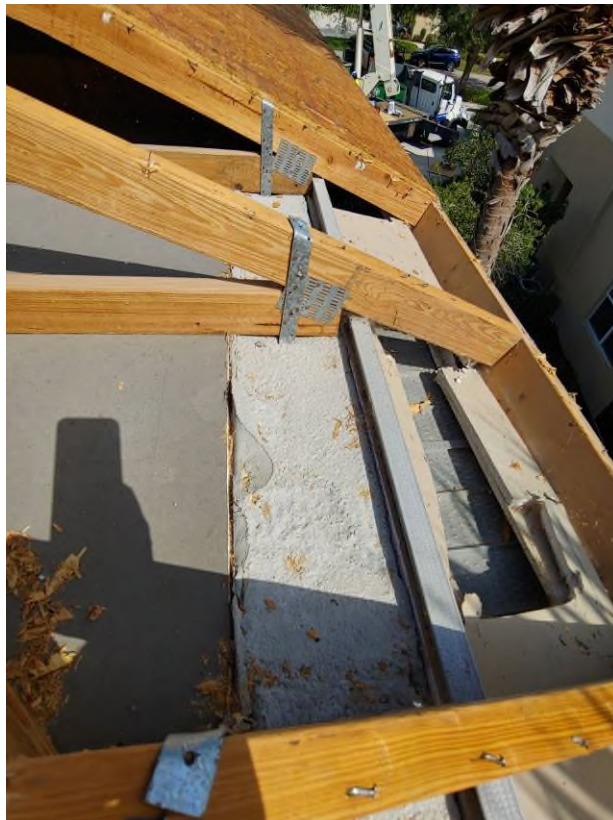
Photograph #18: Existing strap clips on trusses have the required minimum quantity of nails on building 21720.

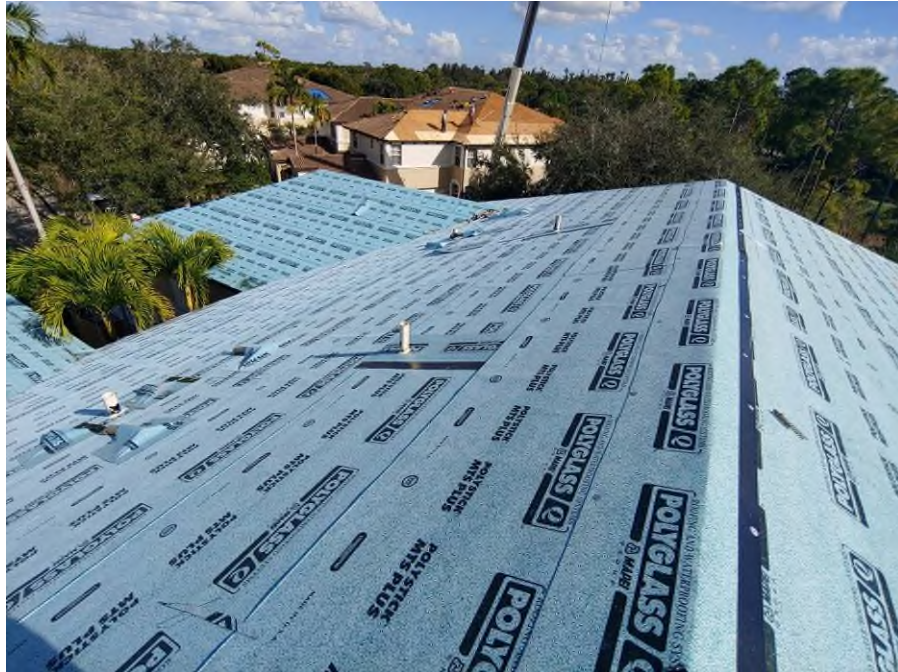
Photograph #1: Polystick MTS Plus underlayment was completed on building 7840.

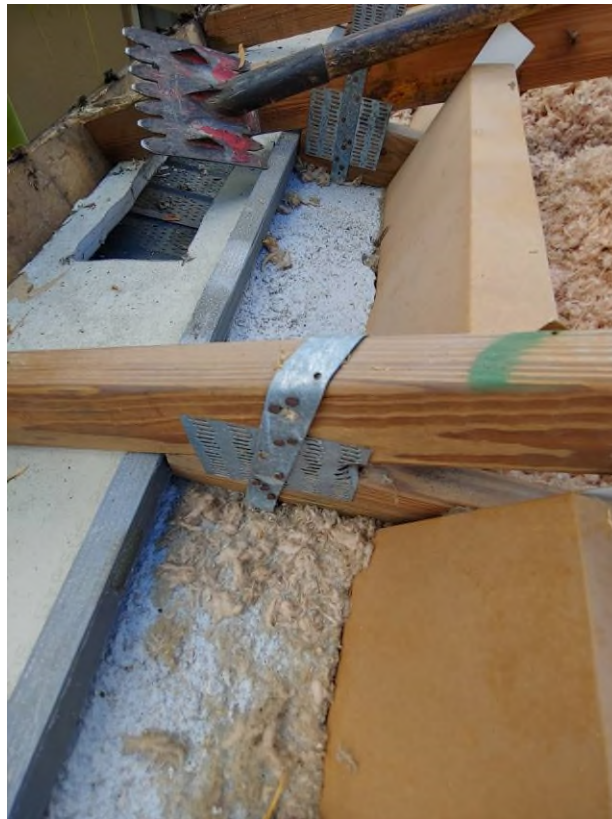
Photograph #5: Existing strap clips on trusses have the required minimum quantity of nails on building 7841.

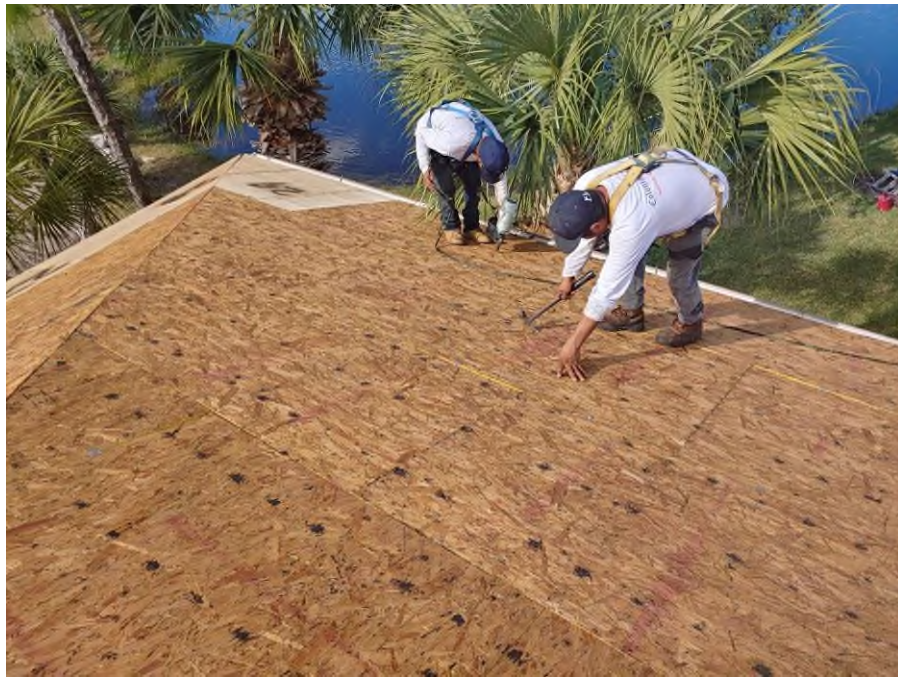
Photograph #6: Existing strap clips on trusses have the required minimum quantity of nails on building 7841.

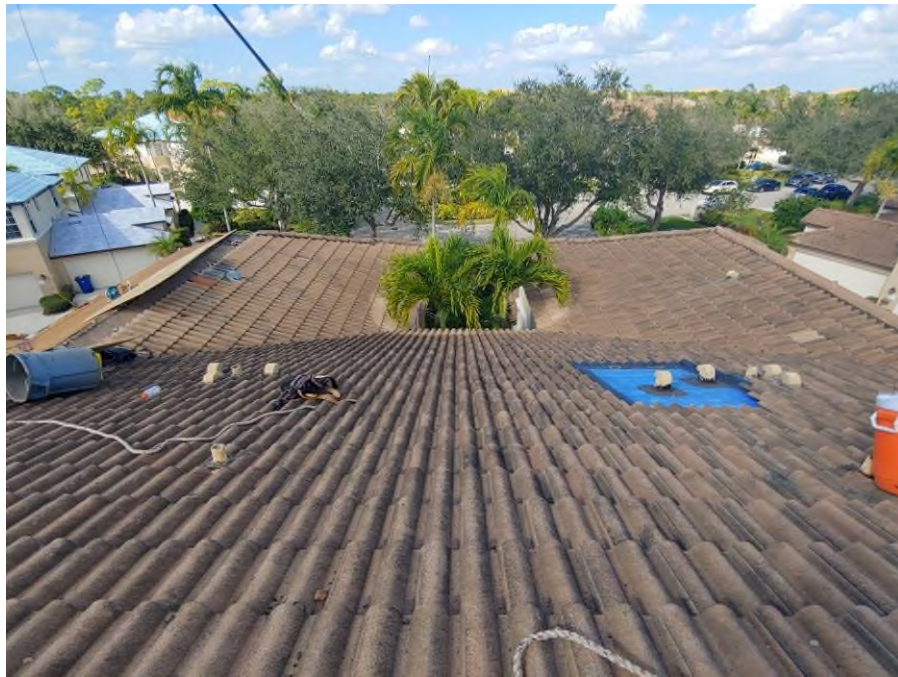
Photograph #10: Underlayment installation was in progress on the west side of buildings 7841.

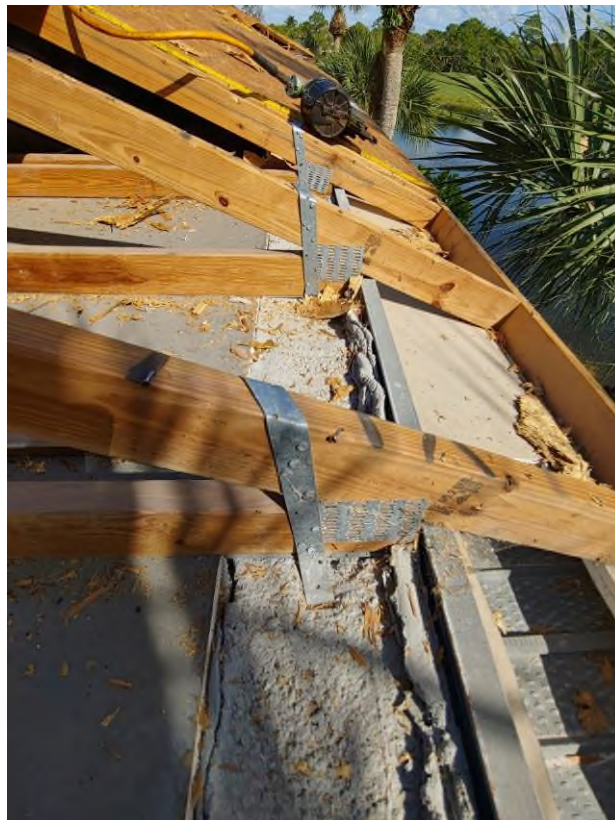
Photograph #11: Roof tile removal was in progress on building 7850.

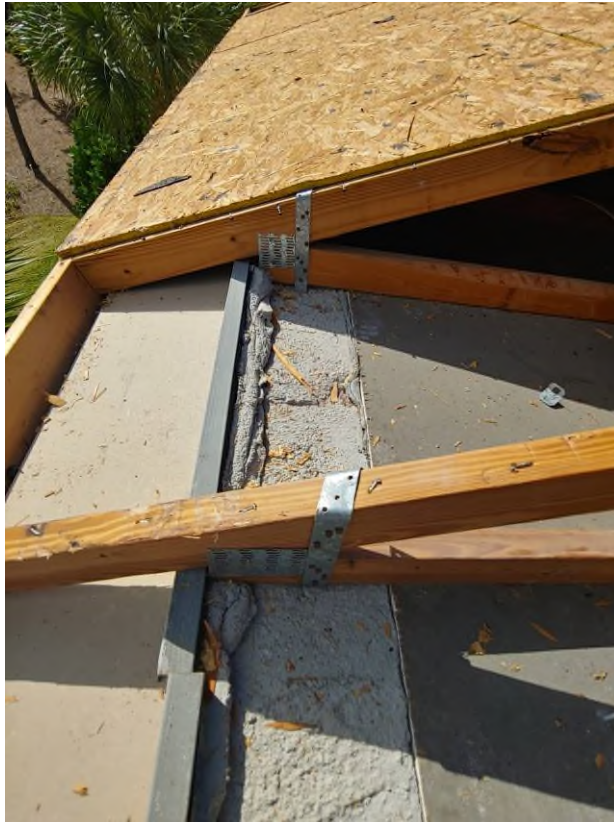
Photograph #12: Existing strap clips on trusses have the required minimum quantity of nails on building 7850.

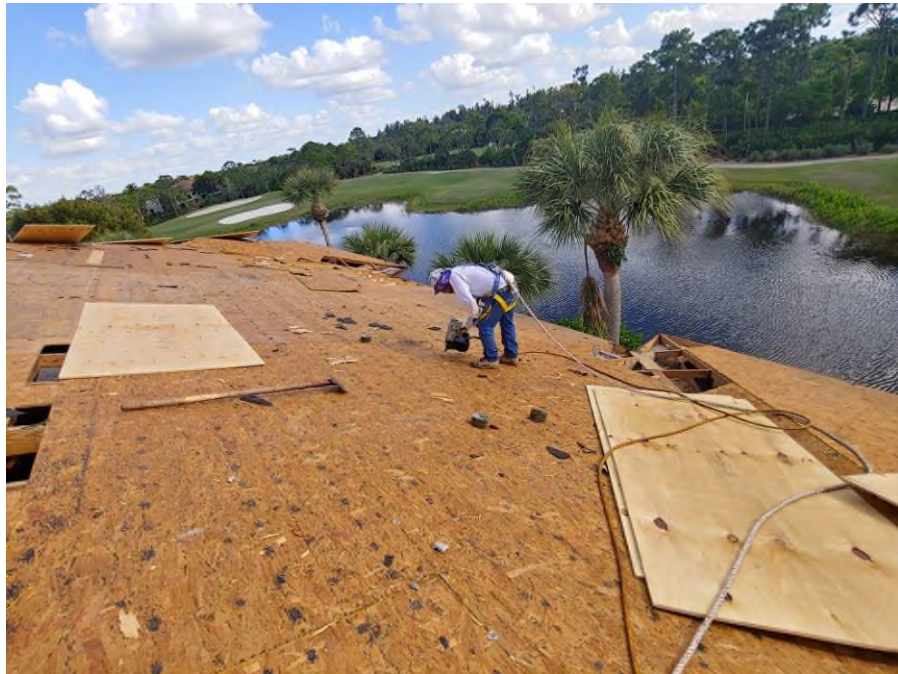
Photograph #13: Existing strap clips on trusses have the required minimum quantity of nails on building 7850.

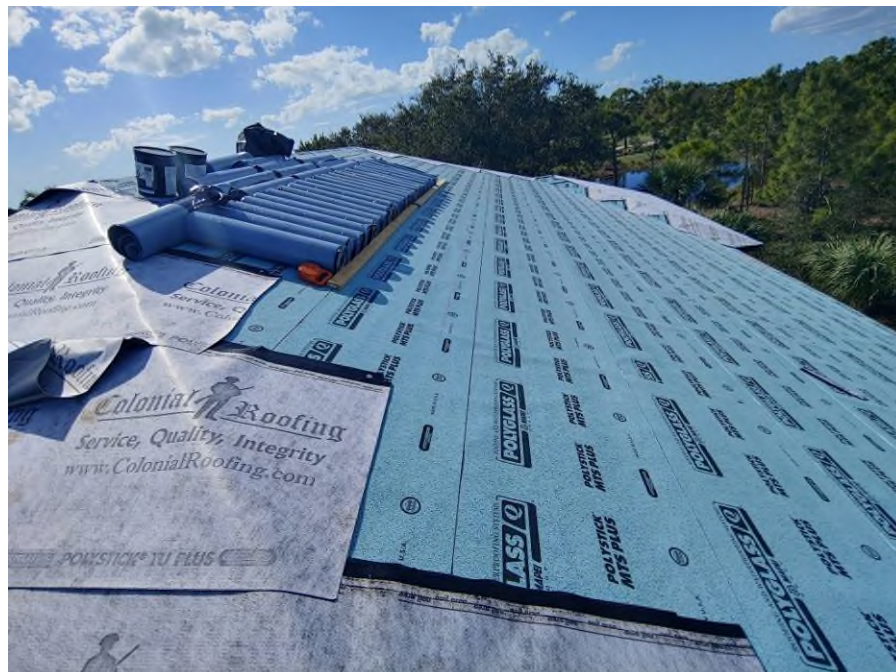
Photograph #19: Underlayment installation was in progress on the west side of buildings 21710.
