Uniform Mitigation Verification Inspection Form

Inspection Date: 06-25-2020		
Owner Information		
Owner Name: Palmetto Dunes Pelican Sound Condominium Association Inc.		Contact Person:
Address: 21711 Palmetto Dunes Drive Units 101,102,201,202		Home Phone:
City: Estero	Zip: 33928	Work Phone:
County: Lee		Cell Phone:
Insurance Company:		Policy #:
Year of Home: 2001	# of Stories: 2	Email:

DATE	March 30, 2020	JOB NO.	20RN-0085
Palmetto Dunes CAI – Roofing Project			
LOCATION	Palmetto Dunes Drive		
CONTRACTOR	EnviroStruct, LLC	Palmetto Dunes CAI	
WEATHER	Sunny	TEMP. 88° F	Time 2:30PM
PRESENT AT SITE	Rahmin Bahar, EnviroStruct (ES) Teresita Nazario-Acosta, Karins Engineering Group (KEG)

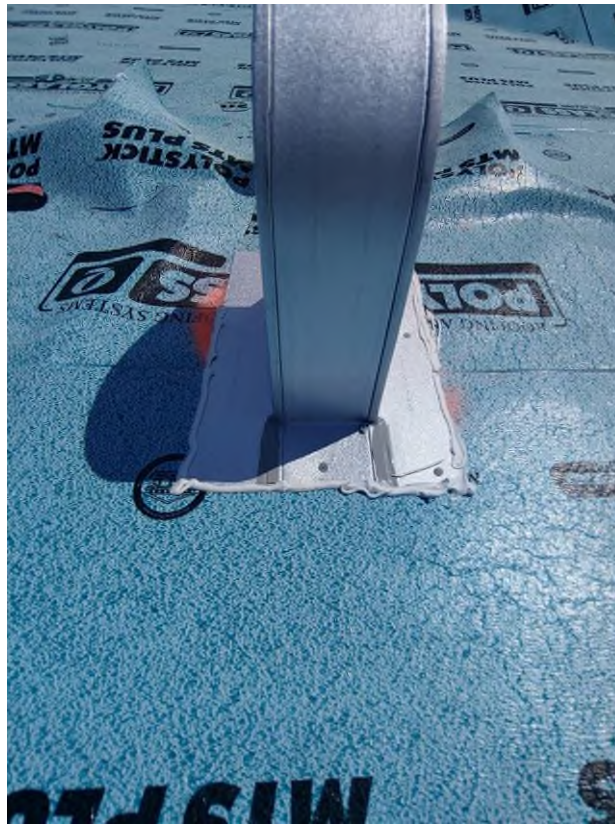
Photograph #22: Exhaust vent installations were in progress on building 21711.
